RE Official information request CDHB 9917

Appendix 2 - Hillmorton Hospital Te Whare Manaaki & Te Whare Hohou Roko – Mechanical and Hydraulic Services Inspection Report.

Hillmorton Hospital Te Whare Manaaki & Te Whare Hohou Roko

Electrical Services Inspection Report

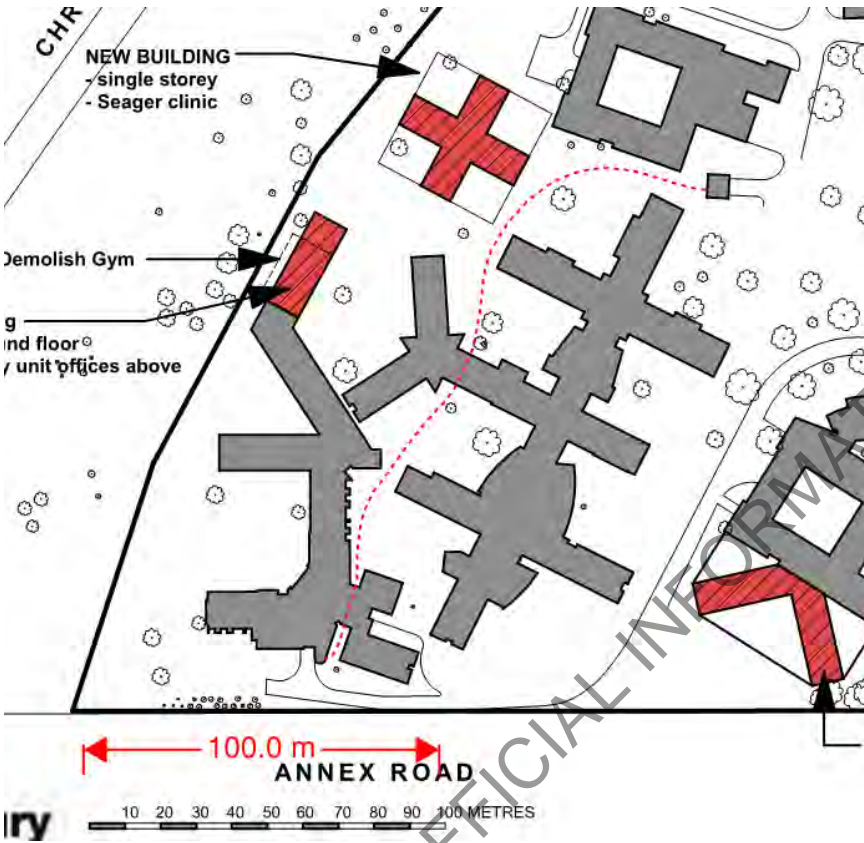
Assumed sub-main cable route from North Villa Sub-station to Te Whare Manaaki

The original electrical sub-main cable to the building main distribution board (MSB/DB.5) has been disconnected due to a faulty cable. A replacement sub-main cable has subsequently been installed. This route has not been recorded on any documents, however after a conversation with Kevin Thomas from Hillmorton Hospital maintenance team, the information gathered has produced a sketch for the likely sub-main route as shown in the figure below.

The new cable is assumed to be 3 x 1C x 240mm² Cu XLPE/PVC, over this distance the cable could support a balance load of 250 Amps per a phase, or an unbalance load of 127 Amps per phase.

It is recommended that CDHB should budget for the survey of the sub main route, as this will help with future development and maintenance. Also future investigation into the distribution board fusing is required to determine the available capacity on the incoming supply.

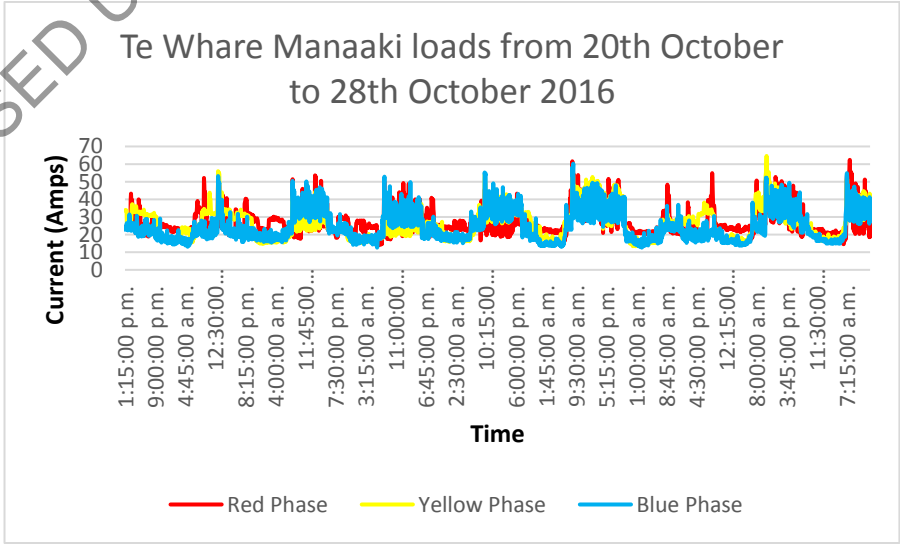
Te Whare Manaaki load graph

The maximum current recorded over 20th October to 28th October 2016 is approximately 65 Amps, as shown in graph below.

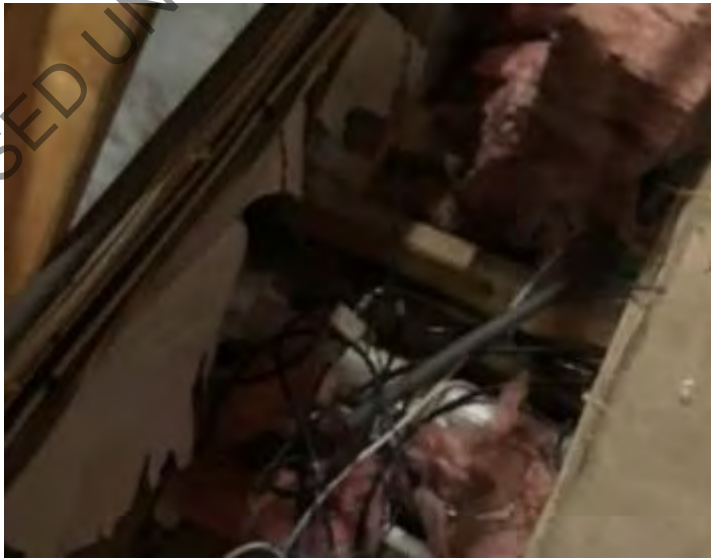
- There are currently two integral emergency lights.
 - Only one has the main indicator operational
- Exposed services at low level subject to mechanical damage

- CCTV conduits at high level are damaged and exposing internal grade cables to the external environment.

- Ensure current and new CCTV system operates smoothly.
- Upgrade the emergency lighting and signage throughout the building.
- Replace old main switchboard and distribution boards, for ease of future maintenance.
- Ensure earthing is provided between the distribution boards.
- Tidy and secure cabling in the roof void, for ease of future maintenance and reduce cable damage.
- Replace any damaged electrical outlets, lighting, etc.

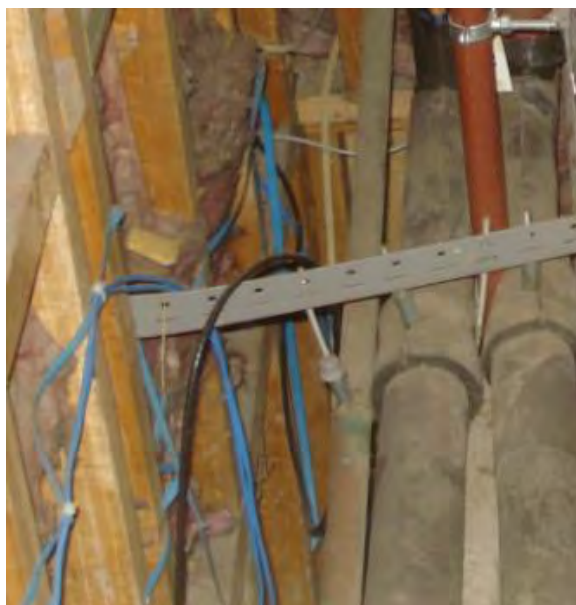
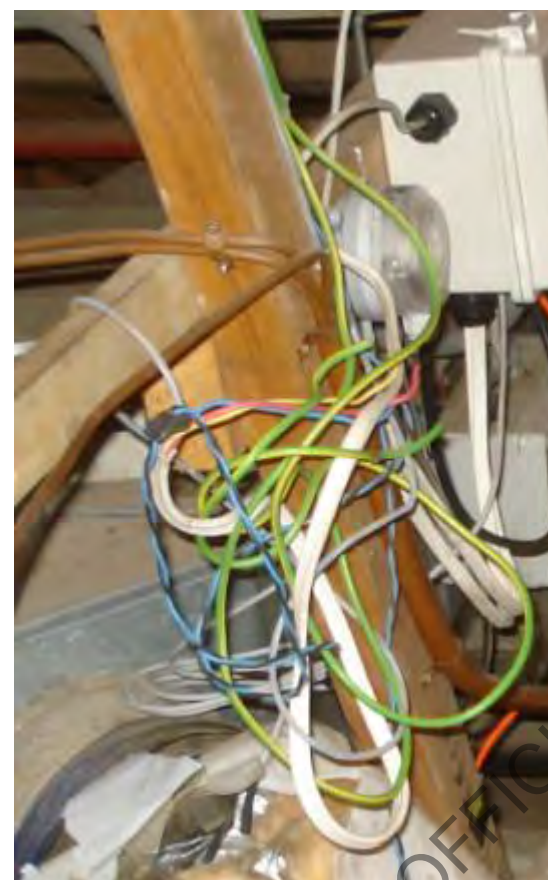
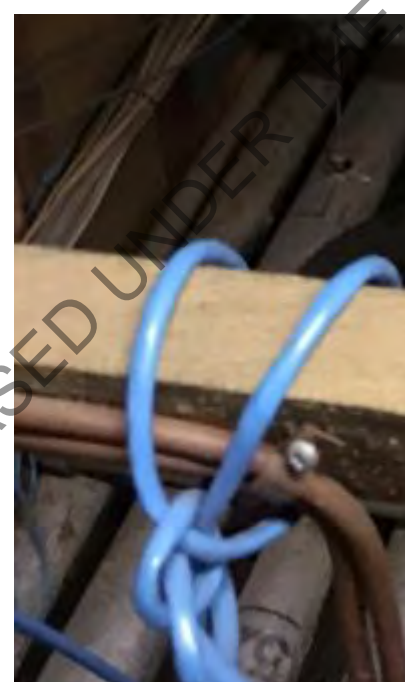
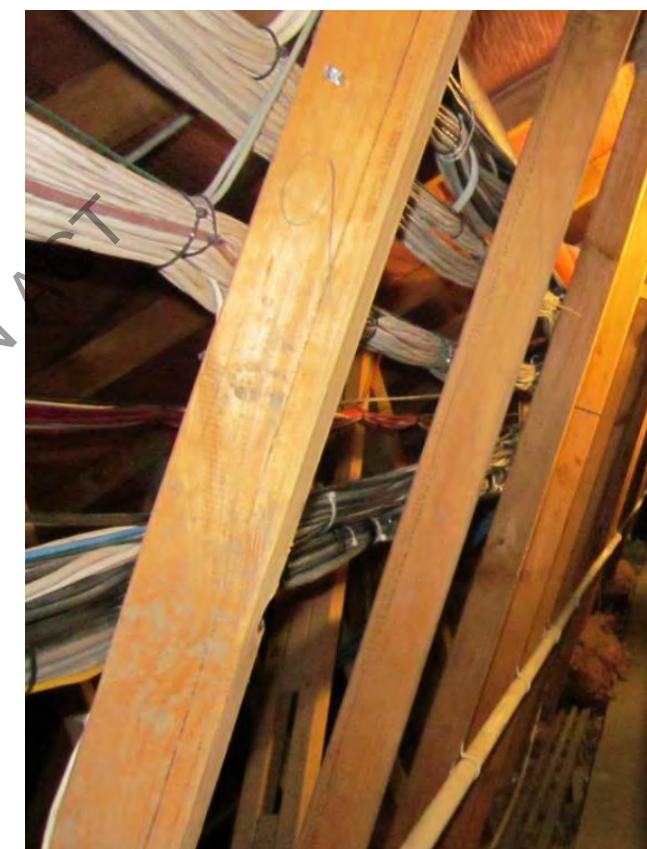
- CCTV system is currently undergoing an upgrade
- Emergency lighting not compliant
 - No emergency lights provided in patient care areas
- Two distribution boards are installed throughout the building
 - Incoming electrical main is protected by 400 Amp Moeller MCCB and set at 300 Amp.
- Existing luminaires are old fluorescent type.
 - Luminaires could be updated to LED type, to reduce operating costs.

- Ensure that current and new CCTV system operates smoothly.
- Upgrade the emergency lighting and signage throughout the building.
- Tidy and secure cabling in the roof void, for ease of future maintenance and reduce cable damage.
- Replace any damaged electrical outlets, lighting, etc.

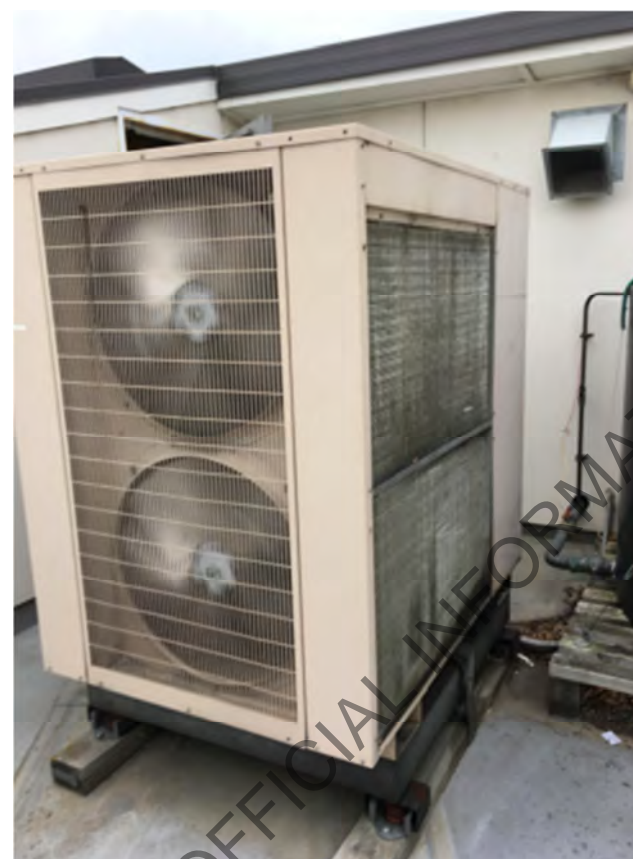
The chillers manufacture Temperzone, has confirmed that both the PWAC and UCA model chillers utilise R22 refrigerant gas. This refrigerant has been phased out due to its ozone depletion properties and the use of drop in or replacement gas is not permitted by the manufacture. For this reason CDHB should budget for the replacement of these chillers as failure may occur in the coming years.

'Te Whare Hohou Roko' – Chiller Enclosure

'Te Whare Manaki' – Chiller Enclosure – Could not be inspected due to access.

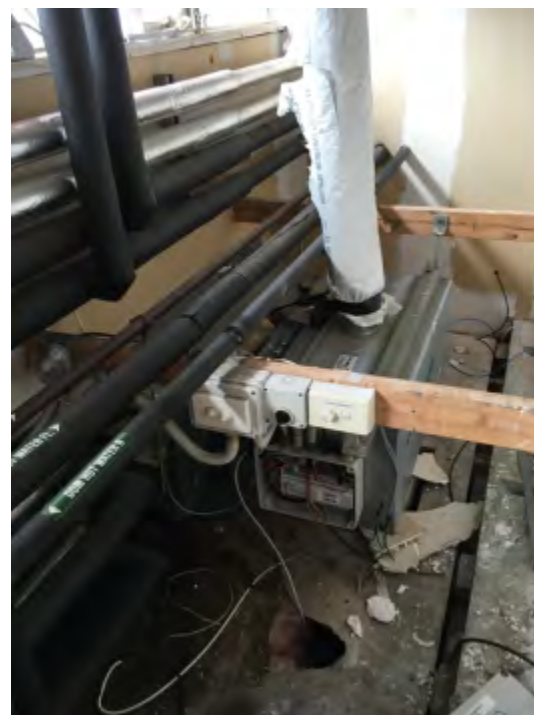
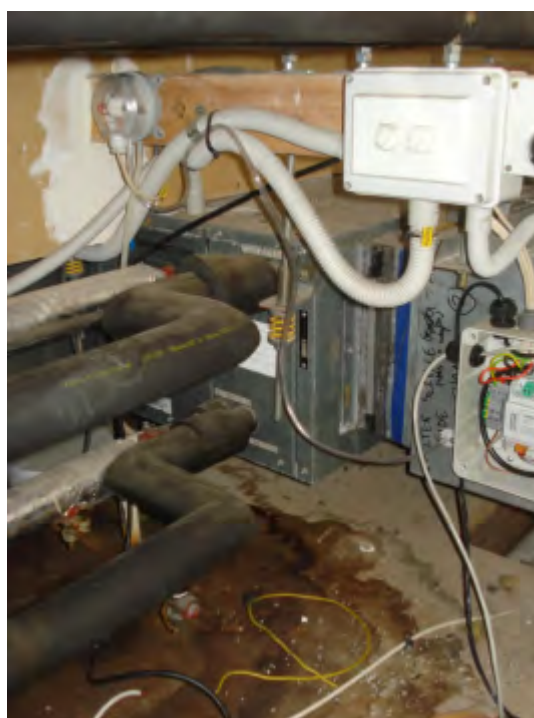
Pictured above are examples of two installed FCU's in the Seclusion Area Plantroom. It can be seen that the general condition of the plant area is poor and there is some evidence of water damage to the plantroom floor where holes have developed over time. Redundant control wiring is visible in both photos and it suggests that modifications to the FCU's

controls have been undertaken at some point, with controller casings not being re attached to the units. Also visible is the poor condition of existing flexible ductwork.

- 2) Replace all defective ductwork associated with FC-1, FC-10 & FC-15.
- 3) Confirm temperature control methodology for fan coil units, review the possibility of room temperature sensors.

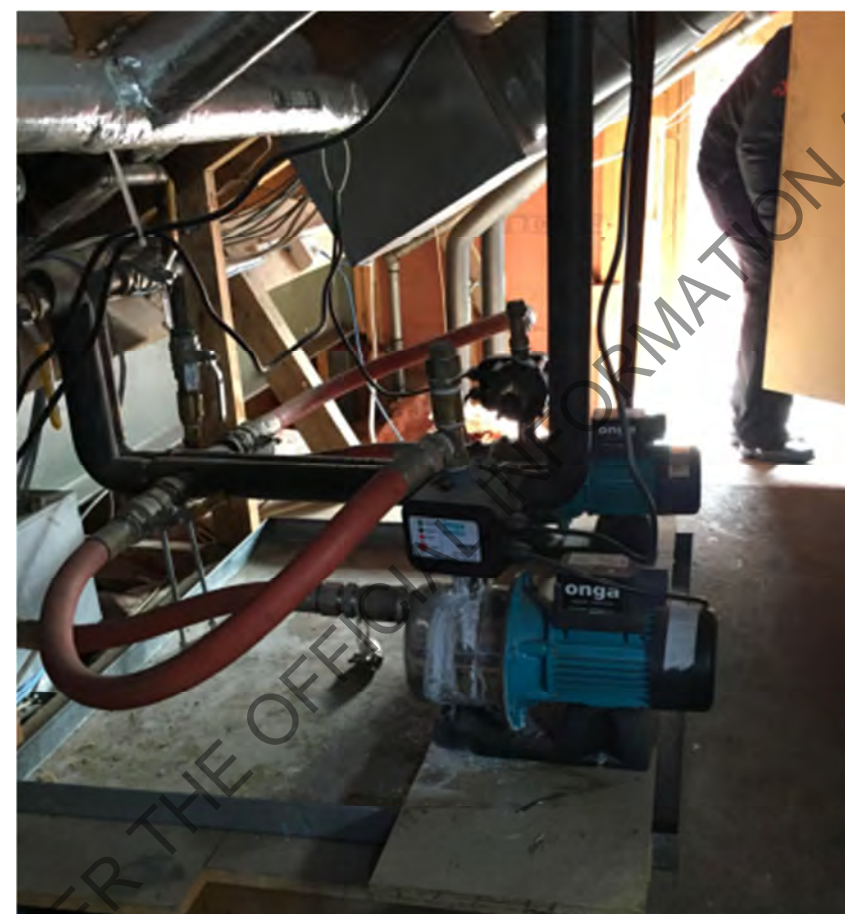
Pictured above are the local domestic hot and cold water booster pumps which have been provided to ensure adequate water pressure in the Seclusion Area.

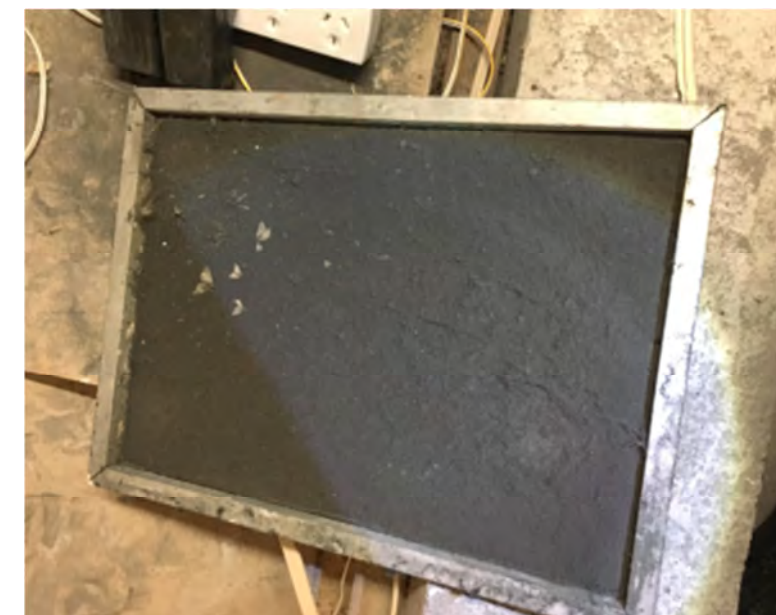
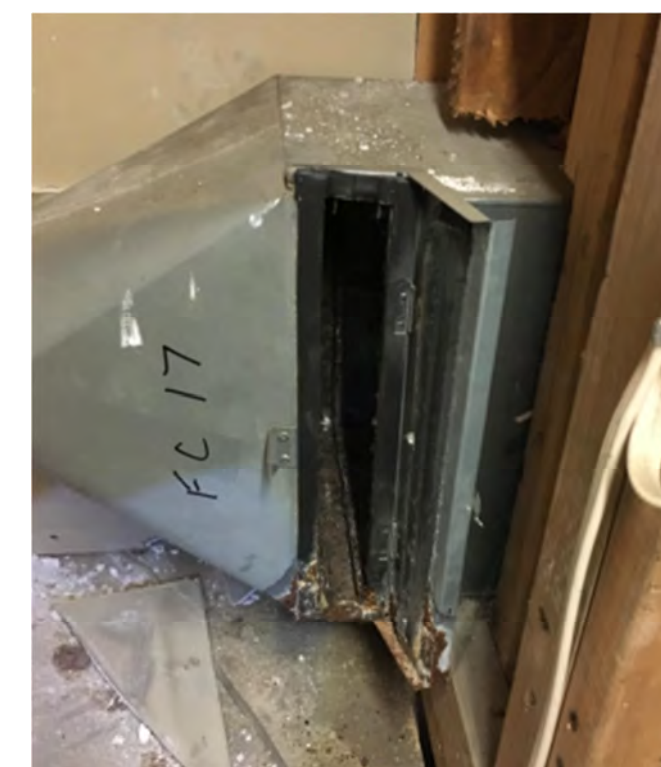
Pictured above are the local air-intake filter and filter frame providing outdoor air to the Seclusion Area, it is clear from the photo's that their condition is poor, evidence of rusting and filter loading is clear. It is likely that the outdoor air fan is not delivering the design outdoor air to the seclusion rooms.

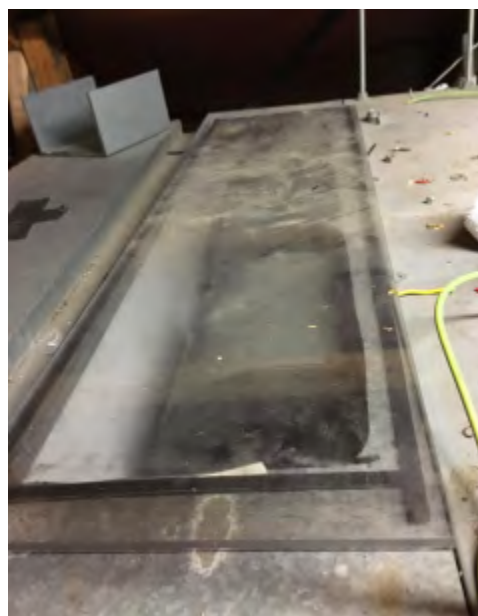
- FC-10 was found to have suffered a fan failure in the past and is now provided with a make shift perspex panel in order to allow the maintenance staff to confirm the fan operation, this is not air tight and is likely to be significantly reducing the volume of conditioned air returning from the rooms (refer to Inspection photos below).

Shown above is the condition of FC-10 fan casing, as can be seen a make shift Perspex panel was been provided to allow visual inspection of the FCU fan following a fan failure. While this is a 'out of the box' solution to the monitoring the fan motor status it is not a long term solution.

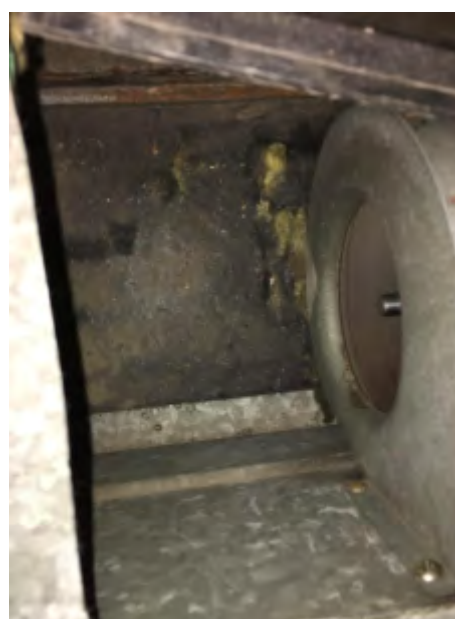
As shown is the condition of the internal fan motor housing, with casings visibly rusty with internal insulation lining beginning to fail with fibre migration highly likely.

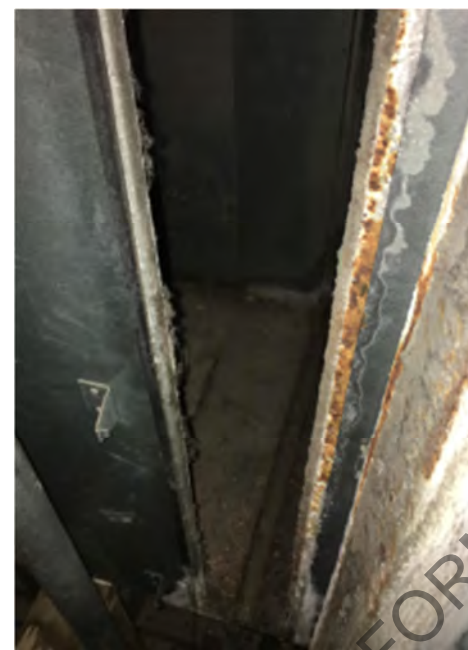
Shown above is the air intake housing associated with SF-2 and the rusting of the outdoor air intake suggests that rain is being drawn into the system resulting in the poor condition of the ductwork and filter housing.

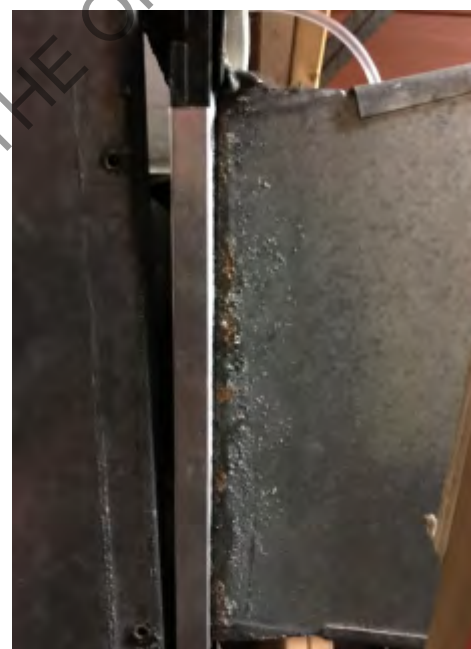
The condition of air filter housing associated with FC-casings and their air tightness is a concen. Fibre migration, dust etc. can by-pass the filter and be transported to the occupied spaces below.

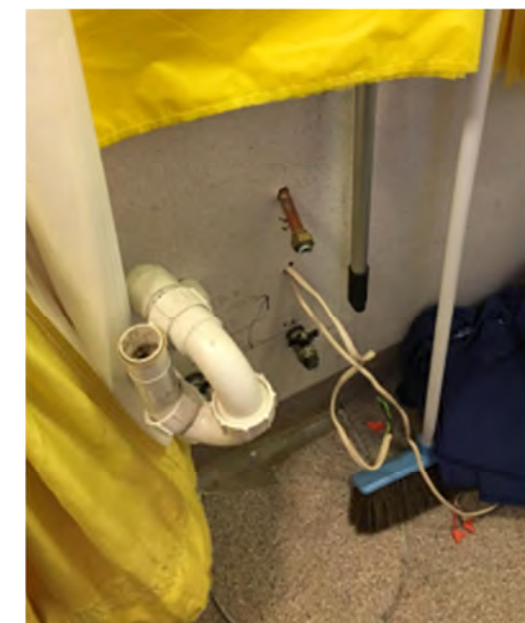
Room G032 has an adjoining Room G032A which was once provided shower and toilet facilities and is now being used as a store room. As can be seen in the photo above the plumbing and drainage connections for the old fixtures are still inplace and need to be properly capped and removed.

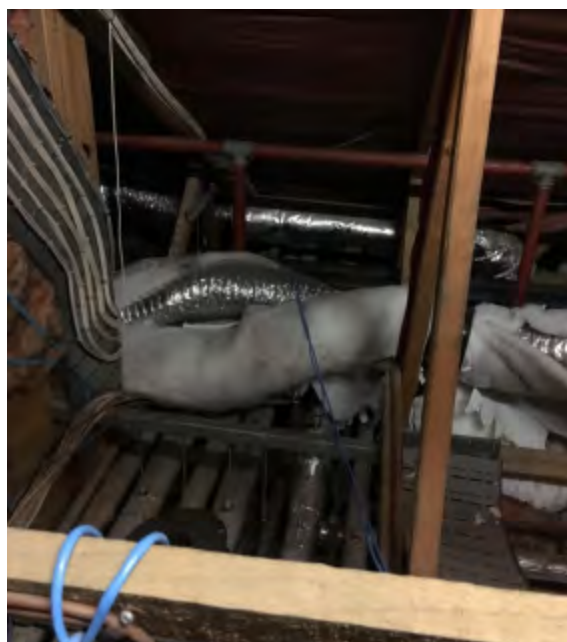
Pictured above is a section of flexible ductwork from FC-1 reticulating to the Housekeeping (G029) & Clinic (G088) Rooms. As can be seen the ductwork insulation has completely detatched from the inner ductlining and the ductwork is also unsupported adding to the FCU fan resistance and reducing system performance.

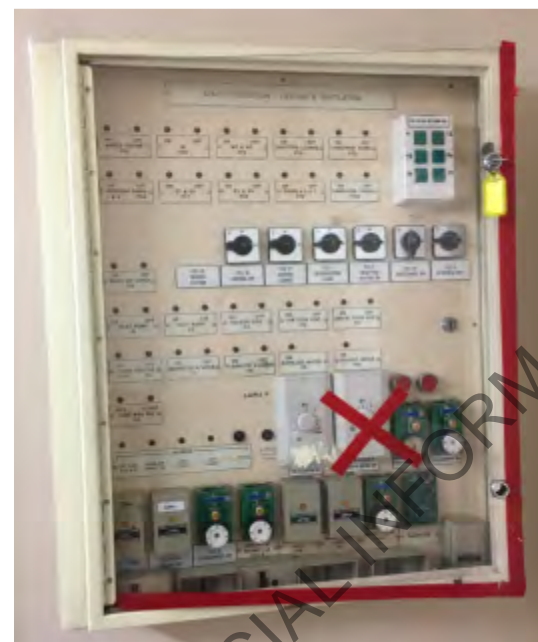
Shown above is the MCC panel for the 'Te Whare Manaaki' building wing, the panel shows some signs of past upgrades. This panel would be replaces as part of any building upgrade works .

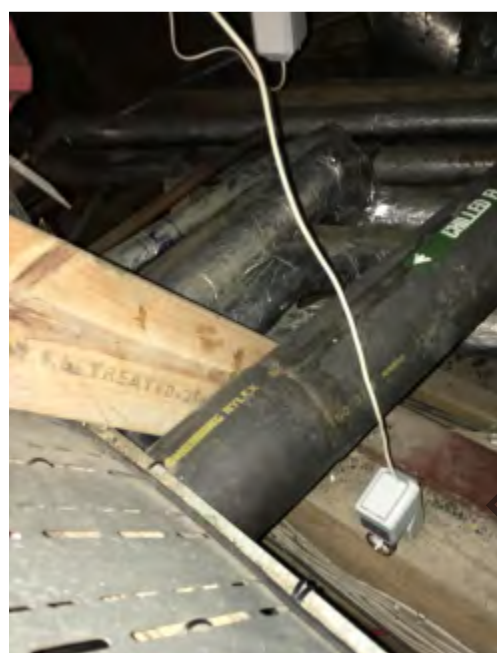
detatched and left sitting next to the unit, this eliminates the control ability of the FCU.

Pictured above is a 3 port valve motorised valve actuator which should be controlling the output of the heating coil associated with FC-1. This valve acutator has been

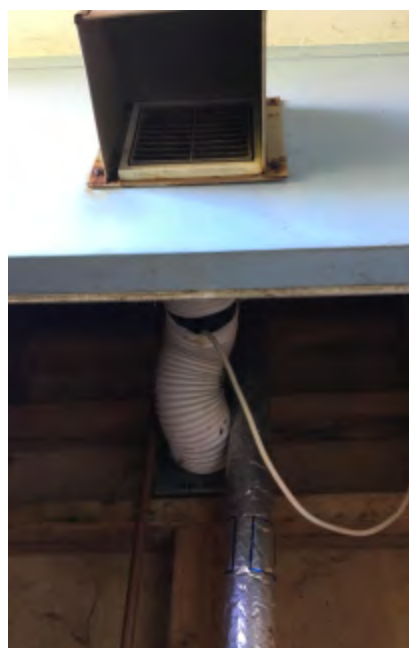
Pictured above is a defective bathroom fan from one from bedroom G058. If these systems are not operational they should be removed.

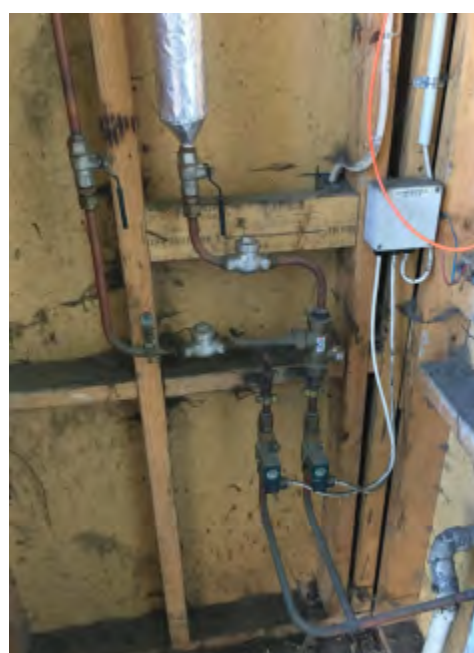
Pipework insulation has been provided on the hot water pipework, however both the hot and cold water pipes should be insulated as they are located in an uninsulated service cupboard.

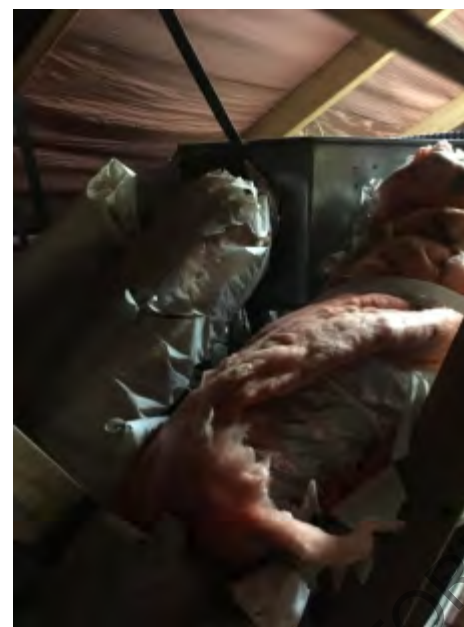
Shown in the photos above is the condition of the fan coil unit secondary ductwork, the efficiency of the system will be greatly reduced due to its poor condition. Design airflow will also be greatly reduced due to the pinhole leaks etc. in the ductwork network.

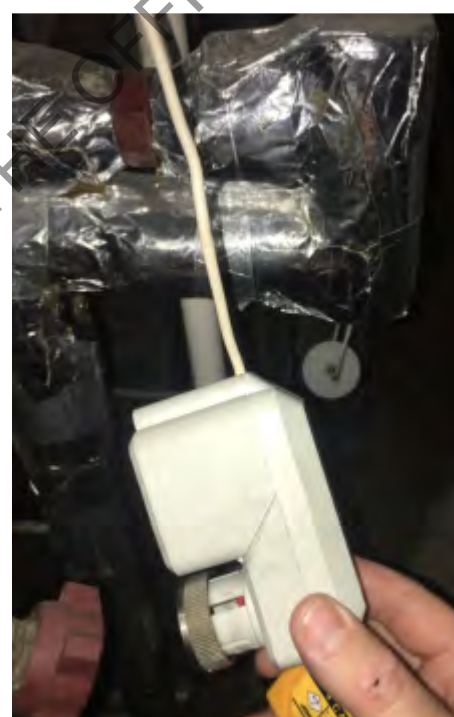
Pictured above is a 3 port valve motorised valve actuator which should be controlling the output of the FCU heating coil. This valve acutator has been detached and left sitting next to the unit, this eliminates the control ability of the FCU.

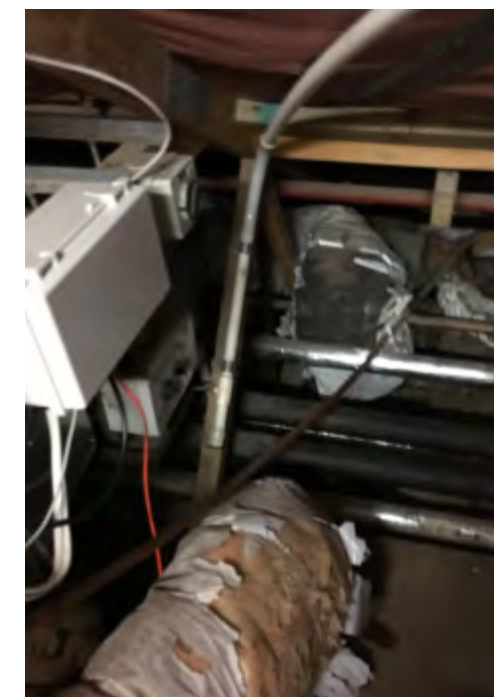
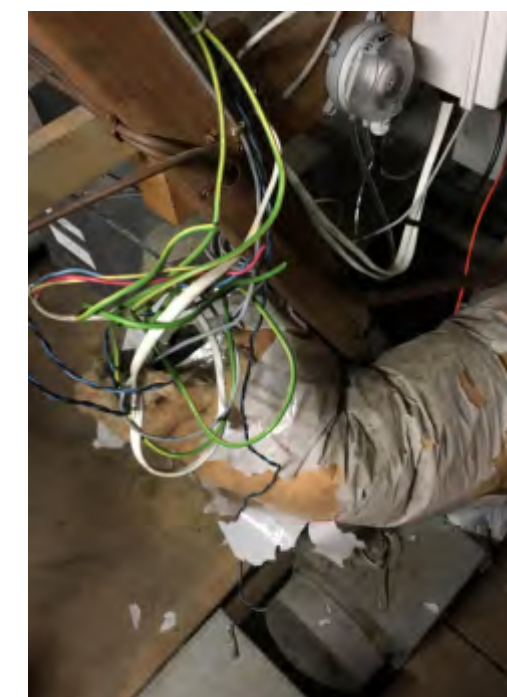
Further examples for the poor ductwork condition is evident in the photos above, also visible are modifications to the control wiring which has been modified and or replaced in an untidy manor with the redundant cabling being left in place.

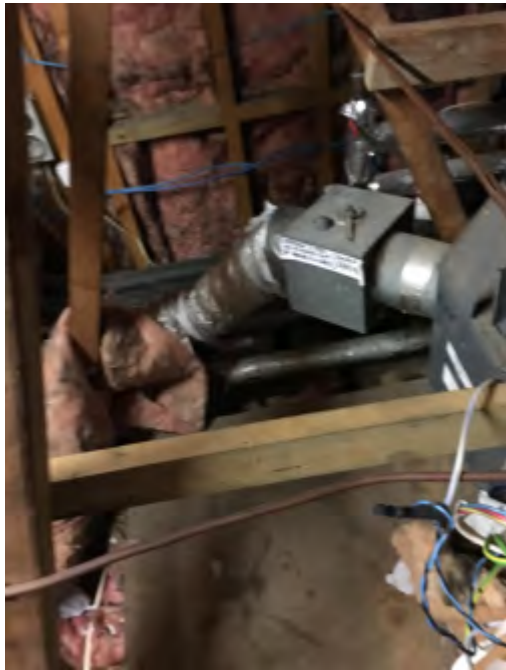
Further examples of the poor ductwork condition is evident in the photo above.

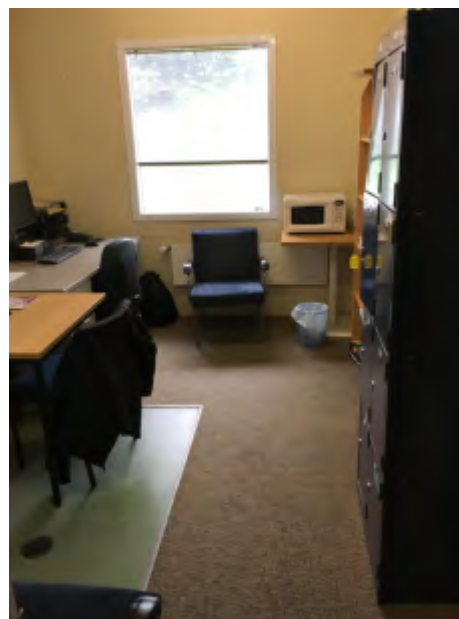
Pictured above is the Housekeeping Room with wall hung radiator, visible in the picture is the base build floor waste gully. As can be seen the room function is has now moved from a cleaners room to an more adminstrative role.

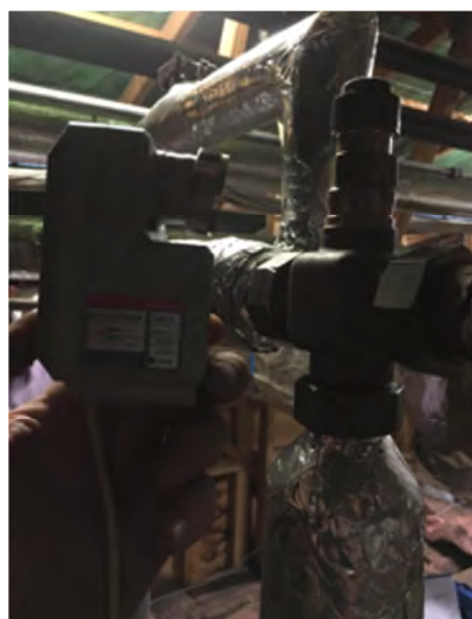
Pictured above is a 3 port valve motorised valve actuator which should be controlling the output of the heating coil associated with EC-1. This valve acutator has been detached and left sitting next to the unit, this eliminates the control ability of the heating coil to modulate its output.

- 1) Check that all three port valve motorised actuators and confirm they are installed and are functioning correctly.
 - In particular the operation and design air off temperatures of EC-01 should be confirmed.
- 2) Confirm temperature control methodology for fan coil units. Local controllers and temperature sensors should be provided in all administration rooms.
 - Consideration should be given to the provision of cooling systems for the Housekeeper/Store and Interview Rooms due to their change of use to administration offices.
- 3) Confirm level of BMS control and monitoring of FCU's stats points i.e. air speed, operation mode (heating or cooling) and return and supply air temperatures.
- 4) Provision of one new fan coil unit for the Housekeeper / Store and Interview Offices.

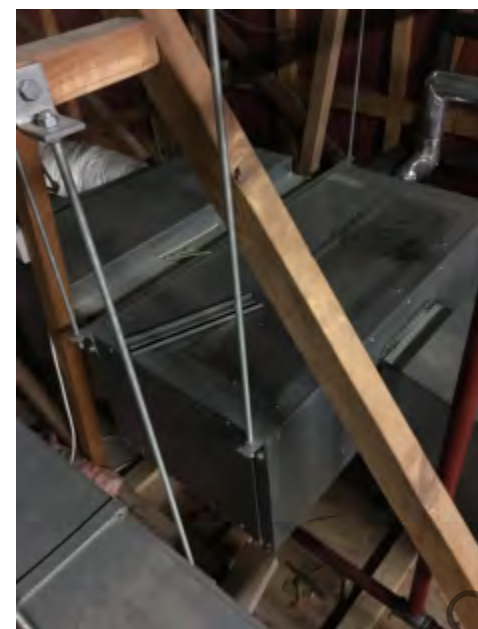
Pictured above is a typical FCU and supporting hanger rods, these are all excessively long. A review of the seismic bracing of the existing mechanical services should be undertaken.

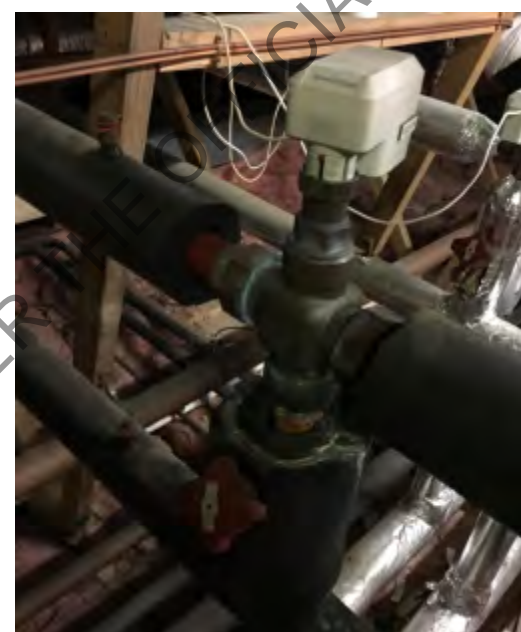
The pipework condition in the area of FCU No.3, 3 port valve should be assessed. Visible signs of corrosion were noticeable, with pipework insulation also in a poor condition.

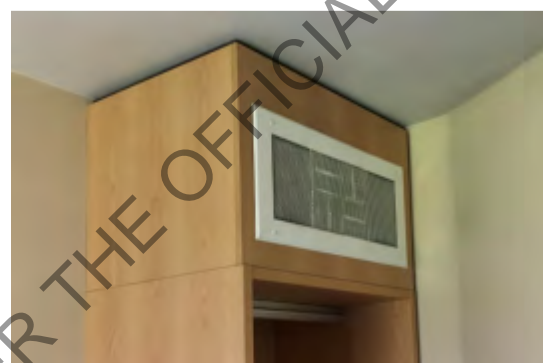
Supply air diffuser in bedroom incorporated into bedroom wardrobe.

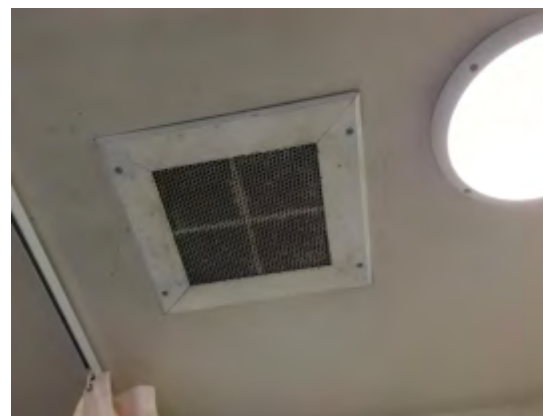
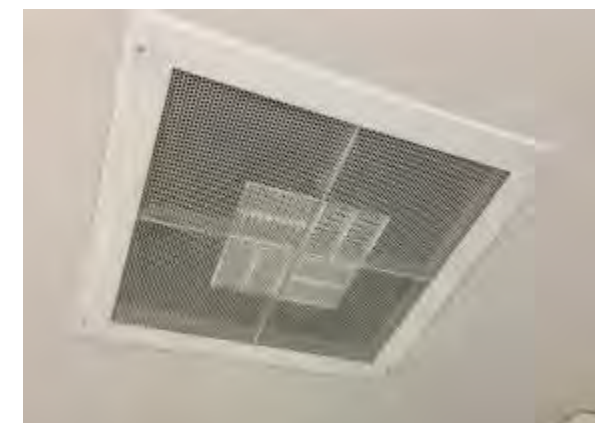
Ceiling air diffusers in bedroom, in 'Te Whare Hohou', neither building have used anti-ligature ceiling diffusers.
