Please find attached as **Appendix 1** the Earthquake Seismic Assessment Report for Christchurch Women's Hospital October 2013 and **Appendix 2** the Detailed Seismic Assessment Report for the Clinical Services Building October 2013.

EARTHQUAKE SEISMIC  
ASSESSMENT REPORT

REPORT 6 - CHRISTCHURCH WOMEN'S  
HOSPITAL

REV 2 - 7 OCTOBER 2013

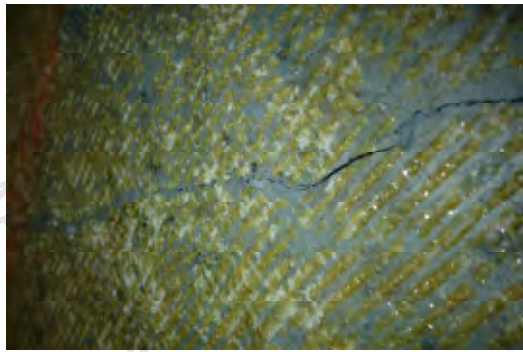
Damage	Locations	Recommendation	Example
1. Floor slabs			
1.1. Cracking between 0.2mm and 0.5mm	BASEMENT: Cracking at various locations throughout basement walk and crawl spaces.	Epoxy inject cracks in slab and raft greater than 0.2mm in width where external and 0.3mm in width where internal. Refer to HCG Specification	No photo
1.2. Inspection	LEVEL 1 & 2 Topping slab cracks as observed on other floor levels	See App F	No photo
1.3. Cracking up to 0.6mm in topping slab + Inspection	LEVEL 3: Cracking in topping slab parallel to beams on GL 3 & 6. Cracks observed on north and south sides of beams.	See App F

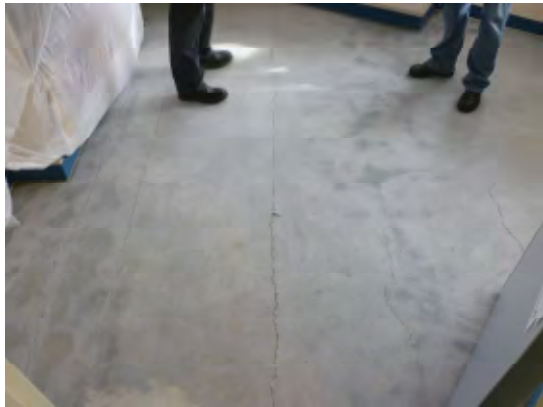
Damage	Locations	Recommendation	Example
topping slab + Inspection	Cracking in topping slab parallel to beams on GL 3 & 6. Cracks observed on north and south sides of beams.		
1.5. Cracking up to 1.2mm in topping slab + Inspection	LEVEL 4:	See App F

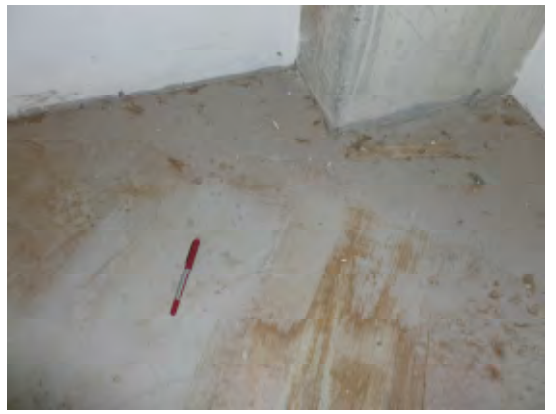
Damage	Locations	Recommendation	Example
1.7. Inspection	LEVEL 5: Possible cracking in topping slab parallel to beams on GL 3 & 6 per Level 3 and 4. Cracks observed on north and south sides of beams.	See App F	See above
1.8. Slab cracks radiating from column	LEVEL 6: South-west corner column	Epoxy inject cracks greater than 0.2 mm in width. Refer to HCG Specification

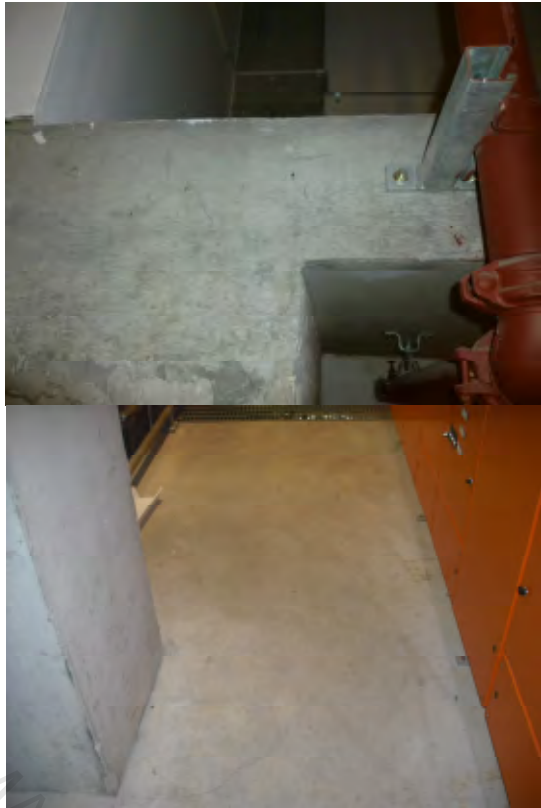
Damage	Locations	Recommendation	Example
1.9. Slab cracks up to 0.7 mm	LEVEL 6 MEZZANINE: Cracks in slab observed in soffit of landing, cantilevered slab and radiating from columns	Epoxy inject cracks greater than 0.2 mm in width. Refer to HCG Specification

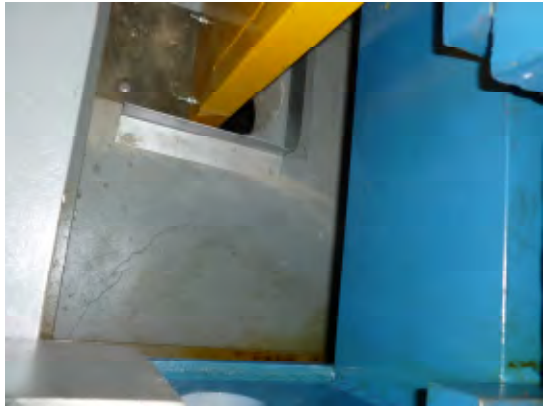
Damage	Locations	Recommendation	Example
1.11. Slab cracks up to 0.8 mm	LIFT MACHINE ROOM: Full slab depth cracks observed around/beneath lift machines and central area of floor.	Epoxy inject cracks greater than 0.2 mm in width. Refer to HCG Specification

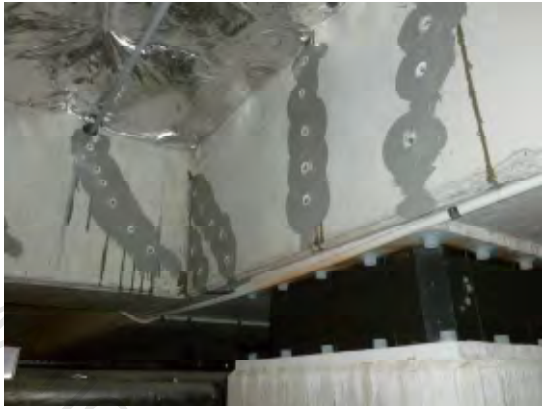
2. Beams and Precast Floor Ribs			
2.1. Flexure and shear cracks up to 0.4 mm + Inspection	BASEMENT: Cracks in transfer beams spanning around the elevator pits GLs C, 6 & E. Also at locations where post-tensioned tie-downs are anchored around perimeter of building	Epoxy inject cracks greater than 0.2 mm in width. Inspect beams with tie-down anchors passing through at east end of building. Refer to HCG Specification

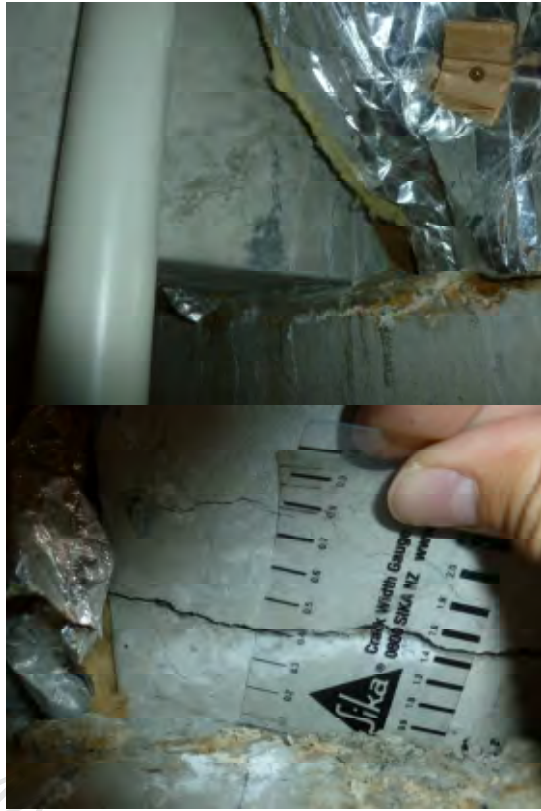
Evaluation of the structural drawings and observations from site do not suggest that any critical structural weaknesses exist in the lateral force resisting system. However the cracks in the precast ribs forming the Lower Ground floor can be considered a significant weakness requiring immediate attention.

Damage	Locations	Recommendation	Example
2.2. Shear cracks in precast concrete rib joists up to 1.5 mm wide	BASEMENT: Cracks in precast ribs near seating at multiple locations as indicated on plan provided Appendix B	Epoxy inject cracks greater than 0.2 mm in width. Where cracks are wider than 0.8 mm provide steel seating detail. See concept sketch SKS-C1 in App. C. Refer to HCG Specification

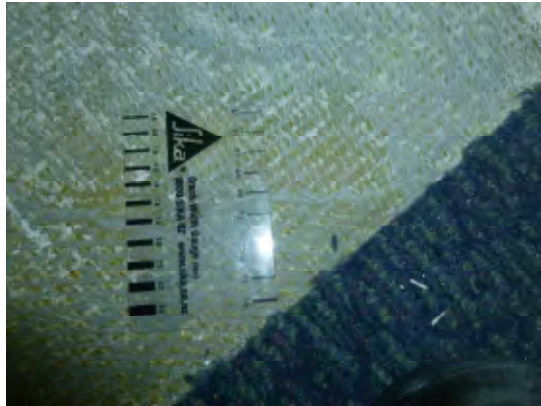
Damage	Locations	Recommendation	Example
2.3. Cracks up to 0.5 mm wide + Inspection	LEVEL 3: Crack noted in slab/top of beam in Rm 3094 on SW side of column	Further inspection required on beams around perimeter of building. Suggest beams are exposed at every 2 <sup>nd</sup> column by lifting flooring, and removing ceiling tiles. If cracks are consistently noted then similar for Level 4 and 5. Epoxy inject cracks greater than 0.3 mm. Refer to HCG Specification

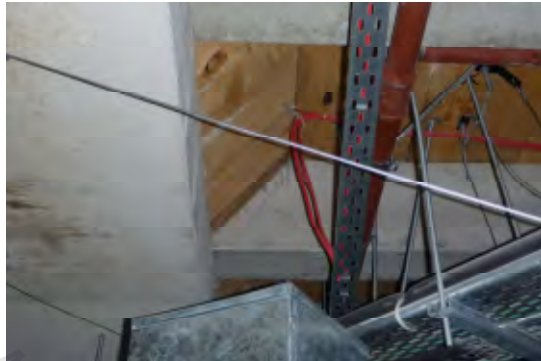
2.4. Precast rib joists	ALL LEVELS: Possible cracks near supports of precast floor ribs.	Investigation of precast floor ribs at all levels required to confirm if similar cracks near the supports is present (as seen in basement). See App. F

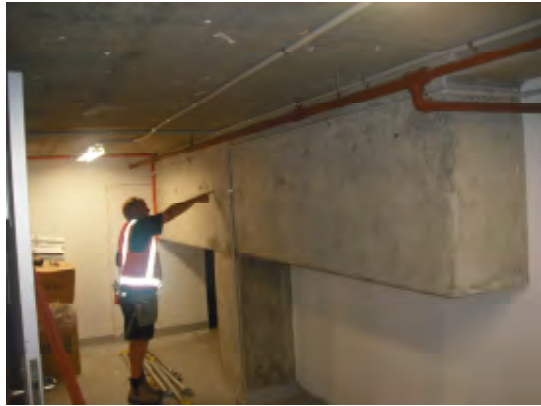
Damage	Locations	Recommendation	Example
2.5. Cracks up to 0.6 mm wide	LEVEL 6: Support beam to mezzanine above as seen at L6 landing.	Epoxy inject cracks greater than 0.2 mm in width. Refer to HCG Specification

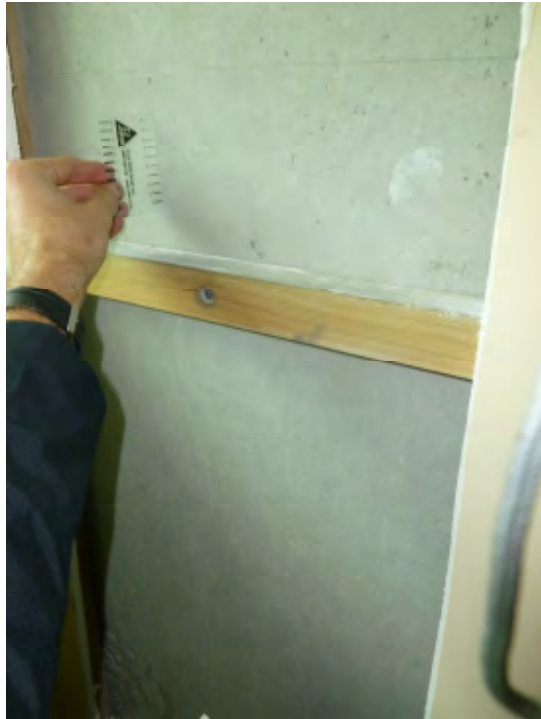
Damage	Locations	Recommendation	Example
3.1. Cracks <0.2 mm. + Inspection	LEVEL 3: Columns inspected in three locations Rm 3009, 3094 & 3096. Minor cracks at mid-height observed.	See item 2.3. Further inspection of every 2 <sup>nd</sup> column required. Epoxy inject cracks greater than 0.2 mm Refer to HCG Specification

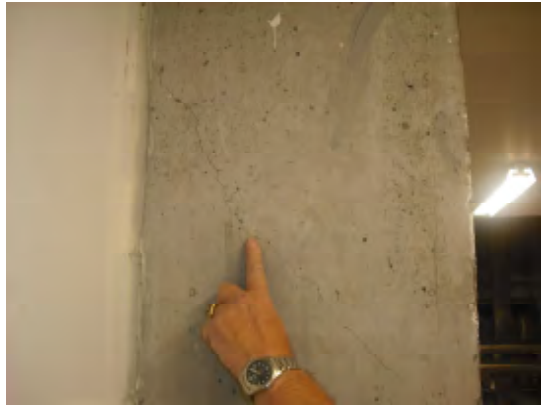
Damage	Locations	Recommendation	Example
3.2. Diagonal cracks up to 0.4 mm	LEVEL 6 MEZZANINE: Crack all way through column at landing GL D/3	Epoxy inject cracks greater than 0.3 mm Refer to HCG Specification

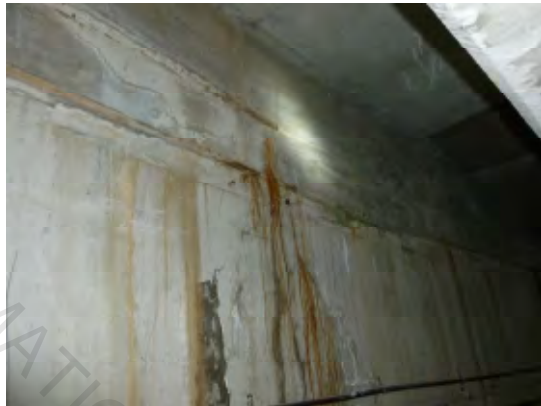
4. Basement Walls			
4.1. Cracks in perimeter walls + Inspection	Some locations already noted/repared. Confirm locations with Fletcher.	Inspect all walls around basement including tunnel through to Parkside and epoxy inject all cracks that are greater than 0.2mm in width. Refer to HCG specification.

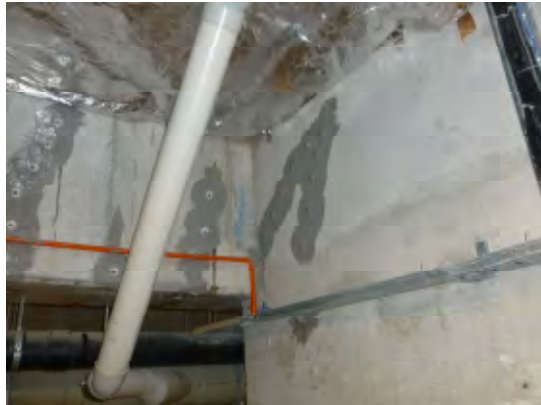
Damage	Locations	Recommendation	Example
4.2. Diagonal cracks up to 1.2 mm wide	Elevator shaft pit walls	Epoxy inject cracks greater than 0.2 mm. Refer to HCG Specification

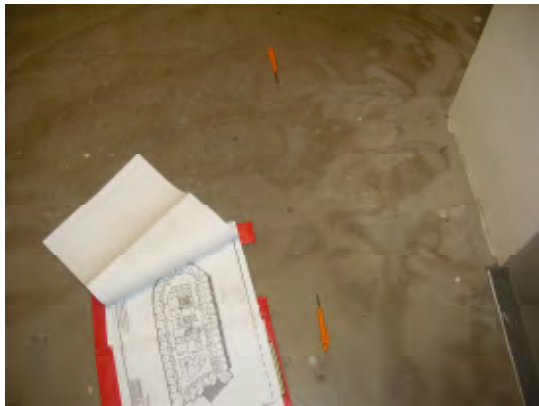
A further critical structural weakness is the detailing of the stair mid-landings. Based on the structural drawings it appears that the preferred allowance for relative movement between the floors levels can not be accommodated by the landing and detailing used, and as such will need to be remediated to ensure that no further damage occurs under large earthquake demands.

6. Staircases			
6.1. Damage to landings noted in west service stair with cracks up to 0.8 mm + Inspection	L3 mid-landing & L5 mid-landing. Confirm if present at other levels as vinyl may be hiding cracks.	Remediation of stair connections similar to concept sketch SKS-C2 App C. Epoxy inject all cracks that are greater than 0.3mm in width. Refer to HCG specification

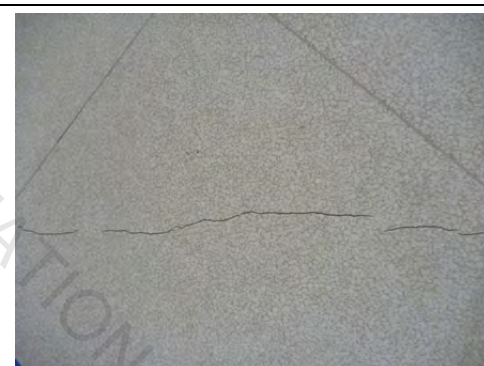
Damage	Locations	Recommendation	Example
1.4. Cracks up to 0.5mm in width at the junction between the original building and the extension to the east.	<p>LOWER GROUND, &amp; GROUND FLOOR:</p> <p>At junction between the original building and the extension to the east.</p>	<p>Inspect the floor joint between the original building and the extension to the east at Lower Ground, Ground, First and Second floor levels and epoxy inject cracks that are greater than 0.3mm in width.</p> <p>Refer to HCG Specification</p>

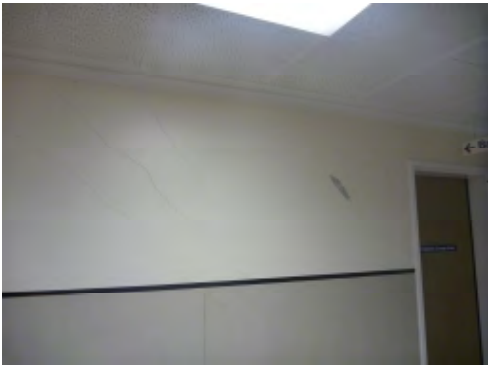
2.2. Cracking to the shear walls on the west face of the building where internal at Lower Ground Level	LOWER GROUND FLOOR: Diagonal cracks in the shear wall at Lower Ground Level and at the base of the piers and spandrels at Ground Level.	Inspect the walls on the west face of the original building at Lower Ground, Ground and First Floor and epoxy inject cracks in the walls that are greater than 0.2mm in width where external and 0.3mm in width where internal.  Refer to HCG Specification.

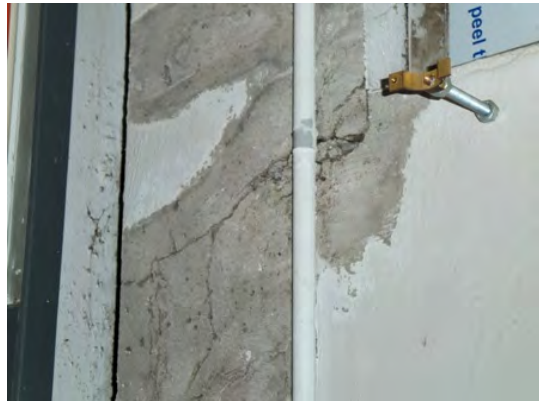
2.8. Vertical cracking up to 3.5mm in width in the plant room	PLANT ROOM: North end of west wall above radiation storage bunker	Epoxy inject all cracks that are greater than 0.2mm in width. Refer to HCG specification.  REPAIRS COMPLETE 10/07/13

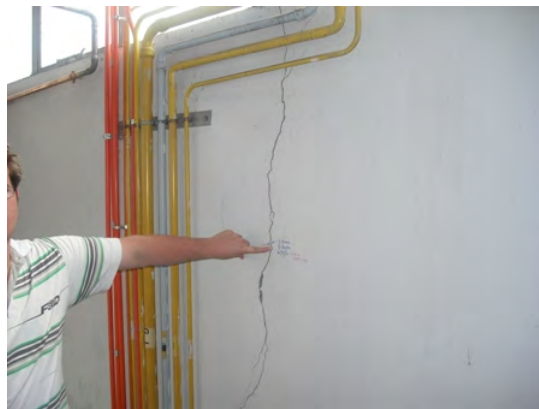
Damage	Locations	Recommendation	Example
2.9. Cracks up to 2mm wide in radiation bunker	SECOND FLOOR Radiation Bunker: Crack up to 2mm wide in what appears to be an original construction joint and diagonal cracks in bunker walls.	Epoxy inject all cracks that are greater than 0.3mm in width. Refer to HCG specification.

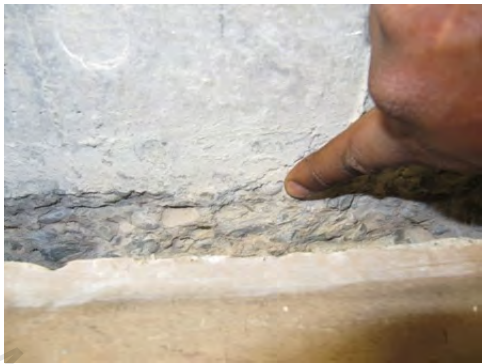
Damage	Locations	Recommendation	Example
4. Basement			
4.1. Cracks in north and south walls up to 1mm in width	North and south walls	Inspect all walls and epoxy inject all cracks that are greater than 0.2mm in width. Refer to HCG specification.

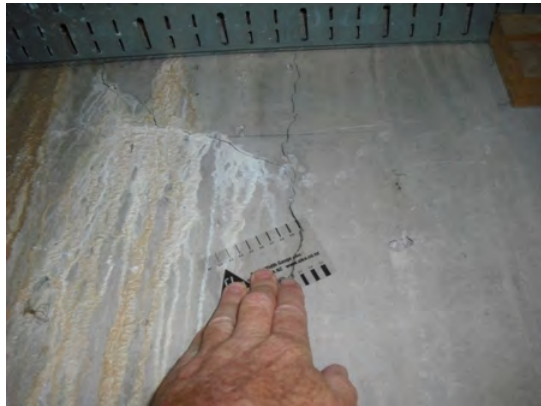
4.2. Cracks in service tunnel walls up to 3mm in width	Service tunnel walls	Inspect all walls and epoxy inject all cracks that are greater than 0.2mm in width. Refer to HCG specification.
