# RE Official Information Act (the "Act") request CDHB 9833 (Part two response)

# BURWOOD HOSPITAL CAMPUS - DETAILED SEISMIC ASSESSMENT REPORT

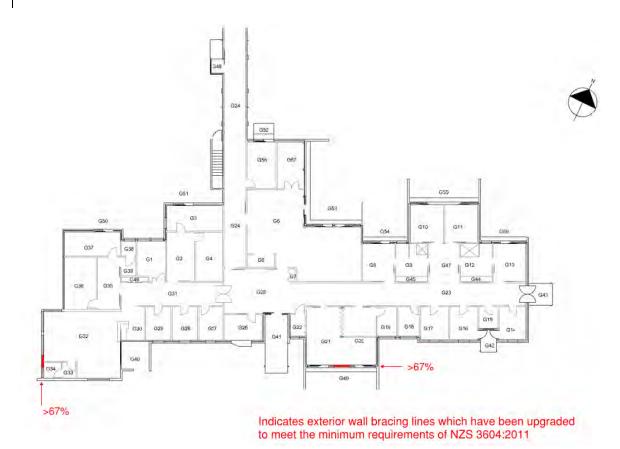
Figure 2-4: Walls upgraded to meet NZ\$3604

The majority of the Orthopaedic Outpatient / BSU Hostel building has been assessed to have a pre-earthquake capacity to resist approximately 25% of the demand imposed by the current loading code Design Basis Earthquake (DBE) in the North-South direction (across the building) and approximately 25% DBE in the East –West (along the building) direction (IL3 - 20%DBE). At isolated extensions of the building, the external wall bracing has been upgraded to meet the minimum external bracing requirements of NZS 3604:2011 [11], as these sections of the building were assessed as low as approximately 15% DBE. See Figure 2-4 below for the specific locations where exterior bracing walls were upgraded with plywood walls.

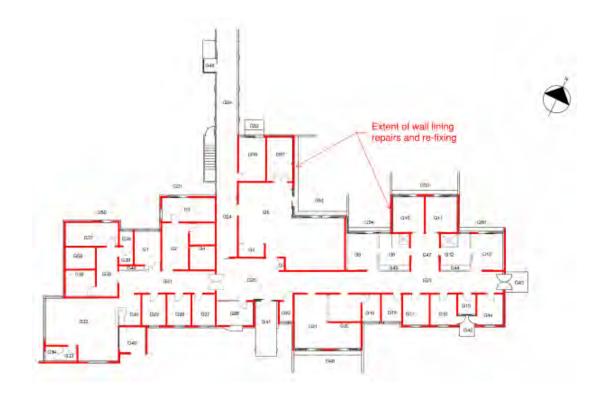
Figure 4-1: Ground Floor Plan – Damage Repairs

Further investigations into the fixings of the bracing walls into the sub-floor concrete walls have shown that the bottom plates are generally only 25mm thick with M10 bolts at approximately 1200mm crs. These fixings will need to be upgraded to enable the bracing walls to reach capacity. A methodology for this is outlined in Section 5.

All repairs to wall bracing are to be completed after any re-levelling to the building has been completed.

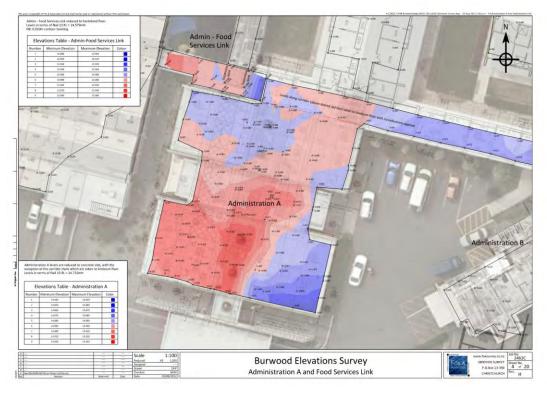
Figure 3-1: Level Survey

A verticality survey was also completed for the architectural precast wall and for the precast columns of the canopy structure. The survey has indicated a permanent lean to the north of up to approximately 2% in the columns and 1% in the wall. The full verticality survey is also included in Appendix C.

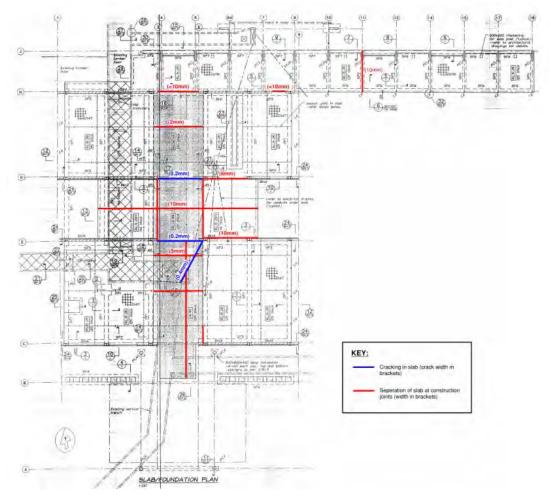
Figure 3-4: Observed Damage to Ground Floor Slab

For the extent of the cracking to the slab on grade see the summary included in Figure 3-4 below and the crack map included in Section 4.

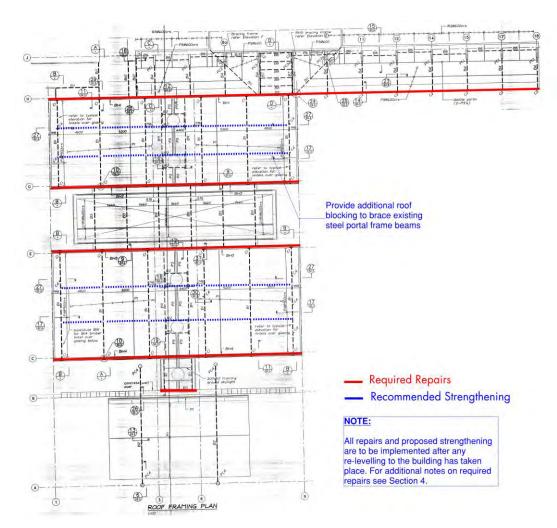
Figure 5-1: Roof Framing Plan - Recommended Strengthening

The steel portal frames, which form the primary lateral force resisting elements in the northsouth direction, have been assessed at 80% DBE. Once this capacity has been exceeded, lateral buckling of the portal beam is expected to occur, potentially leading to loss of stability of the concrete masonry walls. The performance of this system structural system could be improved as a whole) by providing additional bracing to the portal beams along their length. We believe the addition of these bracing elements would provide a high benefit for a relatively low cost.

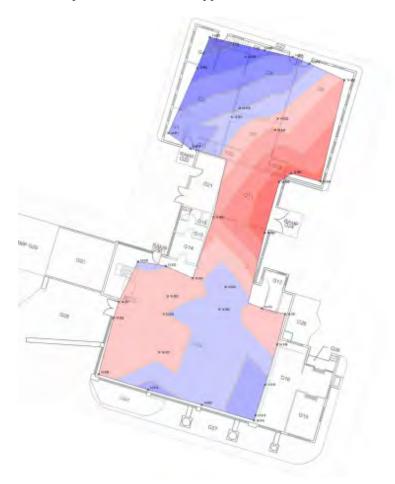
Figure 3-1: Survey of building settlement

It is estimated that parts of the building have settled a total of 80 100mm overall with a differential settlement of approximately 83mm noted across the elevated ground floor slab. The most severe settlement has occurred at the north west corner of the building although there is no visible evidence of this besides the survey. The settlement is shown below in Figure 3 1, a more detailed plan can be found in Appendix C.

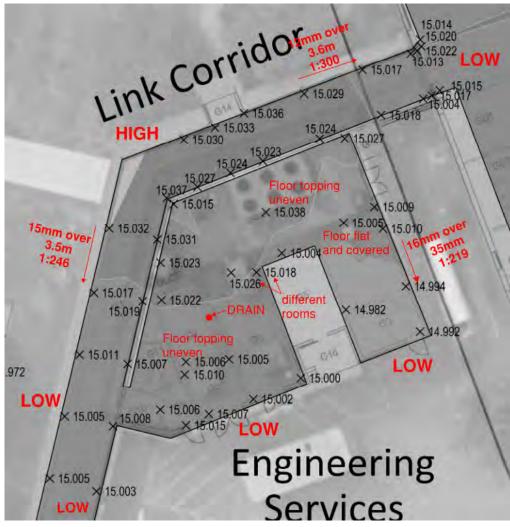
Figure 3-1- Ground Floor Level Survey Showing Falls

For the extent of the differential settlement noted see Figure 3<sup>#</sup> and the levels survey included in Appendix C.

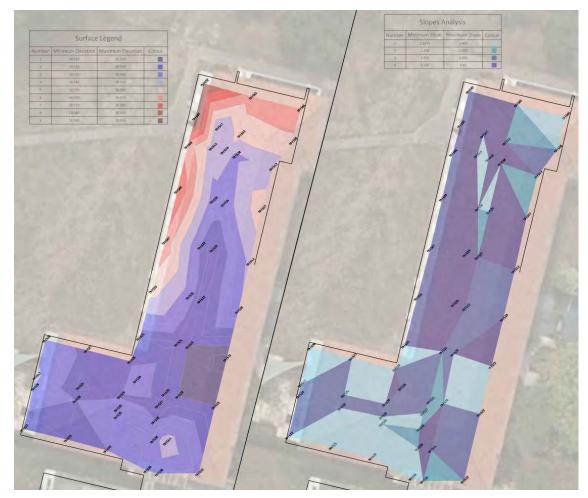
Figure 3-2: Level Survey- First Floor

On 22<sup>nd</sup> January 2013 an additional survey was completed for the suspended first floor slab. The results of this survey indicate a total differential in measure elevation of 83mm across the slab. Worst case measured slopes of approximately 1:75 occur at the north end of the wing.

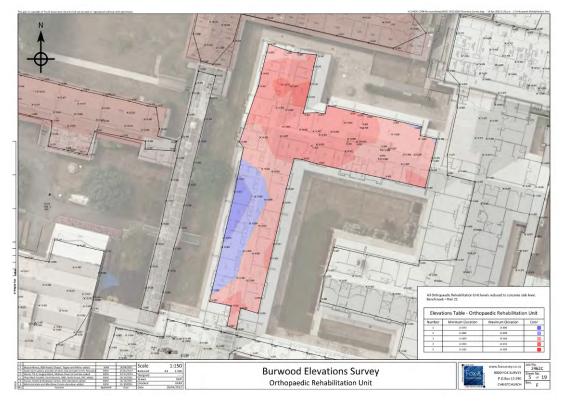
Figure 3-1: Level Survey

While the slopes noted in the ground floor slab may be within the acceptable range for this building, the Orthopaedic Rehabilitation Unit is interconnected with the Administration Building which requires re-levelling. When the Administration Building is re-levelled the Orthopaedic Building will likely be required to be lifted at the same time. For additional discussions on re-levelling see Section 4.

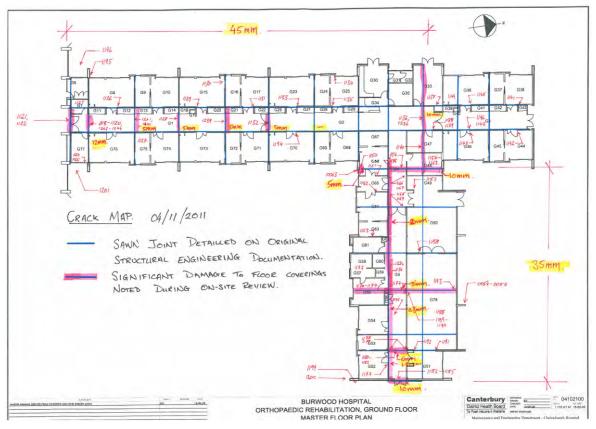
Figure 4-1 Crack map

As discussed in Section 3, ground shaking and liquefaction induced lateral stretching has occurred and is noted by the cracks that have formed across the unreinforced control joints of the existing slab on grade. The locations and degree of cracking are shown below in Figure 4-1. The amount of stretching was measured at each notably cracked joint. The cumulative amount of spreading measured on site was 45mm in the North-South Direction and 35mm in the East-West direction. Spreading at each joint where significant damage was observed was typically between 5mm and 10mm. The largest crack noted on site was 12mm. No significant differential vertical displacements were noted across the joints. The building settlement appears to relatively uniform with only minor vertical stepping across the unreinforced joints.
