RE Official Information Act (the "Act") request CDHB 9833

DETAILED SEISMIC ASSESSMENT REPORT

CHRISTCHURCH HOSPITAL

Detailed Seismic Assessment Update Riverside Central Building

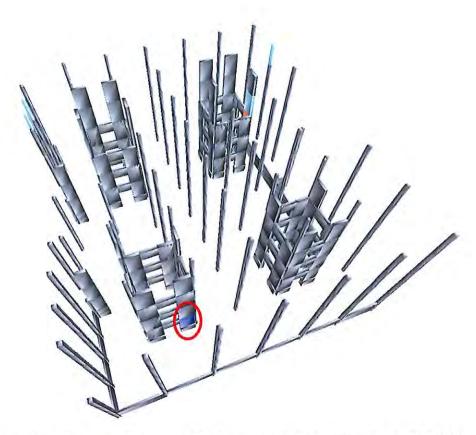
Figure 2-8: Elements that exceed Ultimate Limit State capacity at 78 % DBE (IL4) - View from north-east Corner

The other elements shaded orange and pale blue are ones that are likely to sustain some damage, but are still in a condition where they continue to contribute to the stability of the structure. The beams and floors are not shown in the figure for clarity. The NLTHA indicates that the building will perform as the original designer intended with plastic hinges forming at the bases of the core walls.

At 78 % DBE (the ULS capacity) the maximum interstorey drifts predicted by the NLTHA for the main Block A building are 2.4% in the X (east-west) and 2.6% in the Z (north-south) direction. This magnitude of drift is experienced between Level 3 and the Plant Room Level in the south wing of the building. The maximum interstorey drift limit at ULS for a new building is 2.5%. However, a NLTHA looks at the impact of drifts on specific building elements and as such the 2.5% 'limit' is only really used as an indicator of likely damage. In addition, drift critical elements such as stairs and seismic gaps are addressed specifically.

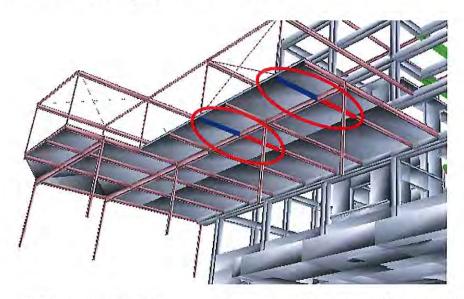
Figure 2-10: Underside of Emergency Department Extension (EDE) with critical beams circled

In the Emergency Department Extension, the elements that first exceed critical collapse limits are two steel beams that support the Ground Floor. These beams cantilever over a primary steel floor beam and pick up the wall bracing above, the two beams can be seen circled in Figure 2-10. The NLTHA indicates these beams yield and reach their ULS capacity at around 50 % DBE loads and CLS capacity at around 55 % DBE.

The Emergency Department Extension was designed as a nominally elastic structure and as such the code did not require it to incorporate principals of capacity design. Therefore, when loads higher than it was designed for are applied an undesirable hierarchy of failure develops. The cantilever beams (which are part of the gravity structure) yield and could result in this part of the floor failing. As such, they are considered a Critical Structural Weakness; however due to the low capacity of other elements, they do not currently govern the structure's performance.

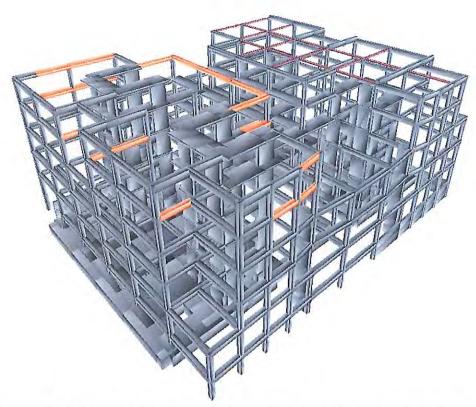
Figure 2-11: Elements that exceed SLS2 limits (55 % DBE) - View from Southeast Corner

At the SLS2 load level (approximately 55 % DBE) numerous elements are indicated as becoming damaged in the main Block A building therefore the SLS2 criteria is not met. All of the elements are beam elements, generally at the upper levels (above Level 2) in the southern half of the building (refer to Figure 2-11 where damaged elements are shaded orange). The reason for this is that above Level 2 the building splits into two (with a courtyard between). Both halves have a concrete floor at Level 3, but only the southern half has a concrete floor at the Plant Room Level. This additional concrete level results in additional load on the southern half of the building; however, there is no increase in structure to account for this.

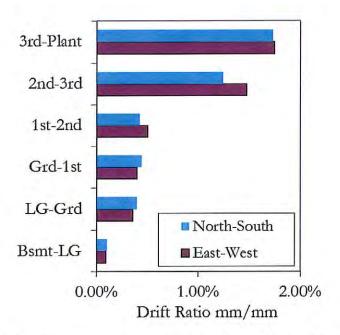
Figure 2-12: Inter-storey drifts up the building at the SLS2 load level

The interstorey drifts of the main Block A building at the SLS2 load level is indicated in Figure 2-12. These are the inter-storey floor drifts taken at the centre of mass. Drifts at the outer corners of the buildings are higher than those recorded at the centre of mass, due to torsional effects and accidental eccentricity and are approximately 2.5% at 67% IL4 maximum. It can be seen that below Level 2 the drifts are typically 0.5 to 0.6%, this level of drift would be expected to cause some damage to internal fit-out, but building function could likely be maintained (or resumed in within a short time frame). Above Level 2 the inter-storey drifts are up to 1.75% in both directions. This would cause significant damage to fit-out and may damage plant and services in these levels. These areas would not remain operational after a SLS2 event. The lower levels likely rely on services and other functions from the upper levels; therefore the Parkside Block A buildings is not considered to meet the SLS2 requirements.

The EDE extension does not meet SLS2 criteria as at this load level ULS and CLS are exceeded for this part of the structure.

As noted above, and can be seen in Figure 2-12, the building drifts are significantly higher above Level 2. This is because there is a change in the structural system above this level. Between the Basement and Level 2 the lateral loads are primarily resisted by core walls connected by beams, above Level 2 the number of walls halve and there are not linking beams between them. A cross-section through Block A indicating this discontinuity in structure up the building and the differences between the north and south wings can be seen in Figure 2-13.

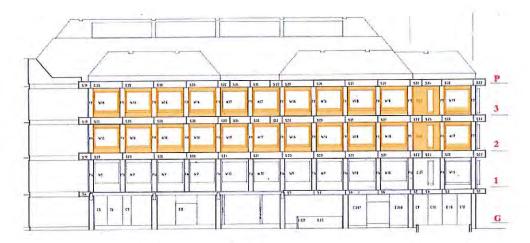
Figure 2-16: South Elevation of Block A indicating precast panels likely to be damaged at around 40 % DBE loading, assuming panel connection bolts placed centrally within oversized holes

An assessment of the expected interstorey drift under increasing seismic loads indicates that the drift demand on precast panels on the Blocks that have no additional plant room area is less than 1 % until a 78 % Design Basis Earthquake (DBE) level event. However, the south wing of Block A, all of Block B and the south wing of Block D all experience higher drift demands above Level 2 than the other Blocks due to the additional concrete plant levels and therefore these areas experience drifts over 1 % at around 40 % DBE. As an example the Block Λ panels that are likely to be damaged at around 40% DBE loading, assuming bolts are placed centrally within the oversized holes, are shaded in the building elevations in Figure 2-16 and Figure 2-17.

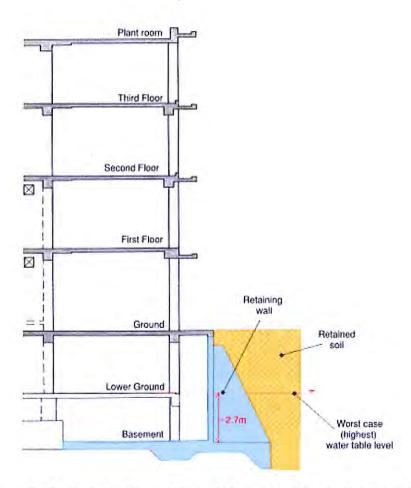
Figure 2-20: Parkside Block A Partial Elevation showing Retaining Walls

Details from the original drawings indicate that the ground floor concrete slab cantilevers out from the building and rests on top of the retaining wall. There is no positive connection between the slab and retaining wall and the retaining wall has been detailed to cantilever. As such the two elements will move independently in a seismic event. Evidence of this movement has been observed around the south east side of Block A where there is an approximate 10–20mm gap in places between the top of the wall and the slab.

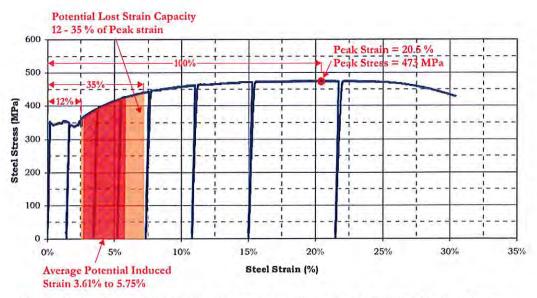
Figure 3-1: Stress-strain curve for steel reinforcement in Parkside buildings, shaded area indicates strain hardness testing results from Block D, Lower Ground Floor Slab

^{*} Remaining strain capacity meets current code requirements if potential lost strain capacity is less than 25 %.

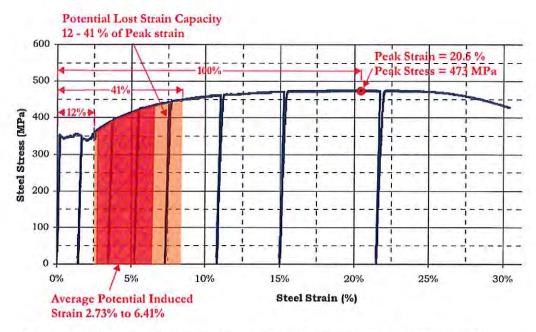
Figure 3-2: Stress-strain curve for steel reinforcement in Parkside buildings, shaded area indicates strain hardness testing results from core walls

^{*} Remaining strain capacity meets current code requirements if potential lost strain capacity is less than 25 %.

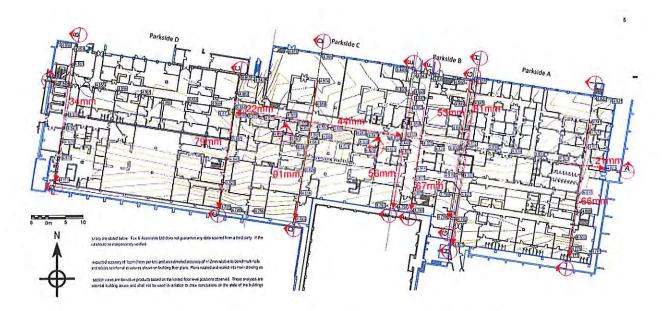
Figure 3-3: Differential Settlements Recorded in the Levels Survey.

The differential settlement of the four Blocks has not been even. As well as the slope down to the south, differential settlements have been recorded across Block C in the east-west direction at 44mm. Localised differential settlements in the east-west direction have been recorded at the east end of Blocks D and A. These differential settlements relate to changes in foundations from stiff rafts foundation beams to thinner slabs. The differential settlements recorded on the Lower Ground Floor are shown in Figure 3-3.

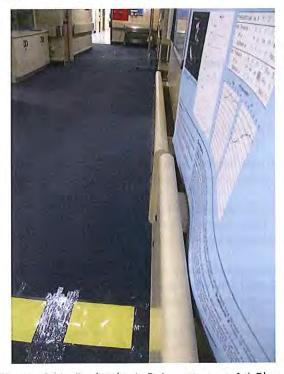
Figure 3-4: Parkside A-B Junction at 1st Floor

The levels survey indicated a step at the interface between Blocks A and B (typically between 5 and 10 mm), this is consistent with observations on site of step at seismic joints up building and illustrates that the settlement of the four blocks has not been even. A horizontal offset of Block A relative to Block B can also be observed at the seismic joints and is shown in Figure 3.1 by the offset at the handrail.

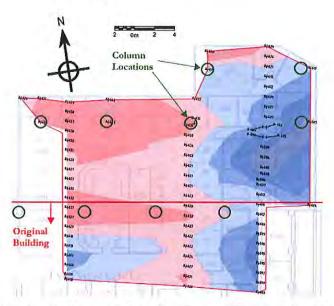
Figure 3-5: Levels Measured on the Ground Floor of the Emergency
Department Extension

Differential settlement was also observed in the Emergency Department Extension survey of the Lower Ground Floor. The levels survey was taken on a suspended concrete floor and therefore measured some floor sag as well as differential settlement. The summary values presented in Table 3-3 were derived only using measurements taken over column locations and therefore do not include the influence of floor sag; the column locations have been circled in Figure 3-5. In Figure 3-5 the high areas are shaded red, while the low areas are shaded blue. It can be seen that the columns along the east side have settled more than the others.
