### RE Official information request CDHB 9881 and WCDHB 9161

## Condition Assessment of Hospital Buildings

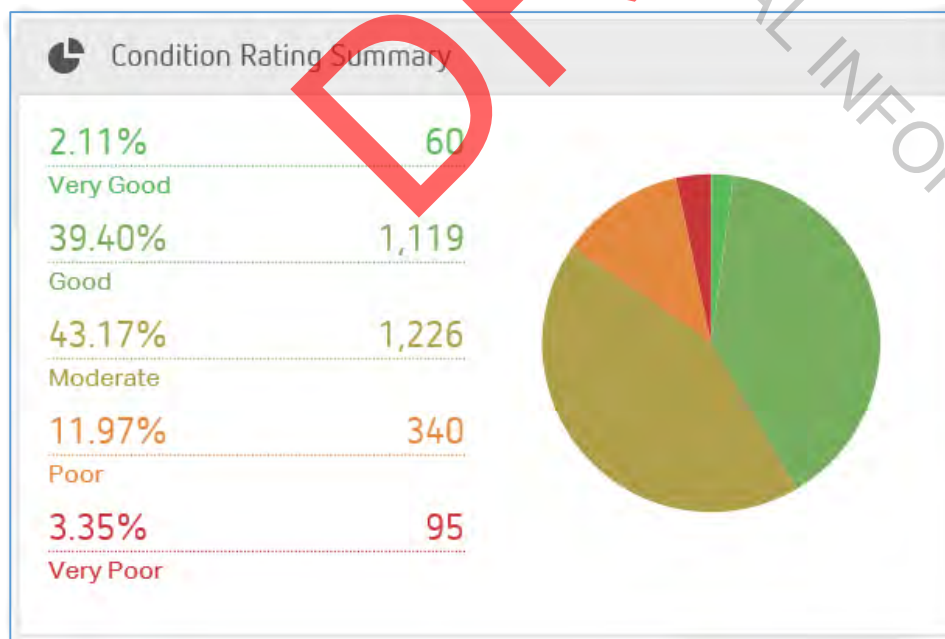
**Figure 1** Overall site Condition Summary

The overall condition of all the assets surveyed is 2.8 out of 5. This includes external elevations, roofs and M&E plant.

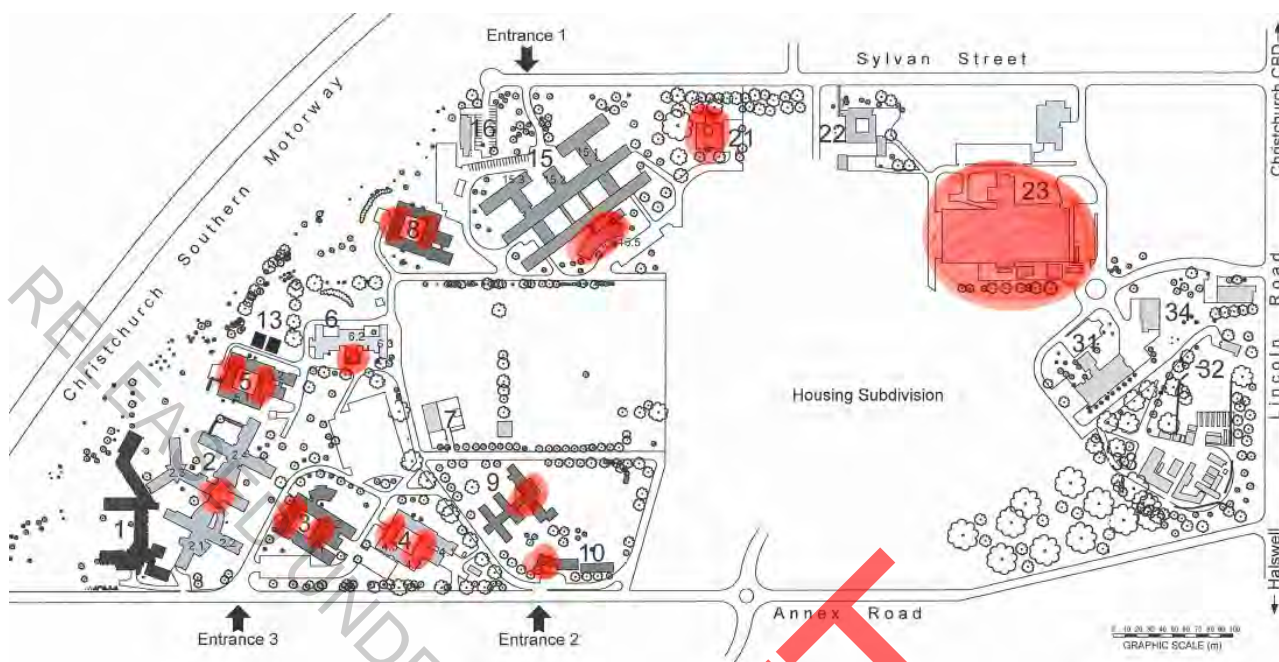
**Figure 4** Plan of roof locations that require further assessment for snow loads

- Part of Building 2
- Building 3
- Building 4
- Building 5
- Part of Building 6
- Building 8
- Part of Building 9
- Part of Building 10
- Front part of Building 15
- Building 21
- Building 23

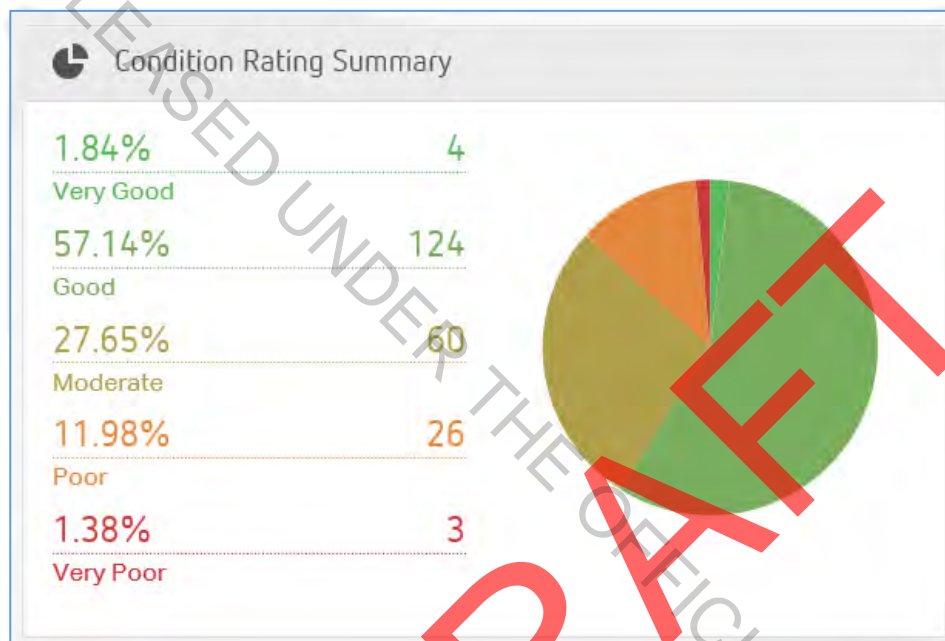
Figure 7 Building 1 Overall Condition

The overall condition of Building 1 is rated at 2.6.

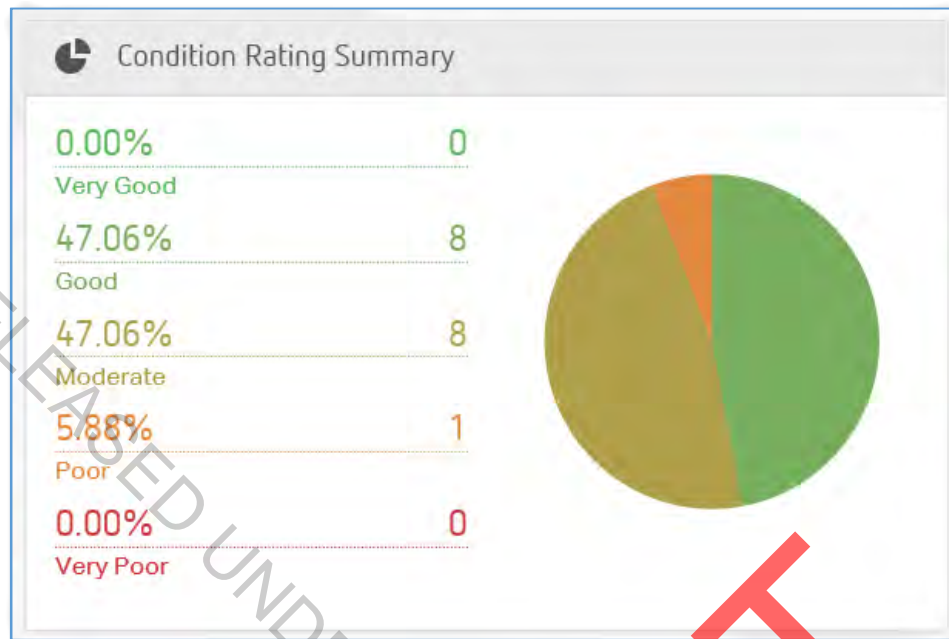
**Figure 10** Building 1 Condition of Mechanical Systems

Heating plant appears to be well-maintained with no apparent issues requiring immediate attention. The mechanical plant generally including the primary heating water pump, calorifier pump, calorifier, chiller and air handling unit are into the second half of their service life and will exhibit increasing maintenance costs over the next ten years. Heating water zone pumps and domestic hot water circulation pump appear to have been replaced more recently and should have more than ten years expected service life remaining.

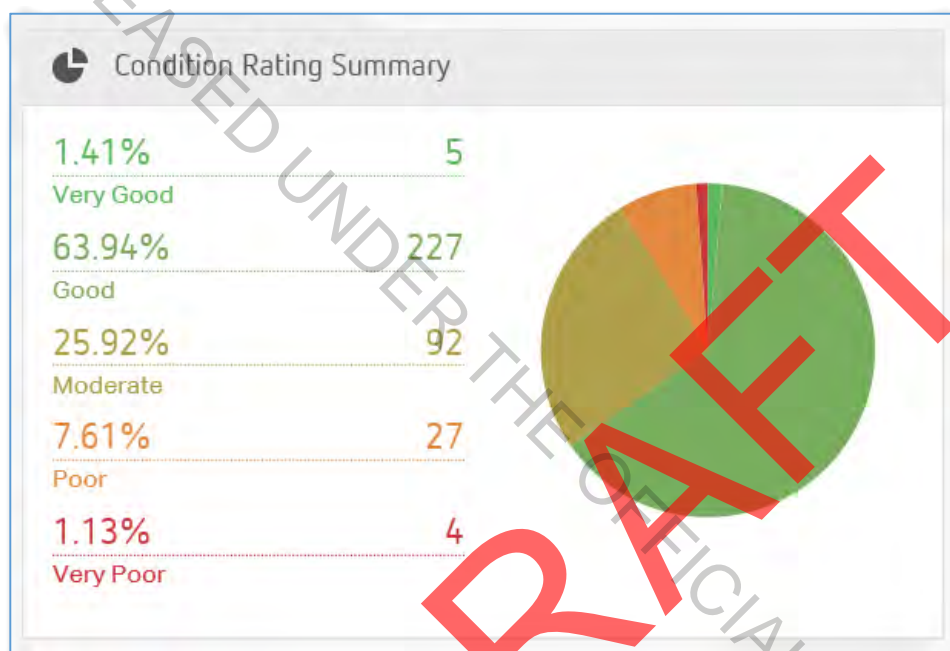
**Figure 12** Building 2 Overall Condition

The building was subject to substantial alterations and extensions in 1998. The overall condition of the building is rated as 2.2.

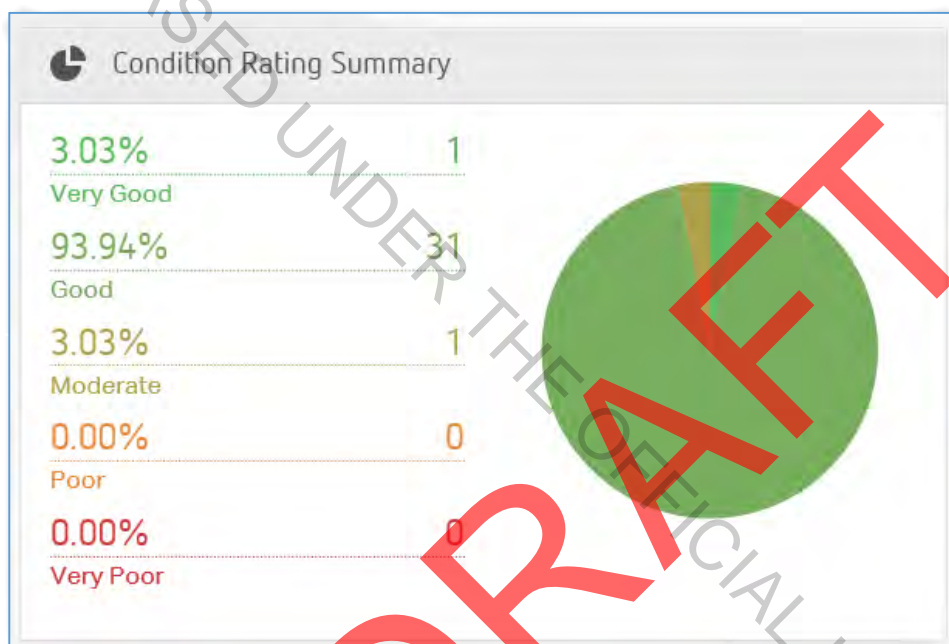
**Figure 15** *Building 2 Condition of Mechanical Systems*

The mechanical plant: pumps, chiller, calorifier, heat exchangers, are in the first half of their service life and should have an expected remaining service life of over ten years.

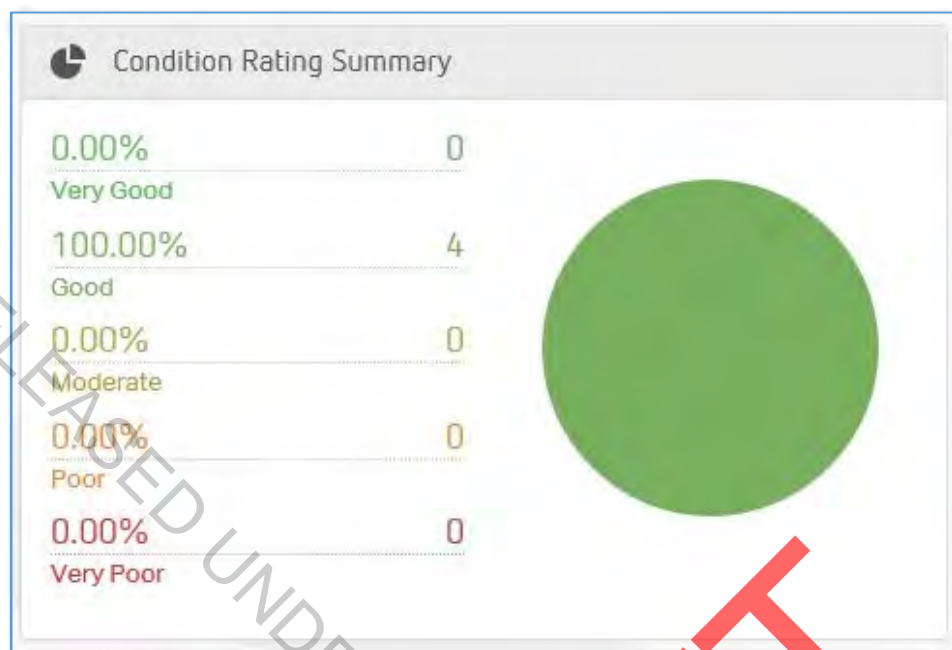
**Figure 16** Building 2 Condition of Electrical Systems

The distribution switchboards and mechanical controls boards servicing the building are of the same age and make, in good condition with modern switchgear and equipment.

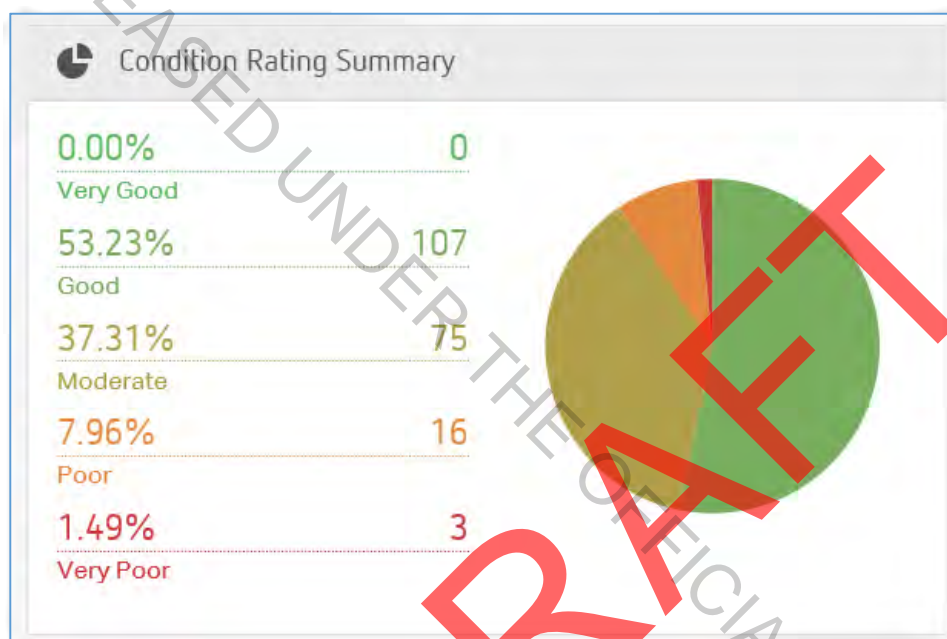
**Figure 17** Building 3 Overall Condition

The building had significant alterations and extensions in 1999. The overall condition of the building is rated at 3.1.

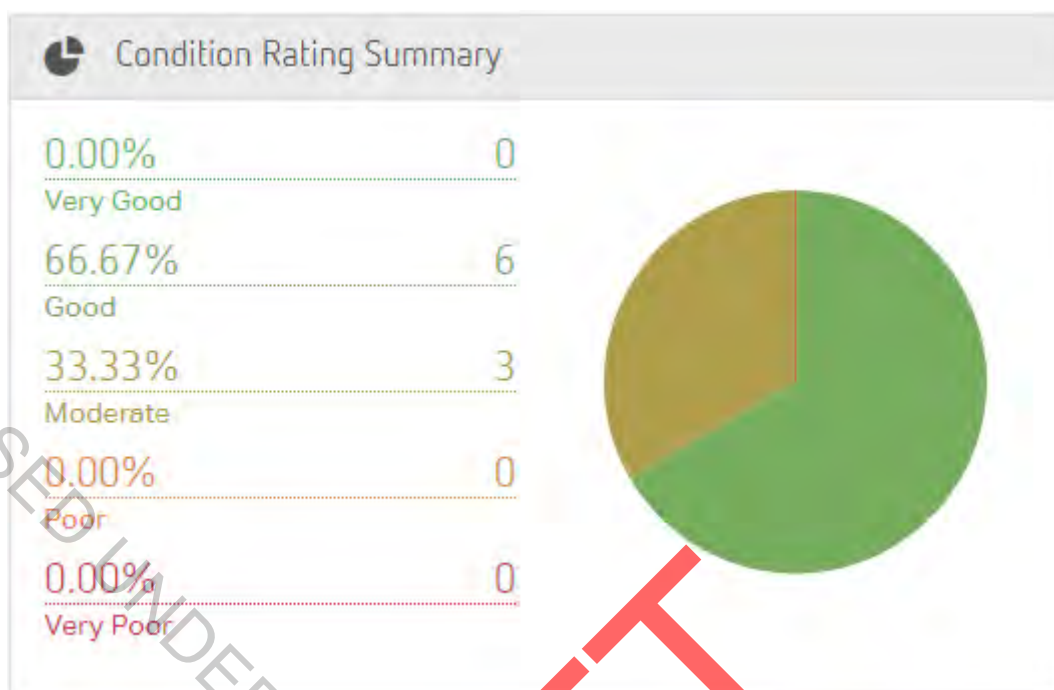
**Figure 21** Building 3 Condition of Mechanical Systems

The exception is the mechanical controls board in the Plant Room, which is at the end of its' economic life. A replacement should be considered and will provide the opportunity to standardise the switchgear and equipment, which will be beneficial to the maintenance team when a replacement part or item is required. In addition, ageing switchgear and equipment are inefficient and potentially dangerous.

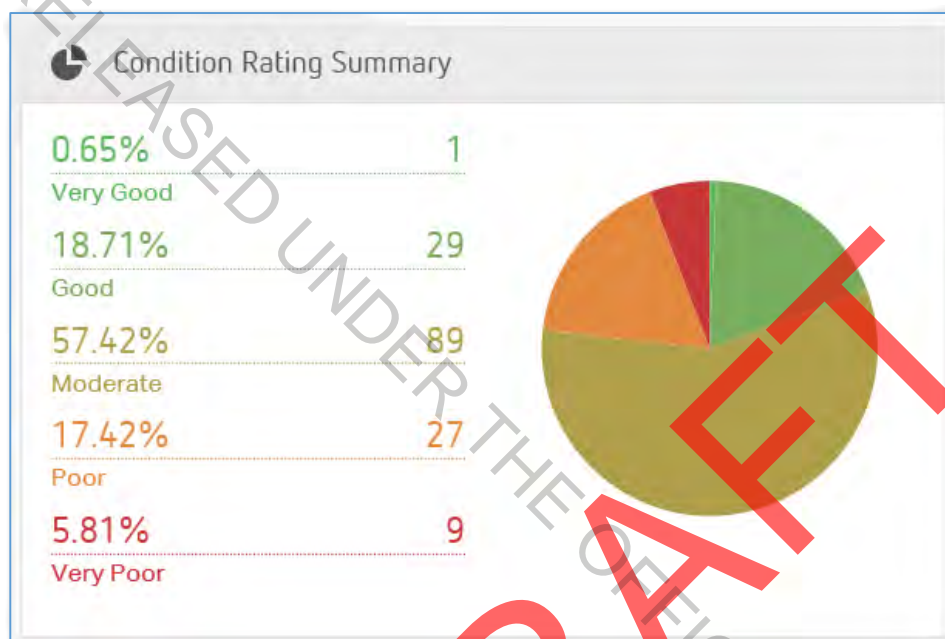
Figure 23 Building 4 Overall Condition

The overall condition of Building 4 is rated at 3.3.

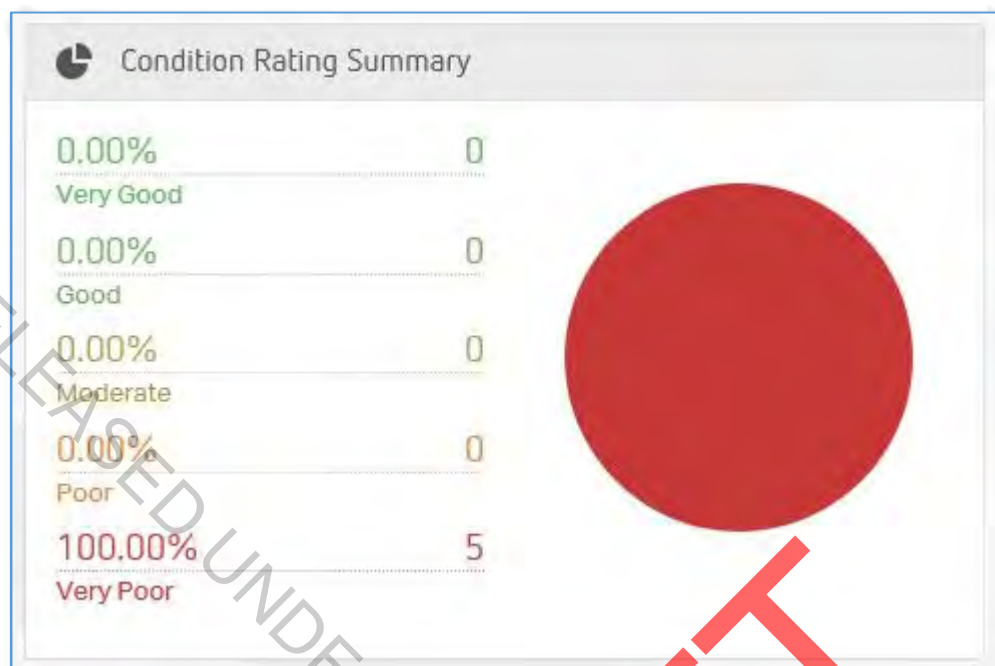
**Figure 27** Building 4 Condition of Electrical Systems

The distribution switchboards and mechanical controls board servicing the building are of the same age as the main switchboard and similarly, replacements should be considered.

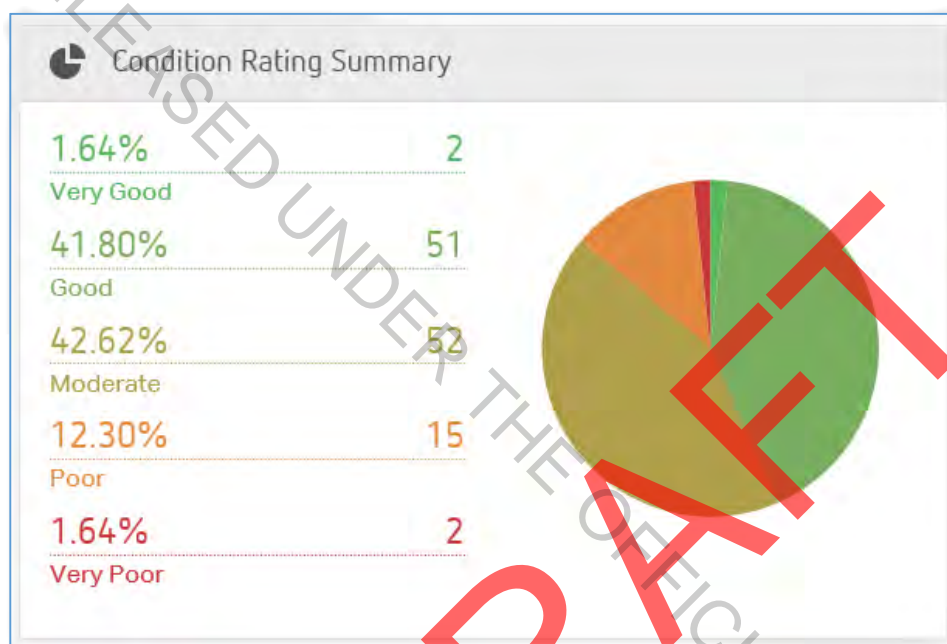
Figure 28 Building 5 Overall Condition

The overall condition of Building 5 is rated at 3.3.

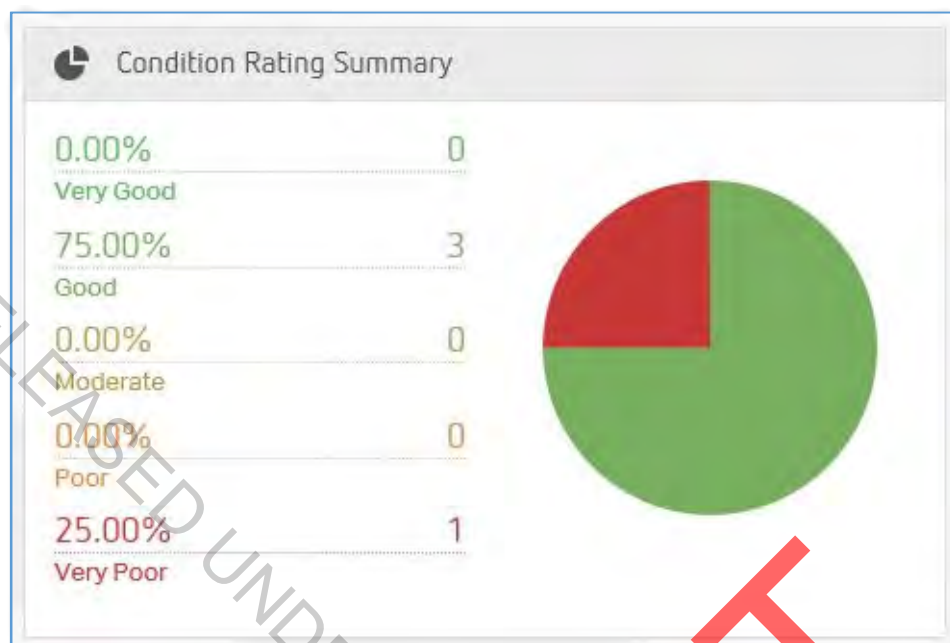
**Figure 32** Building 5 Condition of Electrical Services

The mechanical controls board in the Plant Room is at the end of its' economic life. A replacement should be considered and will provide the opportunity to standardise the switchgear and equipment, which will be beneficial to the maintenance team when a replacement part or item is required. In addition, ageing switchgear and equipment are inefficient and potentially dangerous.

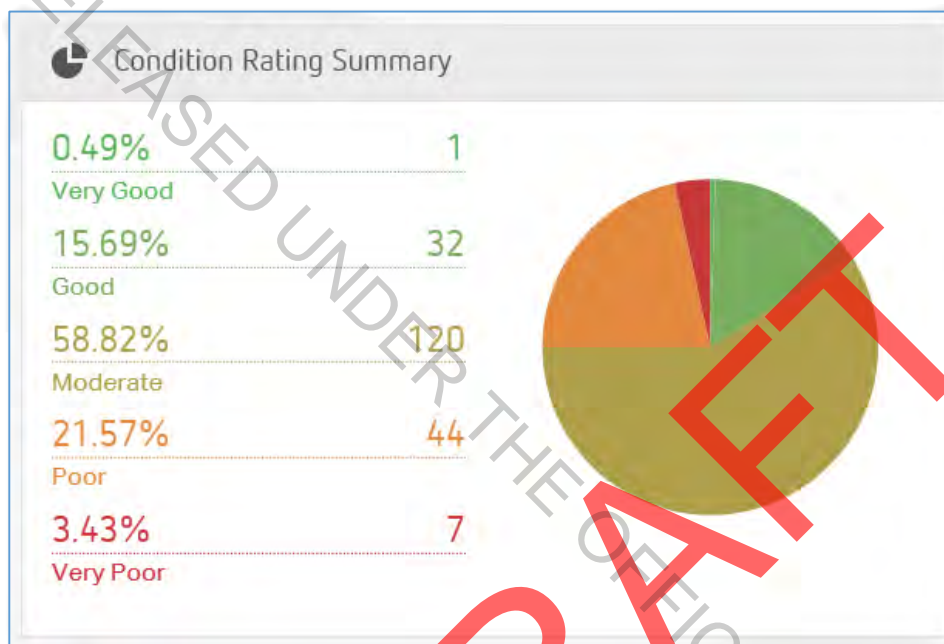
**Figure 33** Building 6 Overall Condition

The building was constructed in 1930. It is timber framed with a weatherboard cladding system and has a corrugated iron roof. Modifications/extensions were made to the building around the years 1978, 1999 and further unknown dates. The building has predominantly timber framed windows. The overall condition of the building is rated at 3.1.

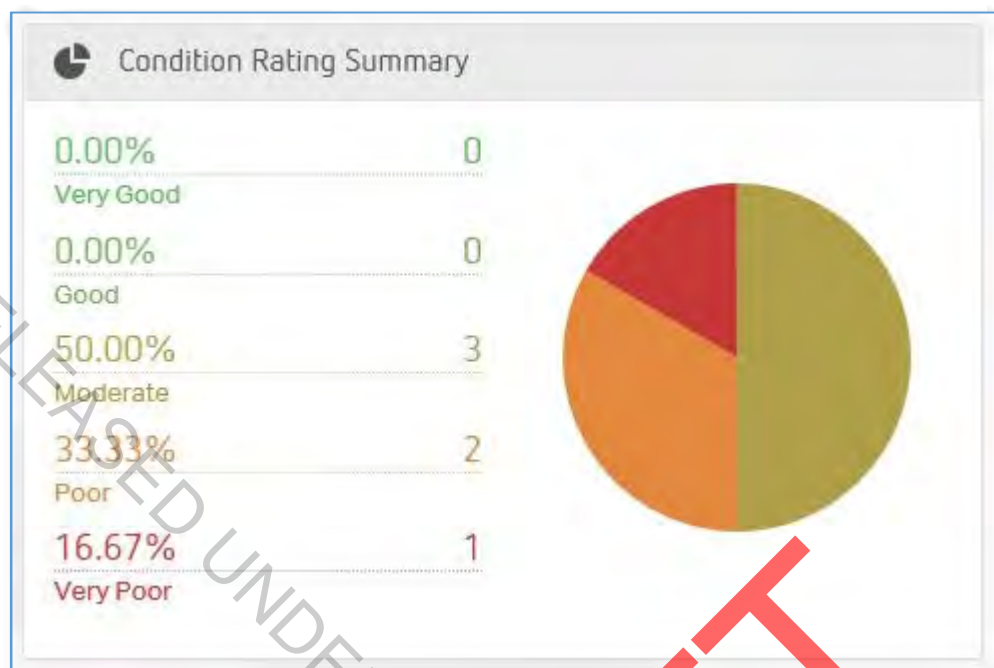
**Figure 37** Building 6 Condition of Electrical Services

The mechanical controls board in the Plant Room is at the end of its' economic life. A replacement should be considered and will provide the opportunity to standardise the switchgear and equipment, which will be beneficial to the maintenance team when a replacement part or item is required. In addition, ageing switchgear and equipment are inefficient and potentially dangerous.

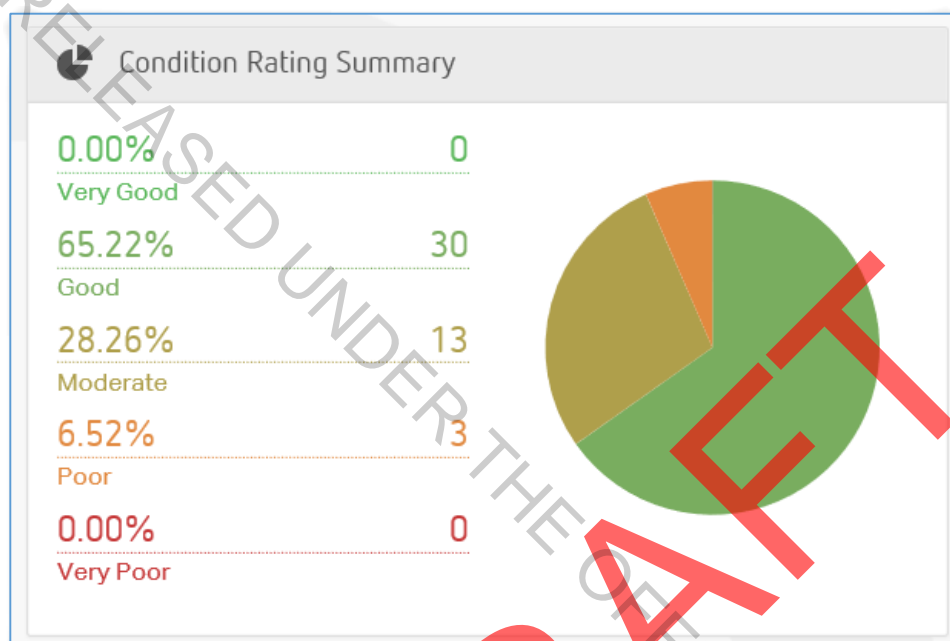
Figure 38 Building 7 Overall Condition

The building was constructed in 1998. It is a reinforced concrete and concrete block structure and has a Diamond V-Rib roof. The building has predominantly aluminium framed windows. The overall condition of the building is rated at 2.3.

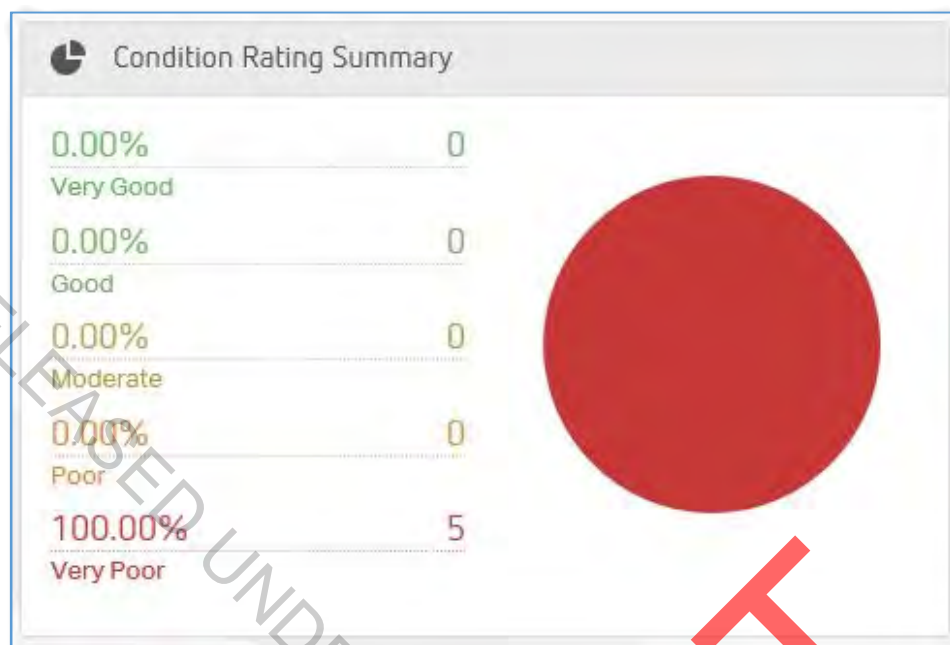
**Figure 47** Building 8 Condition of Electrical Systems

The distribution switchboards and mechanical controls board servicing the building are of the same age as the main switchboard and similarly, replacements should be considered.

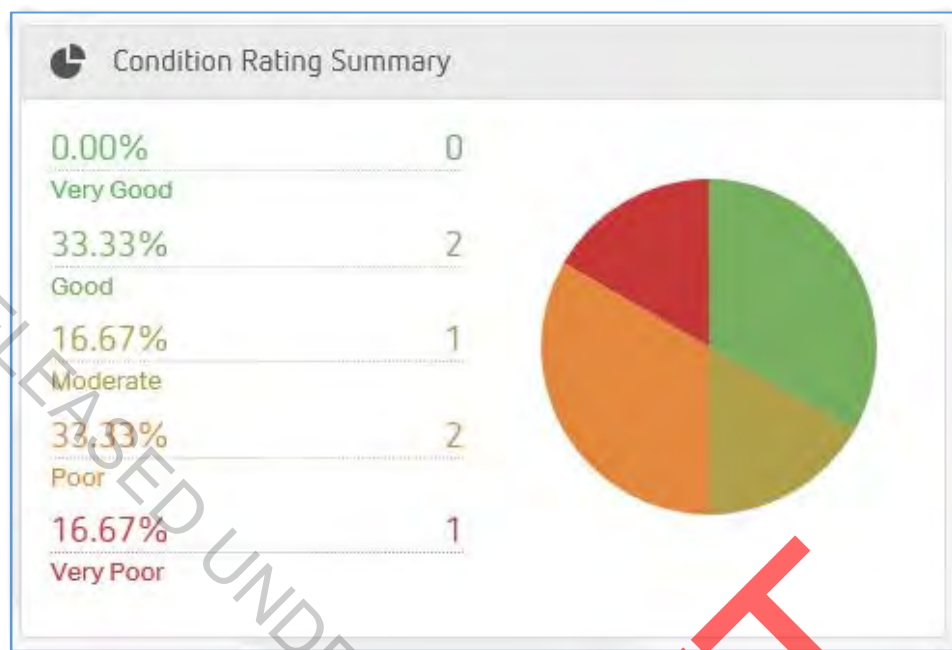
**Figure 52** Building 9 Condition of Electrical Systems

The distribution switchboard in the Kitchen consists of old panels in moderate to poor condition.

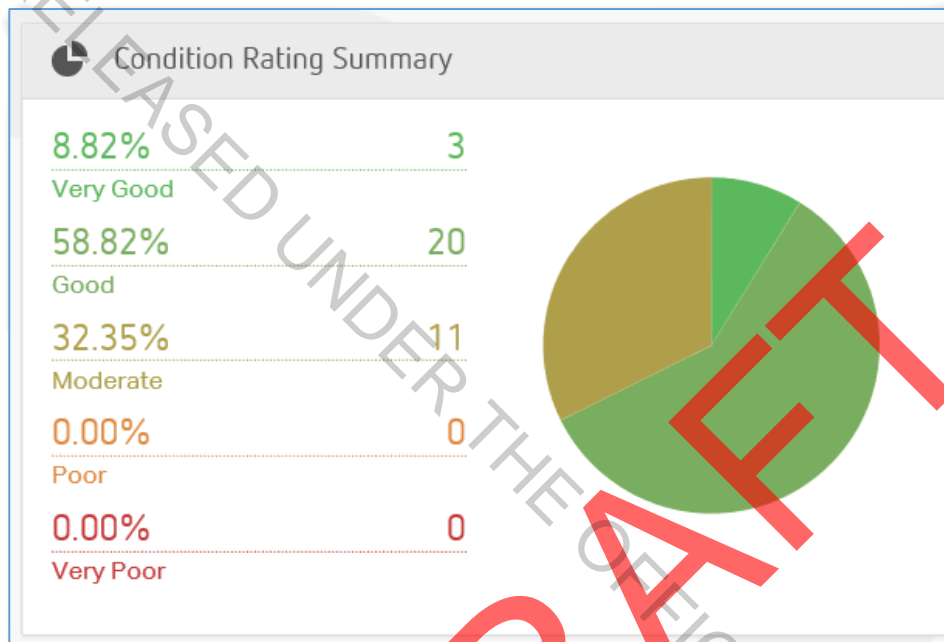
Figure 57 Building 13 Overall Condition

The overall condition of the building is rate at 1.6.

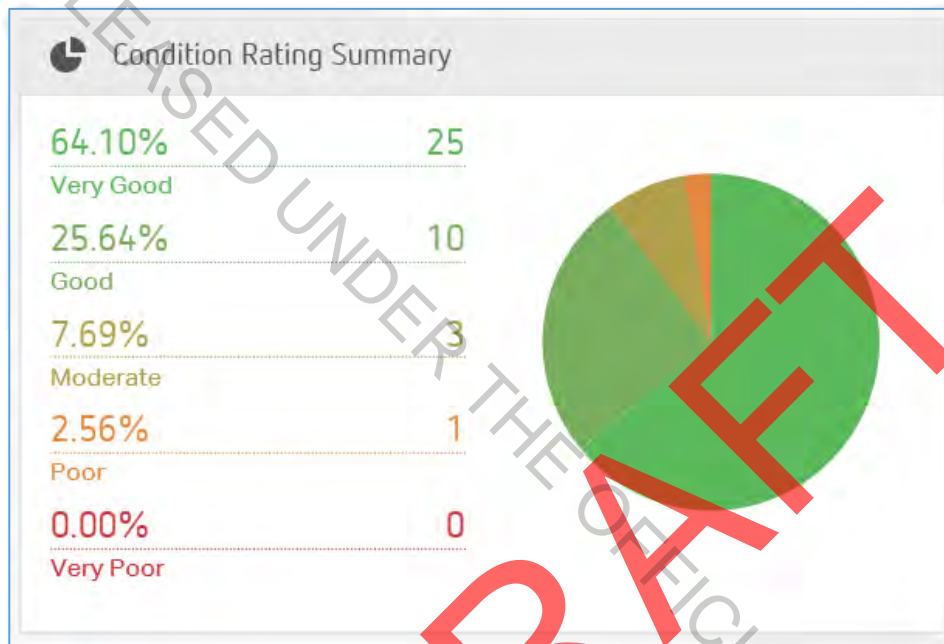
**Figure 67** Building 16 Overall Building Condition

The overall condition of the building is rated at 1.5.

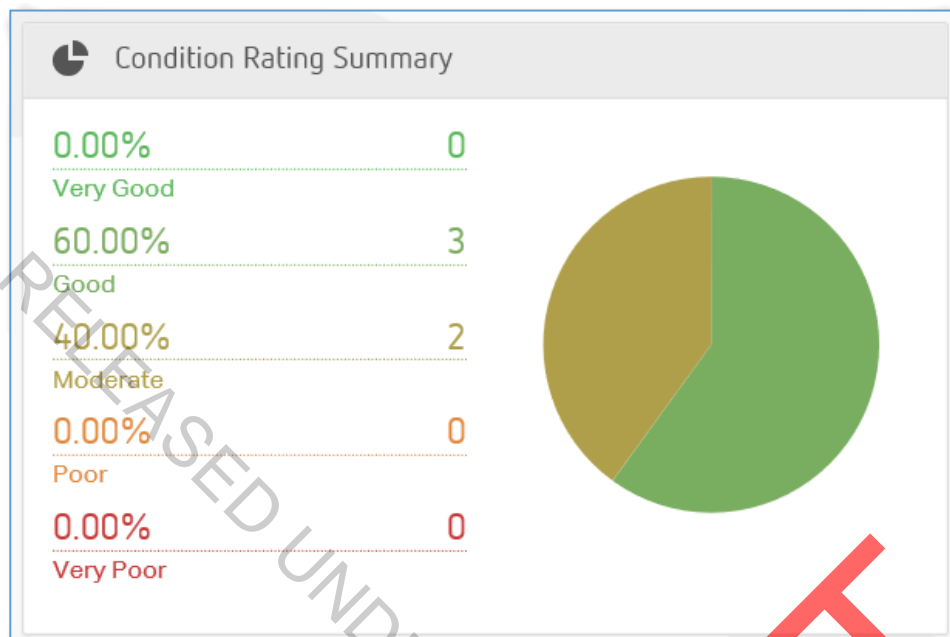
**Figure 75** Building 21 Condition of Mechanical Systems

Domestic hot water is generated in an electric storage cylinder located in the cleaners' room G020. This is nearing the end of its service life and should be scheduled for replacement.

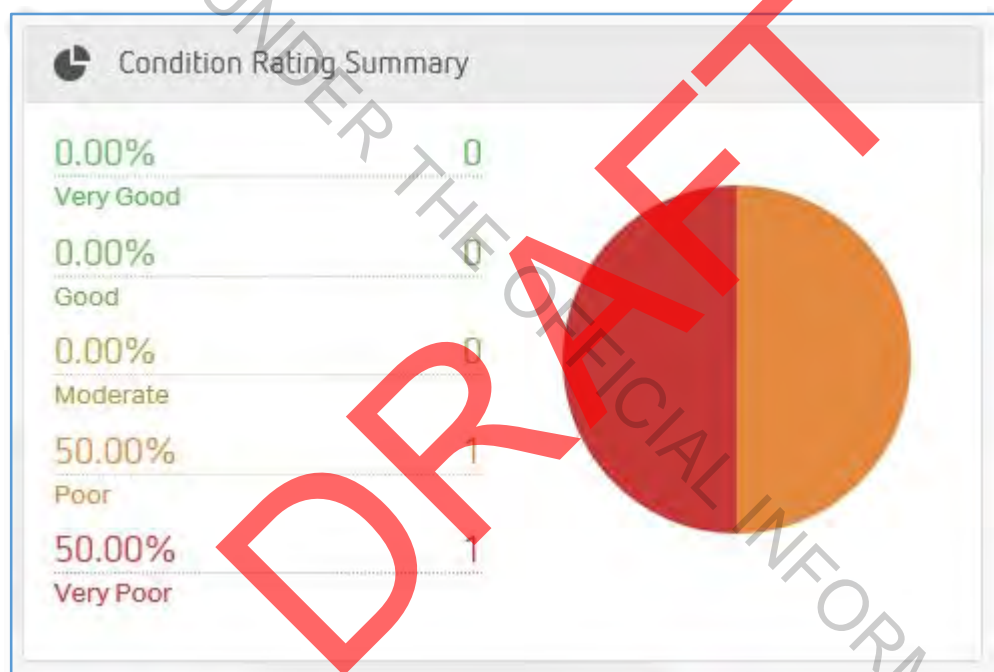
**Figure 81** Building 22 condition of Electrical Systems

The distribution switchboards servicing Building 22 are of the same age as the main switchboard and similarly, a replacement should be considered.

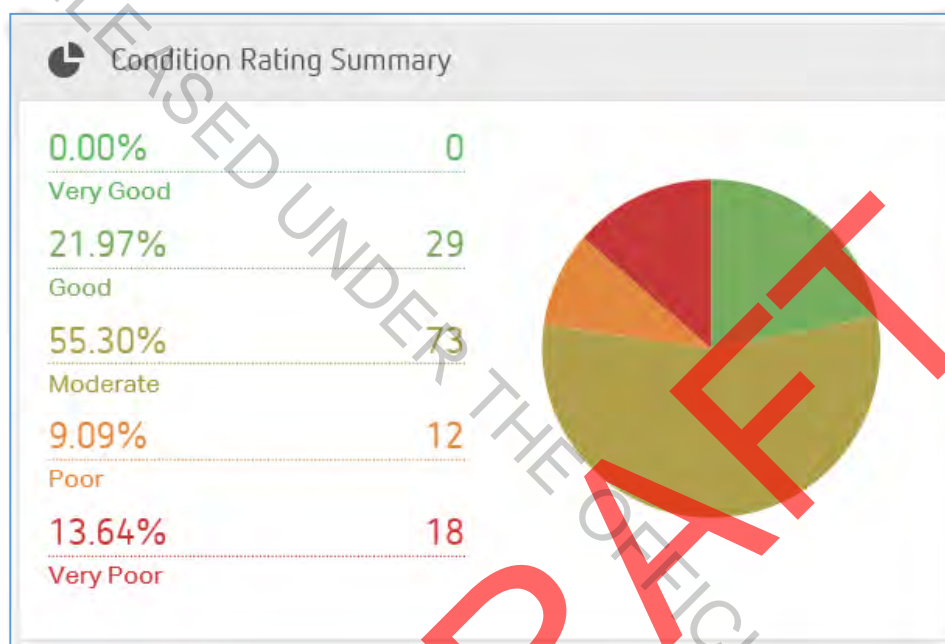
Figure 82 Building 23 Overall Building Condition

The overall condition of the building is rated at 3.1.
