RE Official Information Act request CDHB 9830

Door and Window Condition Assessment

Hillmorton Hospital
Te Whare Manaaki
Te Whare Roko

SEPTEMBER 2016
CDH0001.004

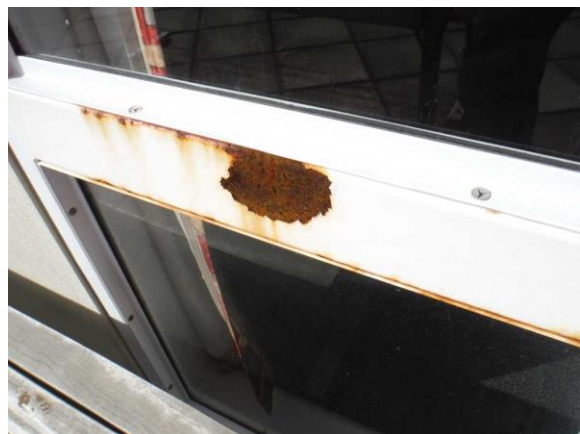
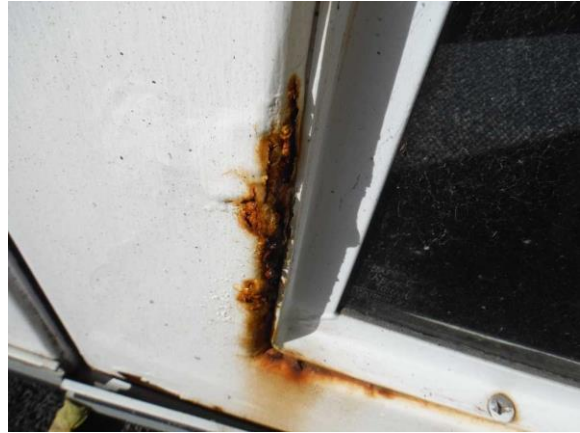
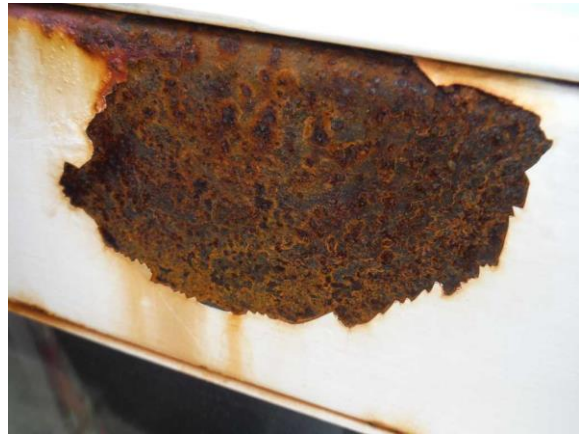
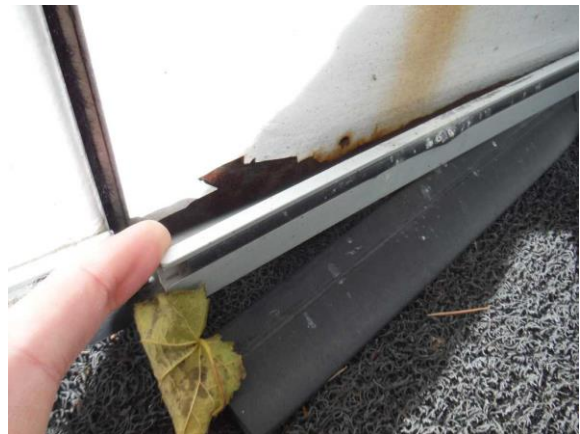
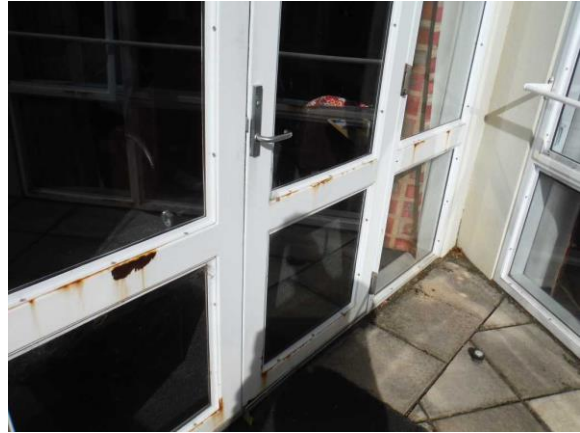
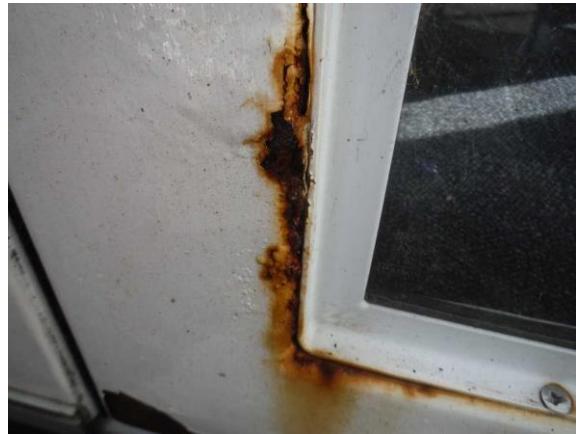
D8	Steel framed double doors glazed top and bottom with powdercoated finish. Stainless steel and anodised ironmongery/ hardware.	Anti-tamper screws have been fixed through frame to install powdercoated steel framed window beading. Note that areas of severe rusting have received a protective paint coating.	Poor. Localised areas of severe rusting to steel frame and blistering of powdercoated finish. Partially displaced aluminium door threshold strip. Neoprene seals to glazing slightly displaced.	Doors to be removed and replaced with new steel framed, powdercoated door inclusive of double-glazed anti- bandit glazing, hardware and associated flashings.	56-69
D9	Steel framed double doors glazed top and bottom and fan lights with powdercoated finish. Stainless steel and anodised ironmongery/ hardware.	Anti-tamper screws have been fixed through frame to install powdercoated steel framed window beading. Note that areas of severe rusting have received a protective paint coating.	Poor. Localised areas of severe rusting to steel frame and blistering of powdercoated finish. Localised areas of minor spot rusting. Partially displaced aluminium door threshold strip. Neoprene seals to glazing slightly displaced.	Doors to be removed and replaced with new steel framed, powdercoated door inclusive of double-glazed anti- bandit glazing, hardware and associated flashings.	70-81

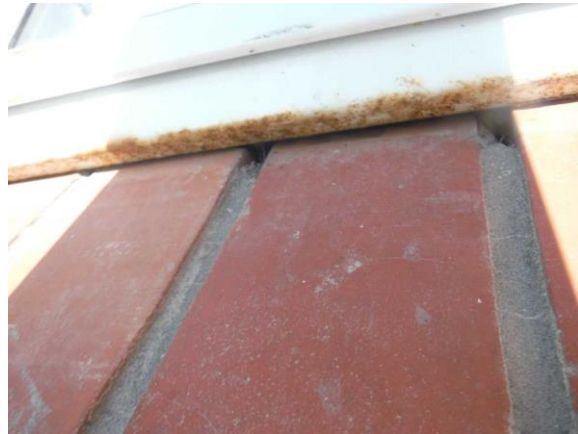
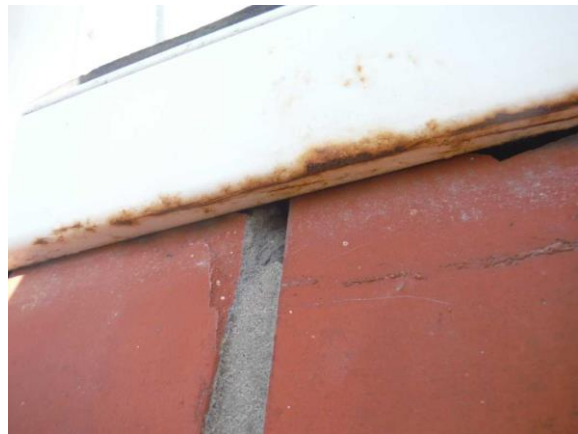
Photograph 169

ITEM	CONSTRUCTION	DEFECT	CONDITION	RECOMMENDATION	PHOTO REFERENCE
	openable top hung awning casement and powdercoated finish.	powdercoated steel framed window beading. Top-hung awning window opens out to strike against exterior column.	and to the exterior face, particularly to the bottom rail. Neoprene seals to glazing displaced. Awning hinges warped; window not closing tightly to frame	window inclusive of double-glazed anti-bandit glazing, hardware and associated flashings. We recommend installing window restrictors to the top-hung awning casement to prevent it impacting against the column.	
W3	Steel framed single glazed window complete with 1nr openable top hung awning casement and powdercoated finish.	Anti-tamper screws have been fixed through frame to install powdercoated steel framed window beading. Top-hung awning window opens out to strike against exterior column.	Poor. Localised spot rusting noted to the casement frame to the exterior face, particularly to the bottom rail and isolated Anti-tamper screws. Neoprene seals to glazing displaced. Awning hinges warped; window not closing tightly to frame	Window to be removed and replaced with new steel framed security window inclusive of double-glazed anti-bandit glazing, hardware and associated flashings. We recommend installing window restrictors to the top-hung awning casement to prevent it impacting against the column.	168-175

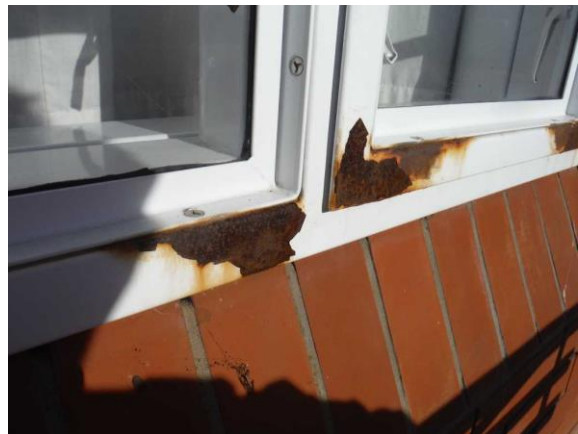
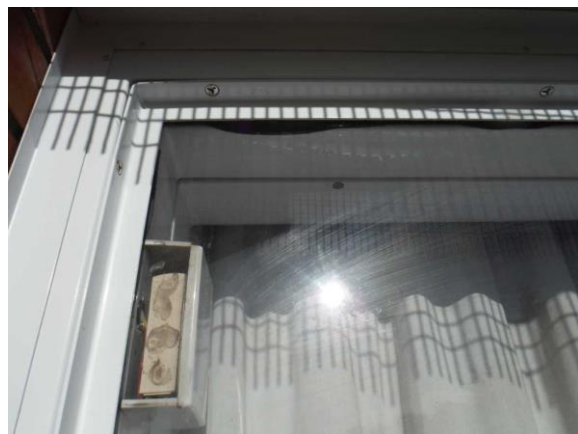
Photograph 193

W5	Steel framed single glazed window complete with 1nr openable top hung awning casement and powdercoated finish.	Anti-tamper screws have been fixed through frame to install powdercoated steel framed window beading. The window opening is too large in length and there is a gap to the right-hand side bottom	Poor. Localised severe rusting noted to the casement frame internally and to the exterior face, particularly to the bottom rail. Awning hinges warped; window not closing tightly to frame. Neoprene seals to glazing displaced. We also noted water to be tracking out	Window to be removed and replaced with new steel framed security window inclusive of double-glazed anti-bandit glazing, hardware and associated flashings. We also recommend installing rubber protective adhesive strips to the top-	192-199

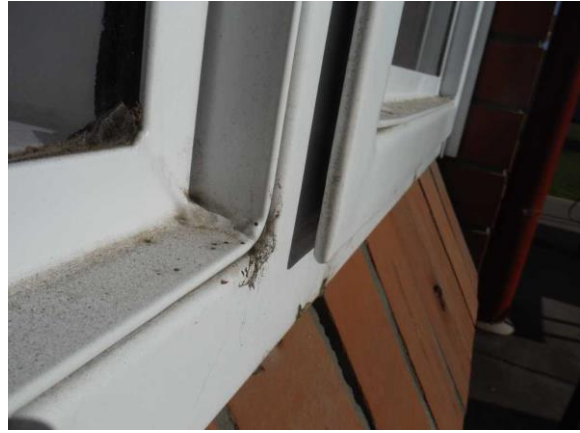
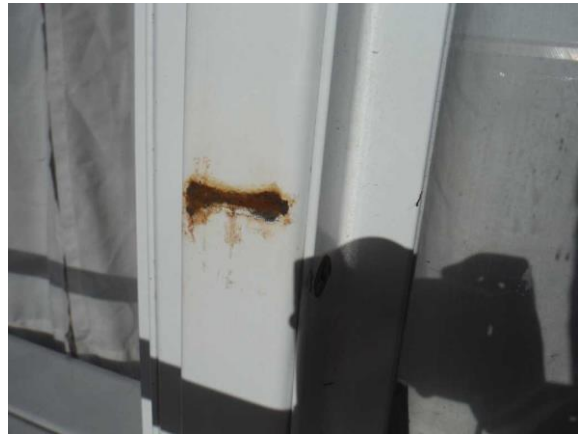
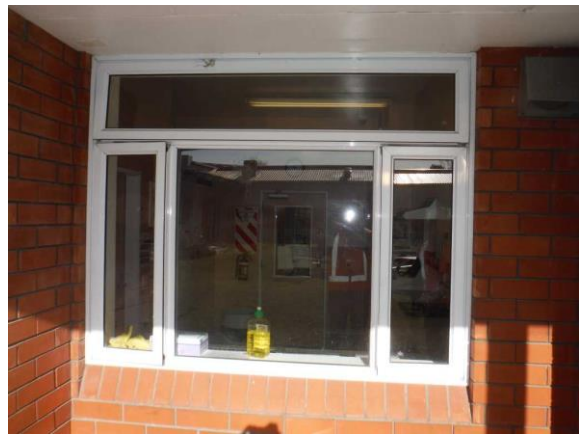
Photograph 203

ITEM	CONSTRUCTION	DEFECT	CONDITION	RECOMMENDATION	PHOTO REFERENCE
		corner.	of glazing bead/frame to bottom rail on to brick veneer. Score marks to the Lexan glazing.	hung awning window where it impacts against column.	
W6	Steel framed single glazed window complete with 1nr openable top hung awning casement and powdercoated finish.	Anti-tamper screws have been fixed through frame to install powdercoated steel framed window beading. Top-hung awning window opens out to strike against exterior column.	Reasonable/Satisfactory. Minor localised rusting to the powdercoated finish at the bottom rail. Isolated rusting to the awning window frame. Awning hinges warped; window not closing tightly to frame. Neoprene seals to glazing displaced. Broken and cracked handles noted.	Window to be removed and refurbished by sand blasting, hot-dip galvanising and powdercoated finish. Allow for new hardware and glazing seals.	200-207

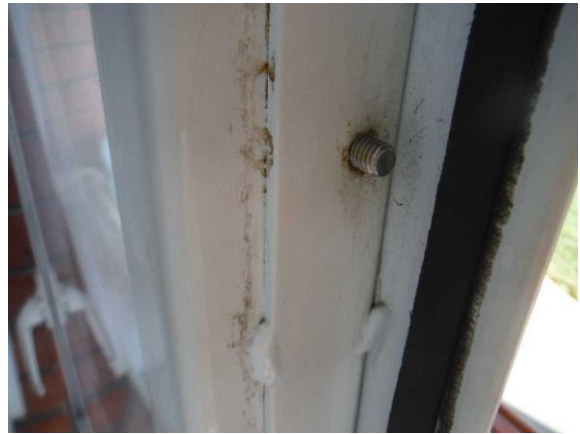
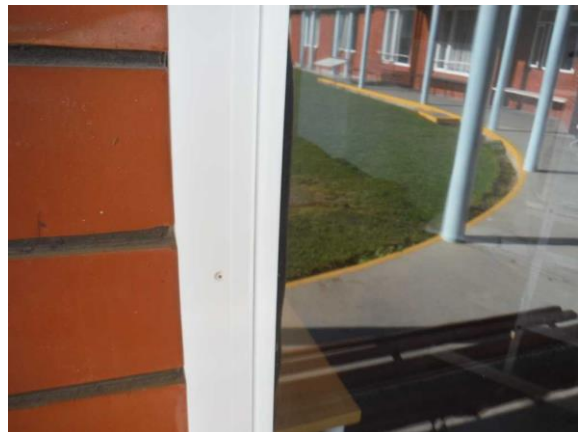
Photograph 217

W9	Steel framed single glazed window complete with 1nr openable top hung awning casement and powdercoated finish.	Anti-tamper screws have been fixed through frame to install powdercoated steel framed window beading. Top-hung awning window opens out to strike against externally fixed steel security rail. Top-hung awning window	Reasonable/Satisfactory. Neoprene seals to glazing displaced. Score marks to the Lexan glazing. Black neoprene seals to awning window deteriorated and missing. Awning hinges warped; window not closing tightly to frame.	Window to be removed and refurbished by sand blasting, hot-dip galvanising and powdercoated finish. Allow for additional hinges to remediate window not closing properly plus new hardware and glazing seals.	216-221

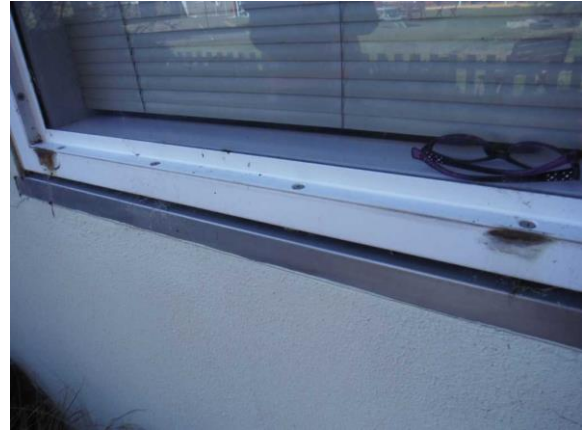
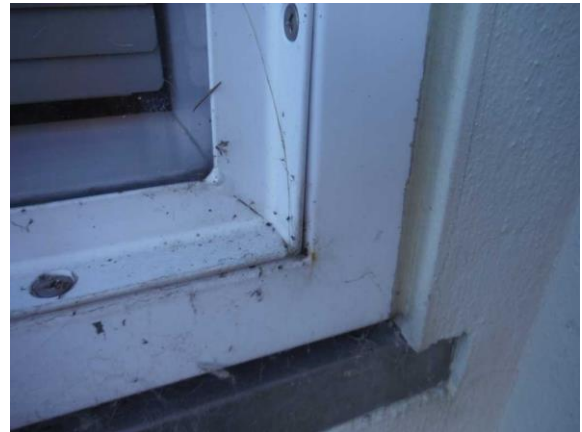
Photograph 257 Window 17

ITEM	CONSTRUCTION	DEFECT	CONDITION	RECOMMENDATION	PHOTO REFERENCE
W17	Steel framed single glazed fixed pane window and powdercoated finish.	Anti-tamper screws have been fixed through frame to install powdercoated steel framed window beading.	Poor. Localised areas of rusting to bottom rail of window casement. Rusting to bottom rail appears to have been rubbed down. Small localised area of minor crazing to bottom right-hand side corner of casement. Neoprene seals to glazing displaced.	Window to be removed and replaced with new steel framed security window inclusive of double-glazed anti-bandit glazing, hardware and associated flashings. Optional, fit trickle ventilation through frame.	257-260
W18	Steel framed single glazed fixed pane window and powdercoated finish.	Anti-tamper screws have been fixed through frame to install powdercoated steel framed window beading.	Poor. Localised areas of rusting to bottom rail of window casement. Rusting to bottom rail appears to have been rubbed down. Localised area of crazing to the top left-hand side corner of the casement frame. Neoprene seals to glazing displaced.	Window to be removed and replaced with new steel framed security window inclusive of double-glazed anti-bandit glazing, hardware and associated flashings. Optional, fit trickle ventilation through frame.	261-264

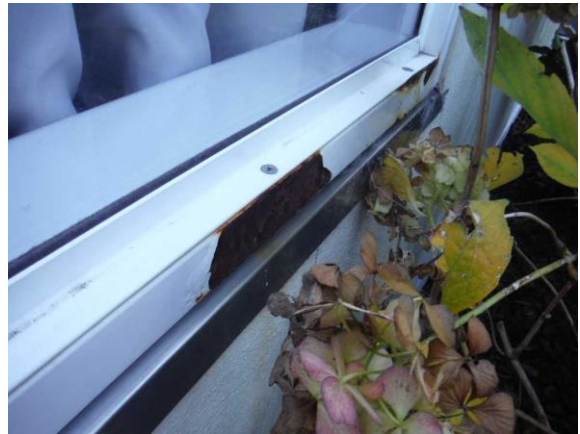
Photograph 271

W19	Steel framed single glazed fixed pane window and powdercoated finish.	Anti-tamper screws have been fixed through frame to install powdercoated steel framed window beading.	Poor. Localised areas of severe rusting noted to bottom rail of window casement. Rusting to bottom rail appears to have been rubbed down. Small localised areas of crazing and spot rusting. Neoprene seals to glazing displaced.	Window to be removed and replaced with new steel framed security window inclusive of double-glazed anti-bandit glazing, hardware and associated flashings. We also recommend installing rubber protective adhesive strips to the top-hung awning window where it impacts against column. Optional, fit trickle ventilation through frame.	265-268
W20	Steel framed single glazed fixed pane window and powdercoated finish.	Anti-tamper screws have been fixed through frame to install powdercoated steel framed window beading.	Poor. Localised areas of severe rusting noted to bottom rail of window casement. Small localised areas of crazing and spot rusting. Neoprene seals to glazing displaced.	Window to be removed and replaced with new steel framed security window inclusive of double-glazed anti-bandit glazing, hardware and associated flashings. Optional, fit trickle ventilation through frame.	269-272

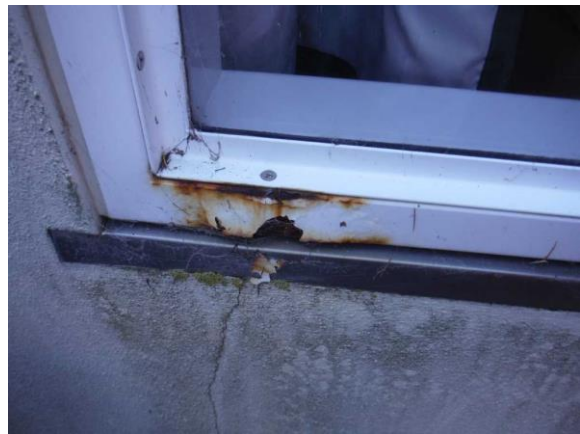
Photograph 273 Window 21

W21	Steel framed single glazed fixed pane window and	Anti-tamper screws have been fixed through frame to install	Poor. Localised areas of severe rusting noted to bottom rail of window	Window to be removed and replaced with new steel framed security	273-276

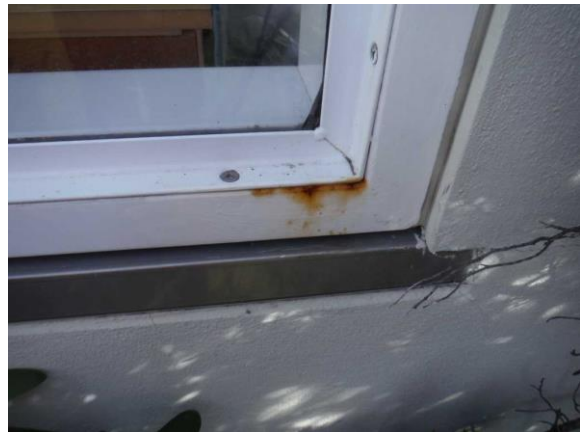
Photograph 285 Window 24

W23	Steel framed single glazed fixed pane window and powdercoated finish.	Anti-tamper screws have been fixed through frame to install powdercoated steel framed window beading.	Poor. Localised areas of severe rusting noted to bottom rail of window casement. Small localised areas of crazing and spot rusting to top casement corners. Neoprene seals to glazing slightly displaced.	Window to be removed and replaced with new steel framed security window inclusive of double-glazed anti-bandit glazing, hardware and associated flashings. Optional, fit trickle ventilation through frame.	281-284
W24	Steel framed single glazed fixed pane window and powdercoated finish.	Anti-tamper screws have been fixed through frame to install powdercoated steel framed window beading. Note that bottom rail has received a protective paint coating.	Poor. Localised area of severe rusting/pitting to bottom rail of window casement. Neoprene seals to glazing slightly displaced.	Window to be removed and replaced with new steel framed security window inclusive of double-glazed anti-bandit glazing, hardware and associated flashings. Optional, fit trickle ventilation through frame.	285-288
