# **Canterbury District Health Board Burwood Buildings**

# Feasibility Study 2017

Project Number: 655-00 Date: 15 January 2018 **Revision: Final**

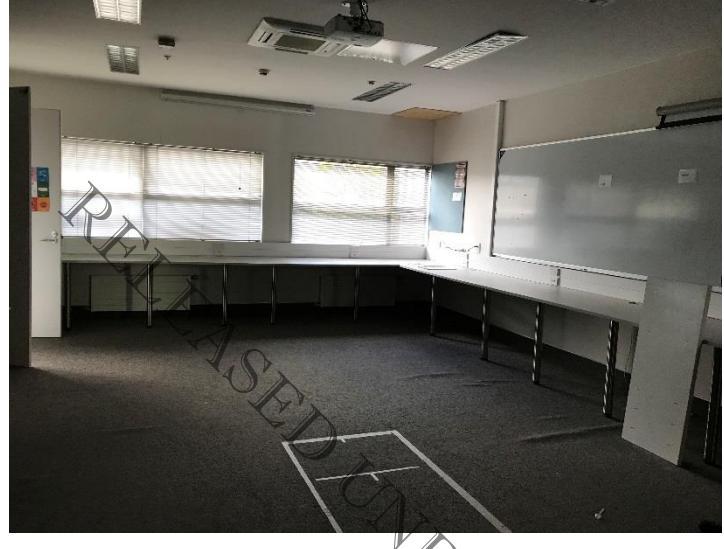
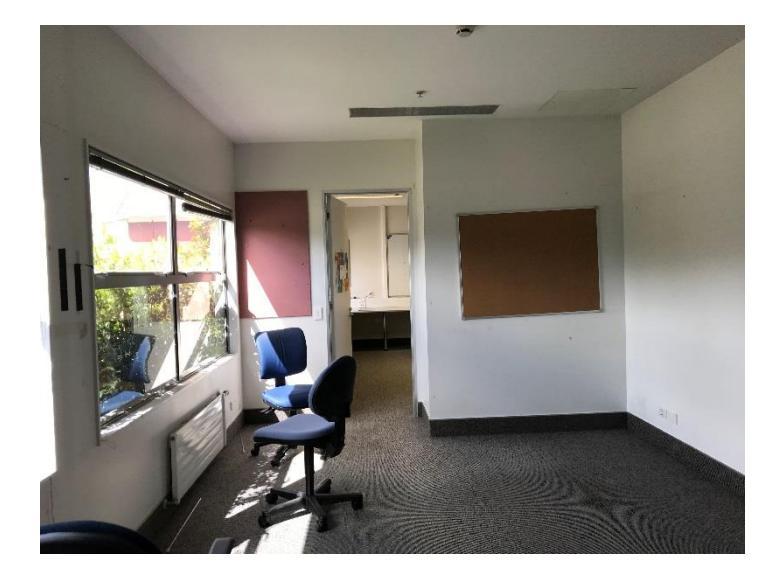
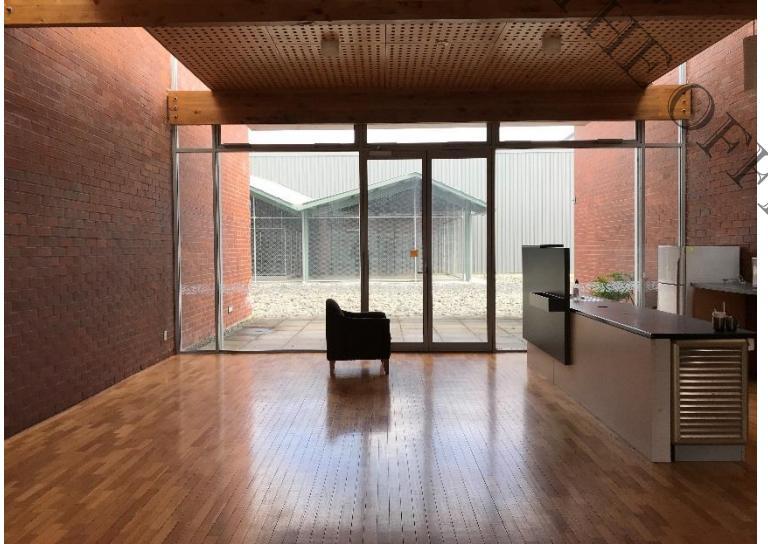
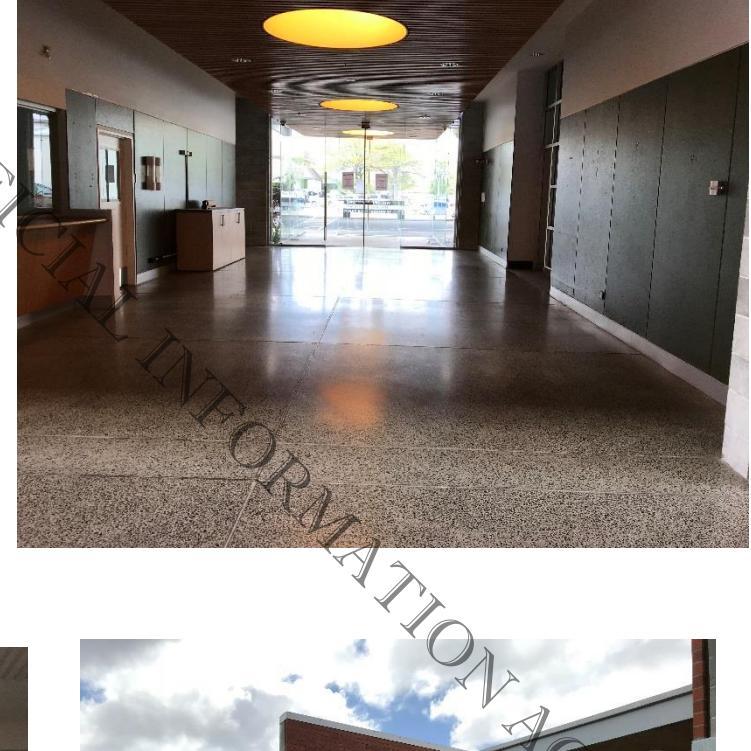
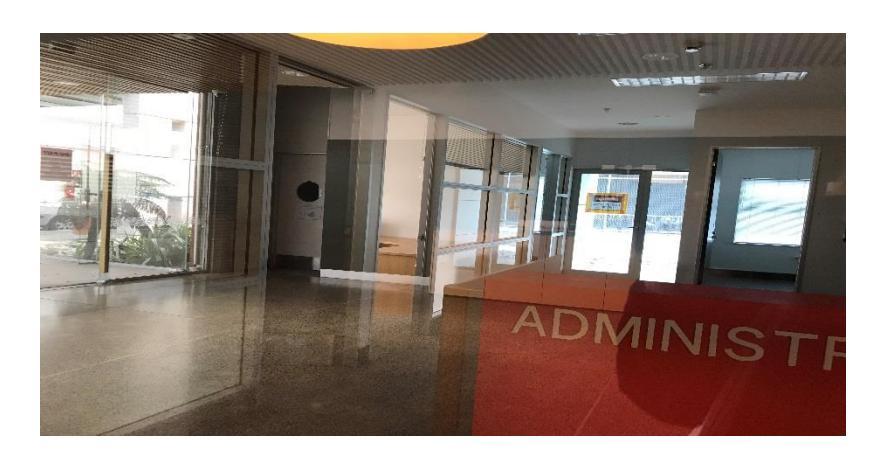
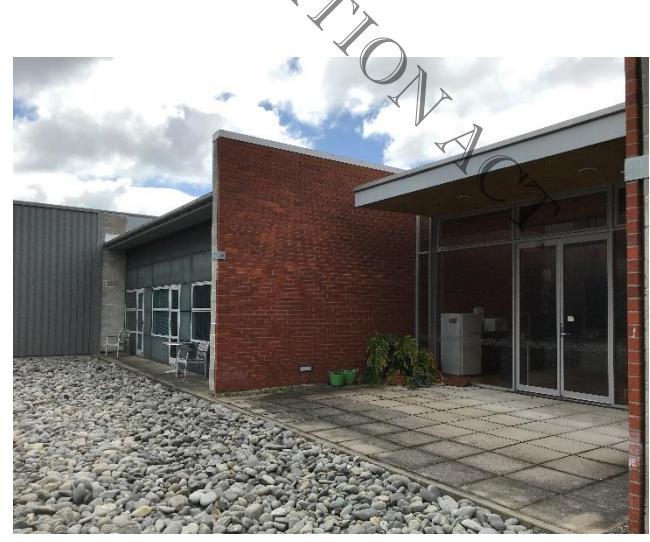
#### Administration Building

In the 2010/2011 earthquakes the Administration Building suffered differential settlement following ground liquefaction in areas of the site. There is some cosmetic earthquake damage visible through-out, primarily to walls and ceilings, and there is evidence of rainwater ingress through skylights, gutters and downpipes. Windows seals were observed to be poorly fitting.

The CDHB asbestos register (dated 2013) indicates asbestos flat sheeting to be present on the exterior walls (note some areas are covered in stucco) in the north-west corner of the building.

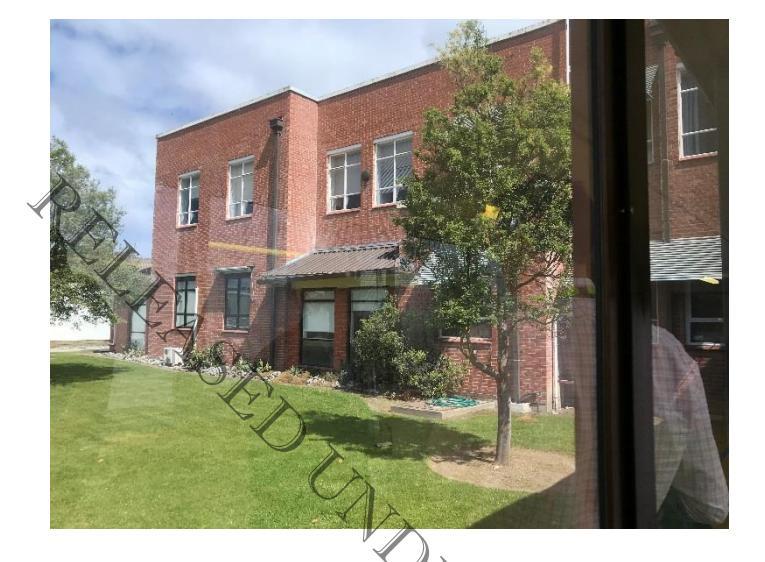
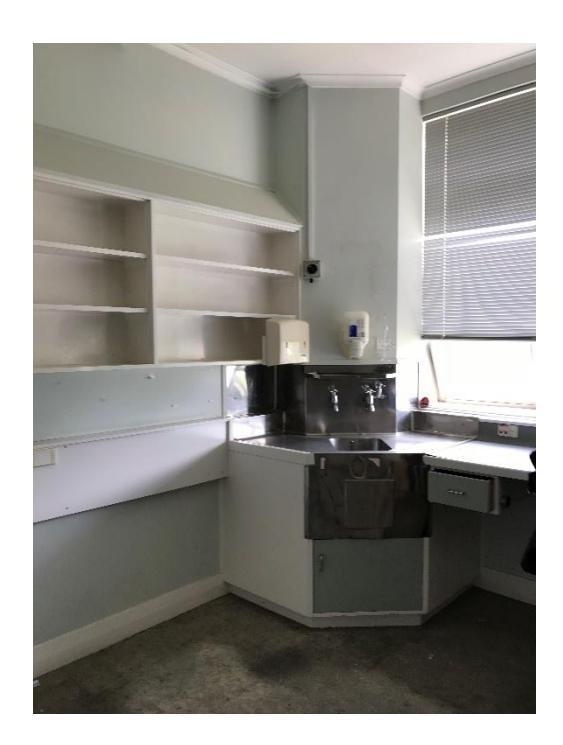
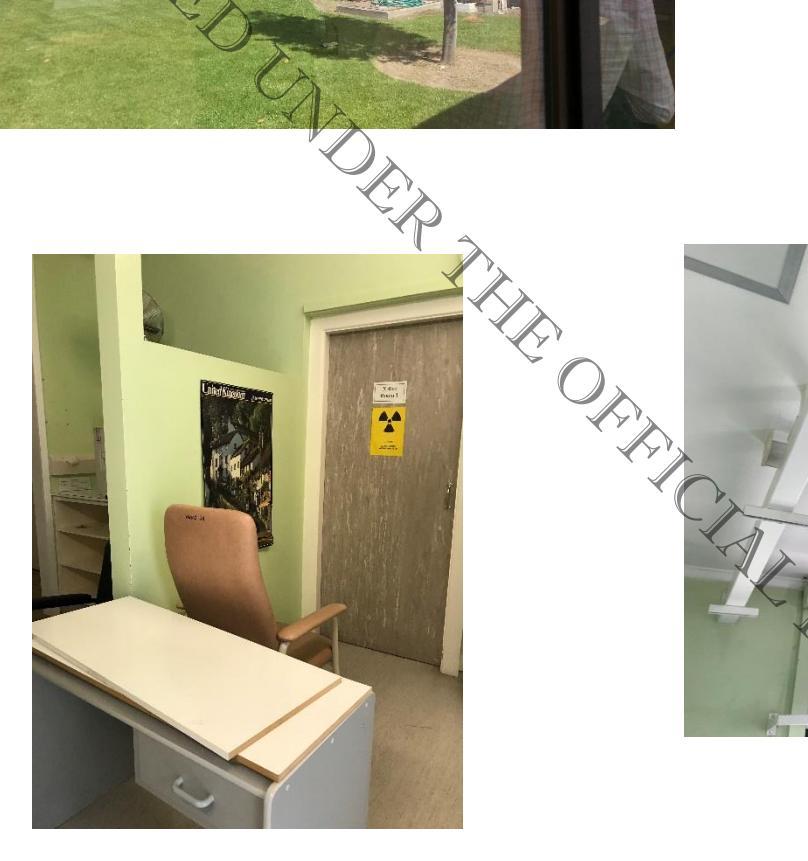
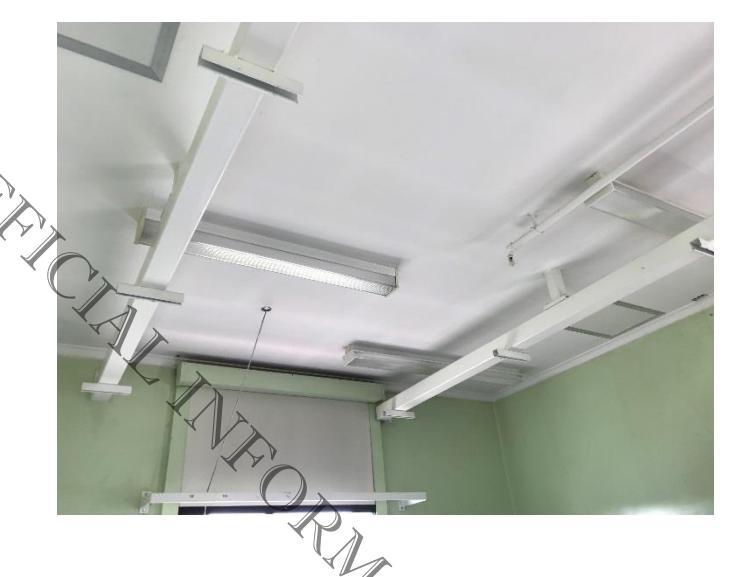
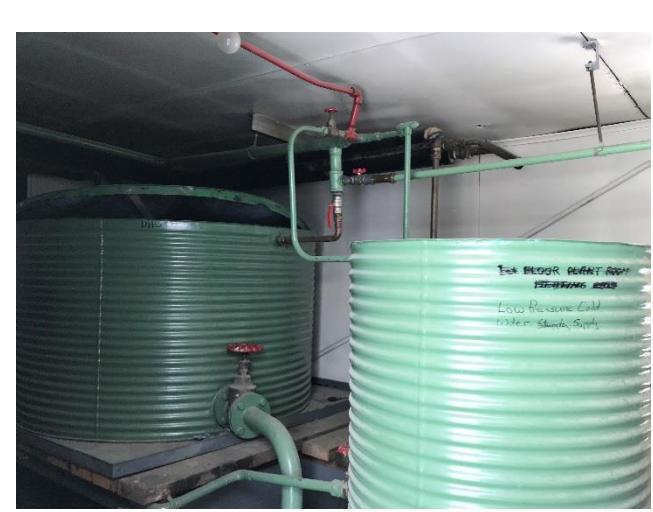
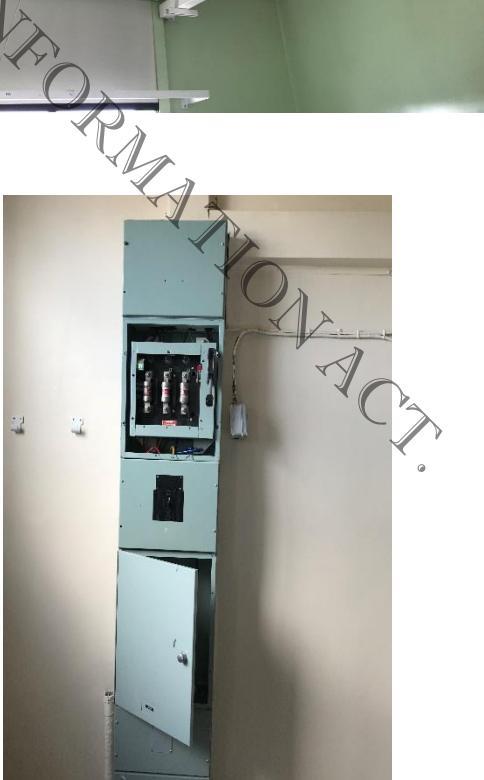
### **Surgical Block First Floor**

Post-earthquake redecoration on the ground floor was undertaken as part of the decant plan to make way for construction of the new building. Structural repairs have been identified to improve the rating to 67% NBS at IL3. This would translate to greater than 80% at IL2. The recommended repairs include removal of internal brick partitions, or ply lining of these, along with strengthening of the tank room walls.

The building services appear not to have been upgraded on a consistent basis. Old "bakelite" switches suggest that TPS (thermoplastic sheathed) wiring remains in place with old-style, fused distribution boards. Steam radiators provide the heating.

The CDHB asbestos register (dated 2013) indicates there is asbestos present in the area for refurbishment on the first floor. The Chemsafety report for the ground floor (dated 15 August 2013) identified asbestos in lagging on pipes in the ceiling void (beneath Level 1 floor), and behind radiators. In the roof space plant room, asbestos flat sheeting is noted to be present on the ceilings, western interior walls and soffit areas.

The roof of the building appeared in satisfactory condition, however water tanks in the roof space plant room are free standing and require seismic restraint. The single glazed, metal framed windows were noted to be in a poor state of repair, the sashes poorly fitting in the frames with corrosion evident.
