Please find attached as **Appendix 1** the Earthquake Seismic Assessment Report for Christchurch Women's Hospital October 2013 and **Appendix 2** the Detailed Seismic Assessment Report for the Clinical Services Building October 2013.

EARTHQUAKE SEISMIC  
ASSESSMENT REPORT

REPORT 6 - CHRISTCHURCH WOMEN'S  
HOSPITAL

REV 2 - 7 OCTOBER 2013

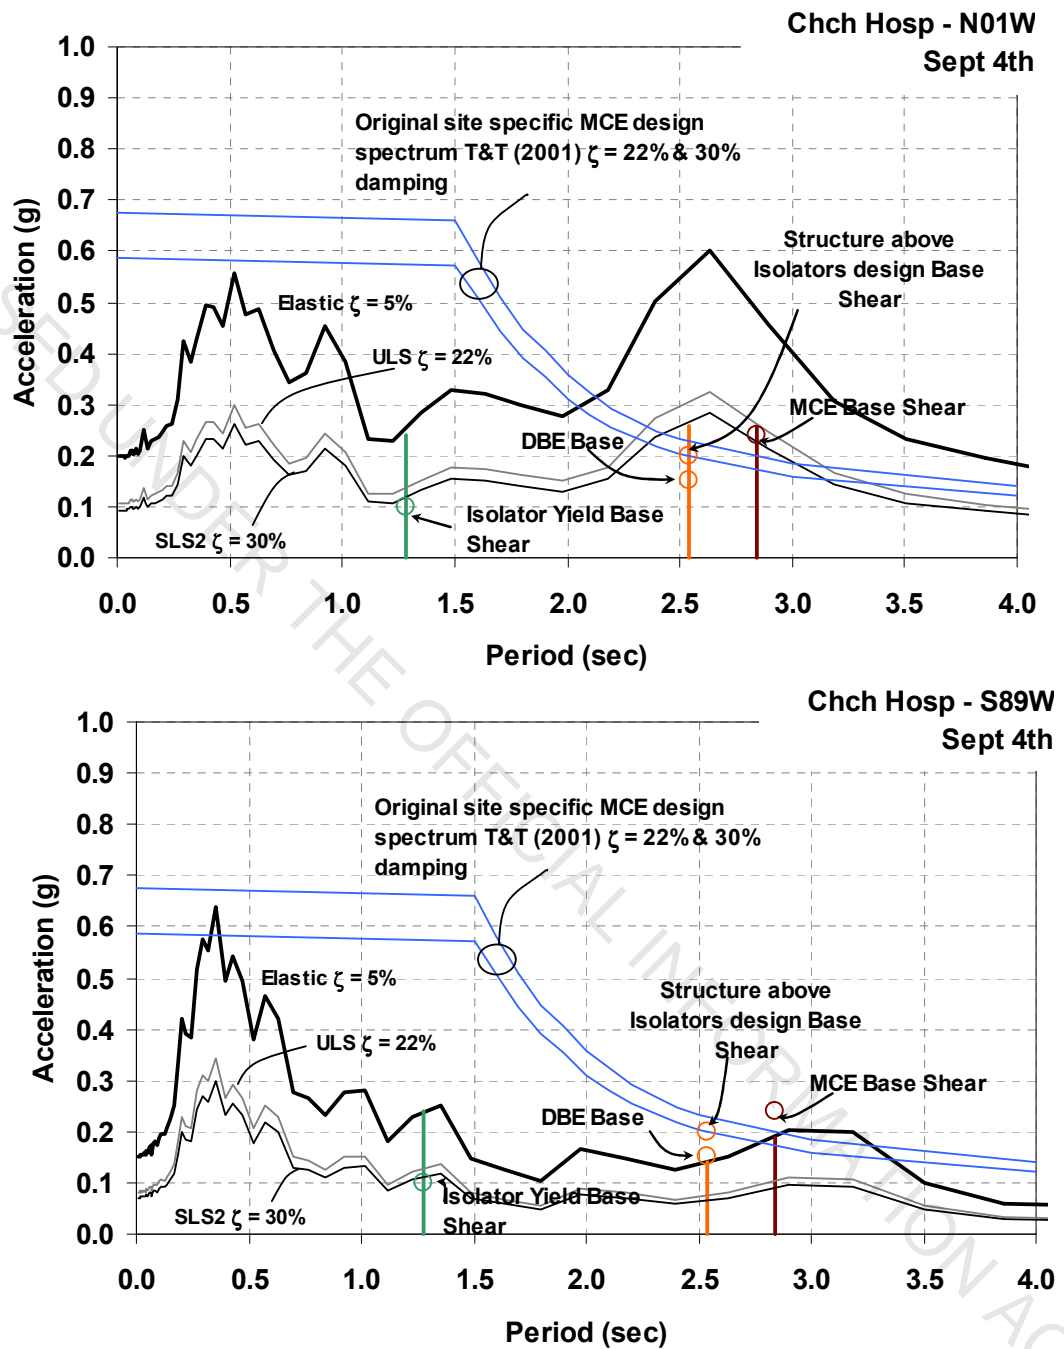
The Darfield earthquake had stronger ground motion in the north-south direction (N01W), than in the east-west (S89W). Figure 3-1 shows this response when comparison of the record spectra is made between (a) and (b). It is not possible to interpret the exact demands that the building experienced from these spectra, and in particular the behaviour of the building after the isolator units yield can only be generally interpreted. To this extent the indications are that the isolators would have yielded in both building principal axis directions when the structural period was approximately 1.28 seconds and apparent damping approximately 5%. Following the isolator yield the effective period of the building moved to 2.5 seconds at which point the next performance level is the Ultimate Limit State.

At an SLS2 level the seismic demand shown by the "SLS2  $\zeta = 30\%$ " curves (" $\zeta$ " represents damping) suggest that the building could have developed the SLS2 and DBE/ULS isolator base-shear levels and the design base-shear demand expected for upper structure. However as noted in Section 2.2.1 the as-designed overstrength has led to a structure that responds in an essentially elastic manner up to ULS levels. Thus even with these near-design level forces it is unlikely that significant structural damage would have occurred in the seismic system. Observations of the structural members suggest that this is in fact the case as the damage noted in the log does not correspond to significant demands in the upper structure.

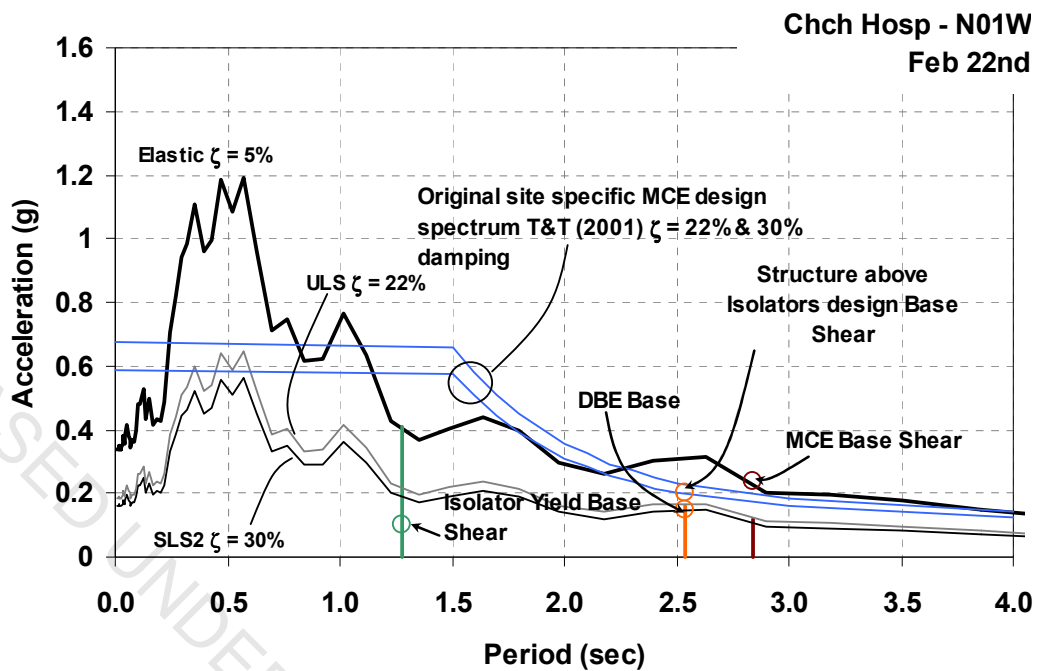
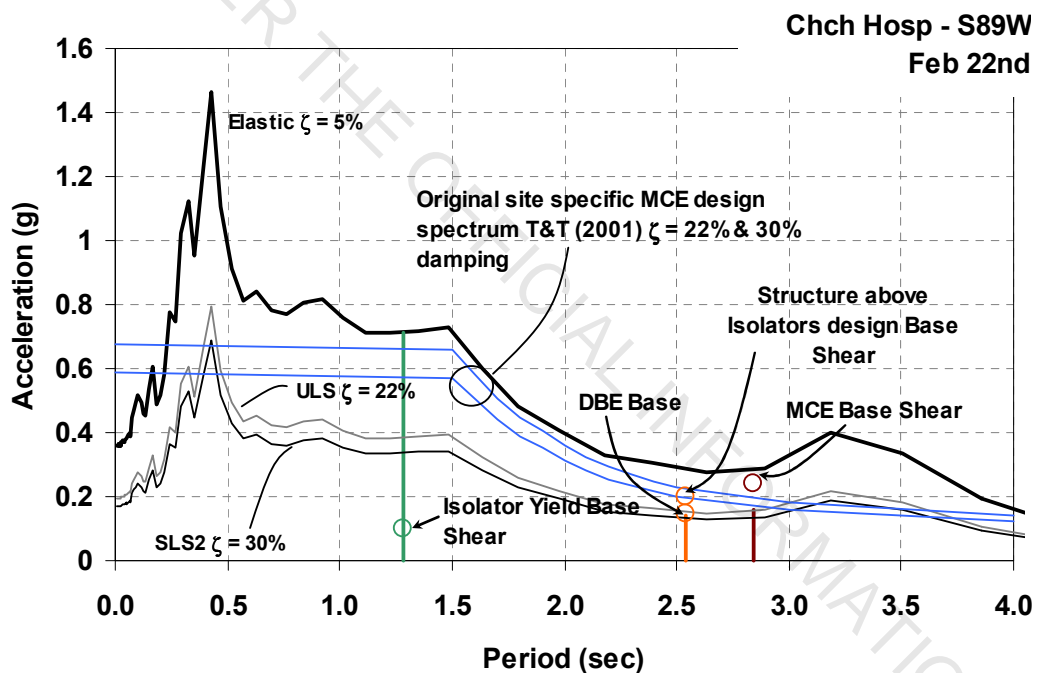
It should be noted that the Lyttelton earthquake was very short in terms of the strong shaking produced, with the strong motion only lasting for approximately 10 seconds. Rupture of the Alpine Fault is expected to contain 60 seconds or more of strong motion.

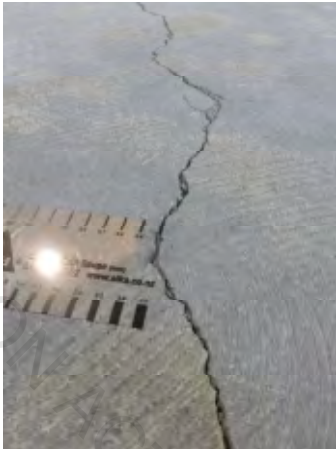
Damage	Locations	Recommendation	Example
1.7. Inspection	LEVEL 5: Possible cracking in topping slab parallel to beams on GL 3 & 6 per Level 3 and 4. Cracks observed on north and south sides of beams.	See App F	See above
1.8. Slab cracks radiating from column	LEVEL 6: South-west corner column	Epoxy inject cracks greater than 0.2 mm in width. Refer to HCG Specification

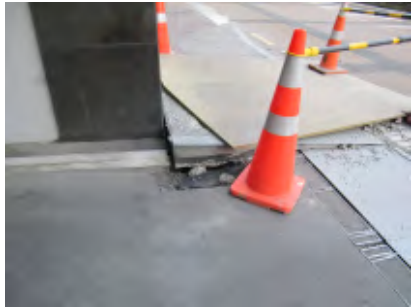
Damage	Locations	Recommendation	Example
5.2. Exterior covers have pounded perimeter wall	Perimeter “moat” around exterior of building at Lower Ground floor	Contact locations to be repaired per original specifications. See revised details issued previously.

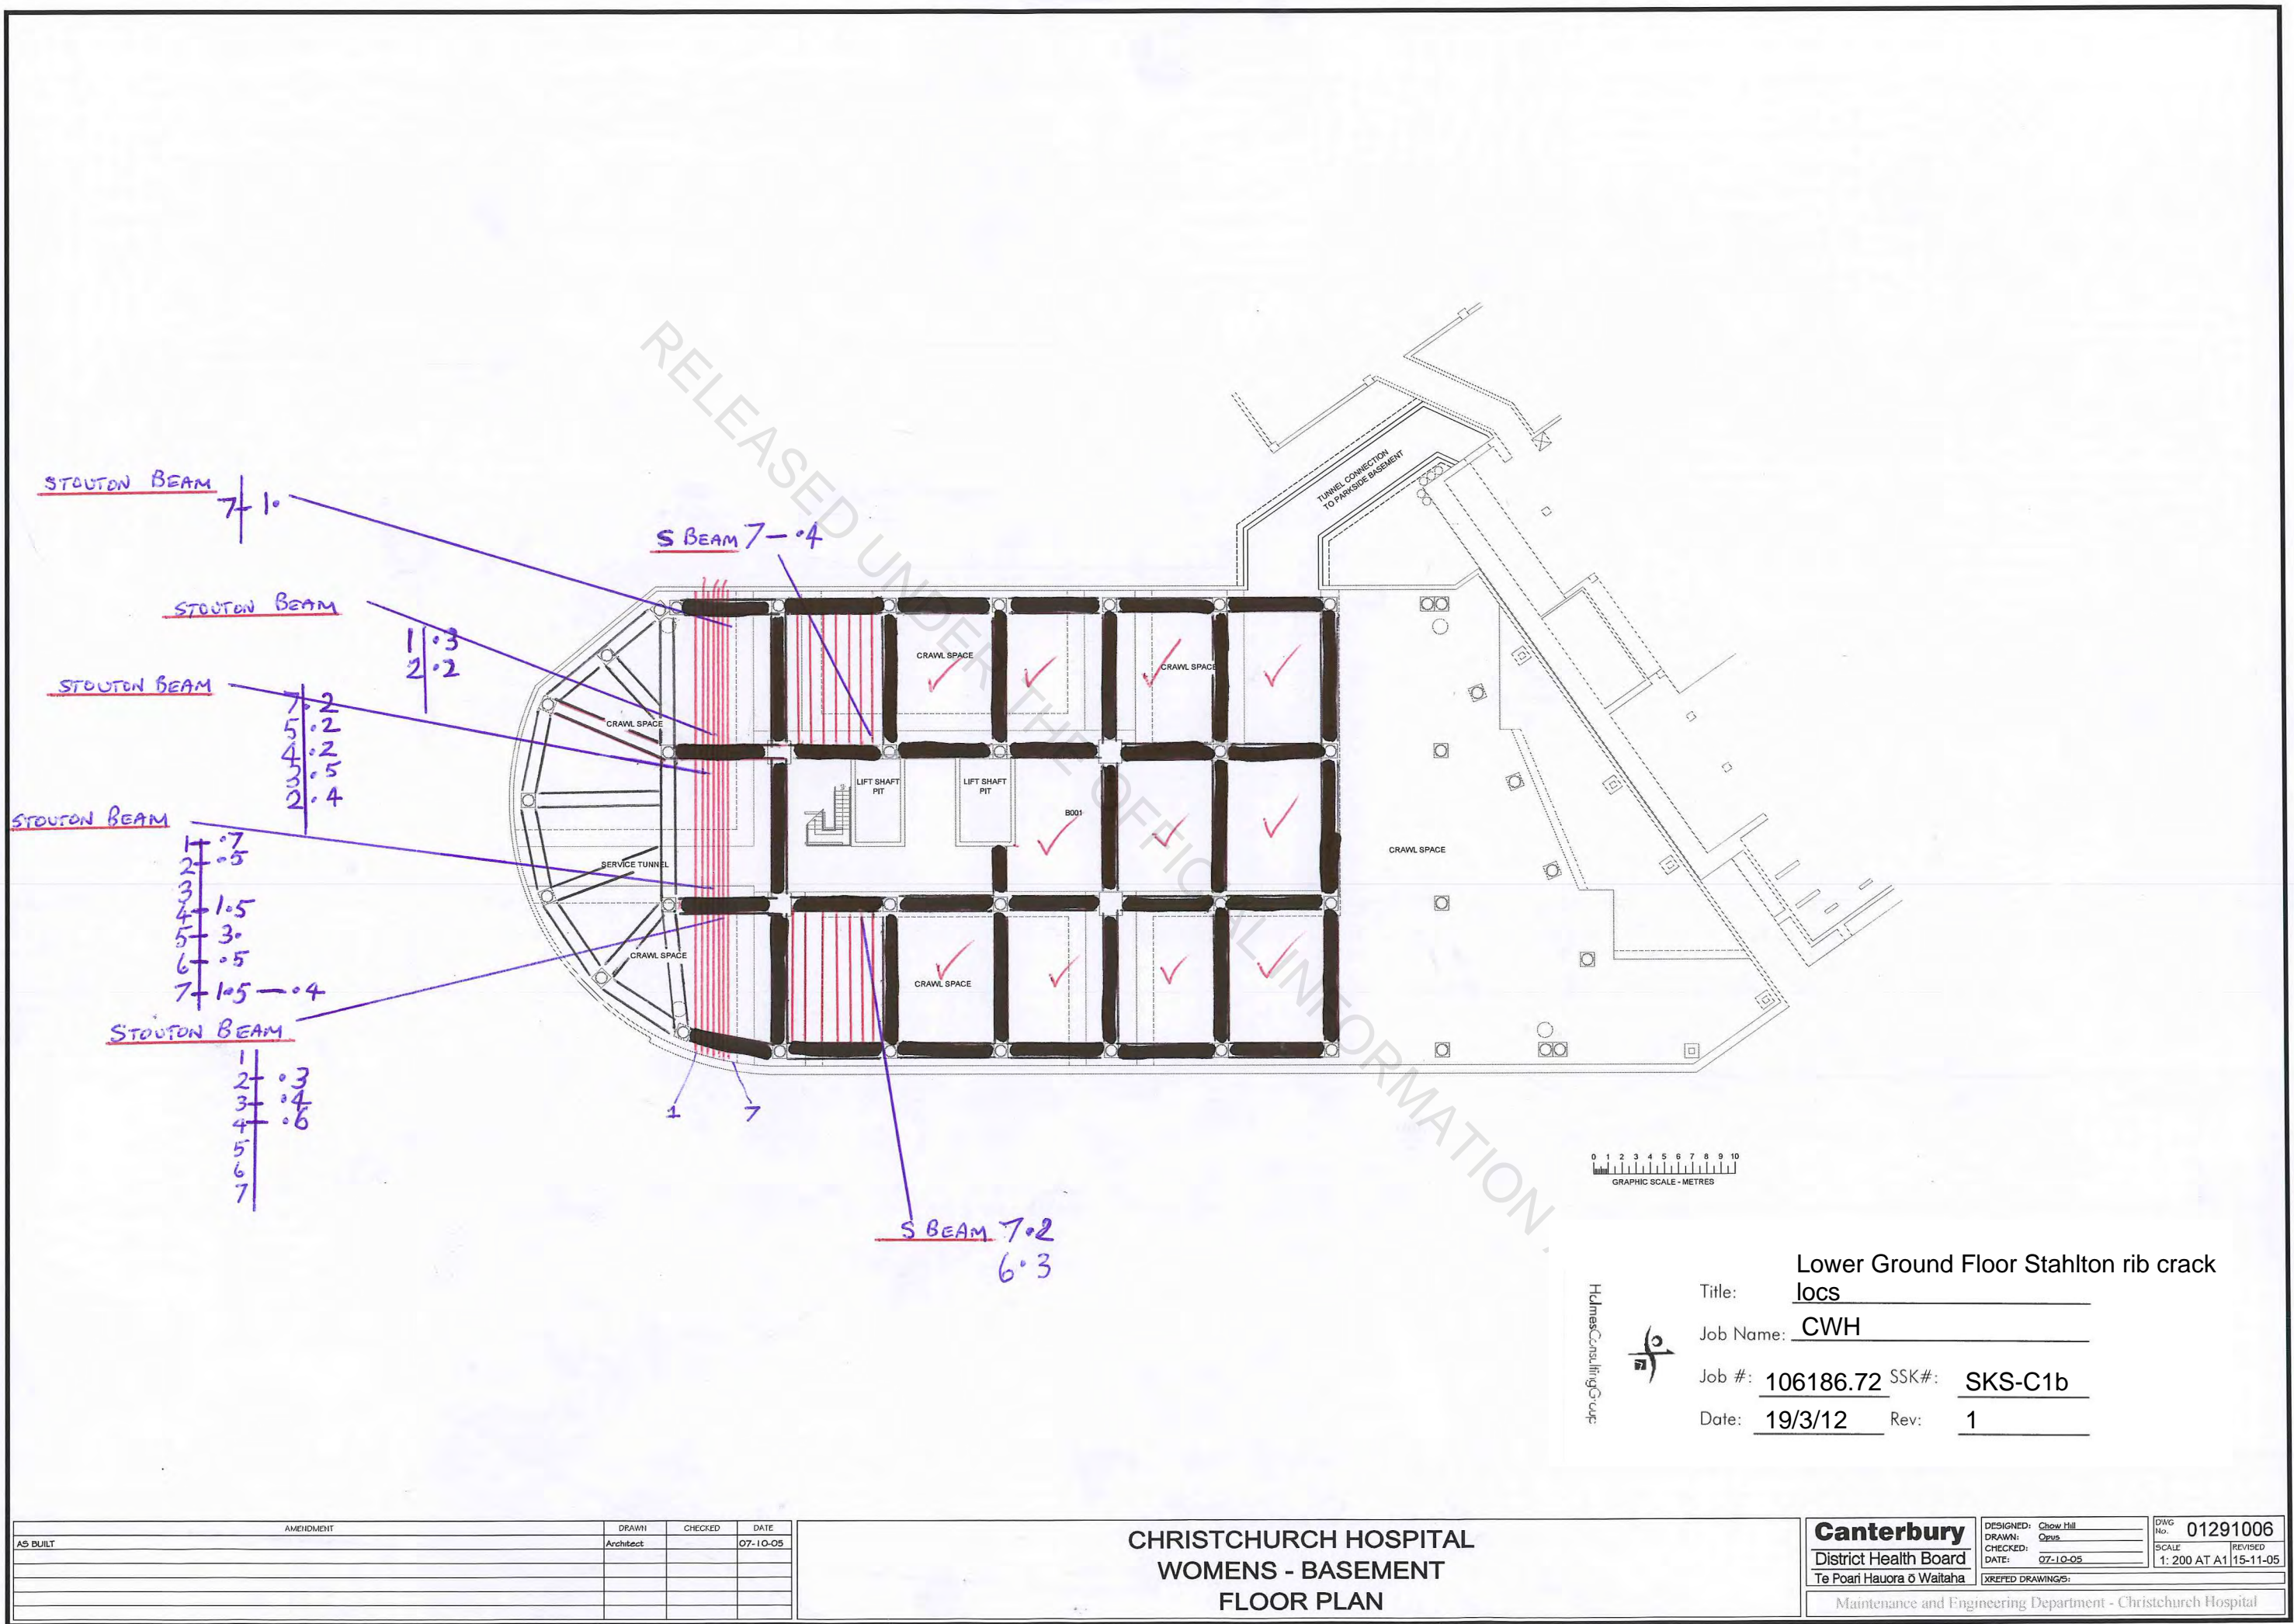
Title: Lower Ground Floor Stahlton rib crack locs  
Job Name: CWH  
Job #: 106186.72 SSK#: SKS-C1b  
Date: 19/3/12 Rev: 1

The precast concrete floor ribs that make up the Lower Ground floor and are observable from the basement have shown a consistent amount of damage in the western half of the building.

Single cracks have developed in a number of the units near the seating with cracks widths ranging up to 1.5 mm in size. A remediation Site Instruction and detail has been issued for the locations considered to be critical, where epoxy injection will not be sufficient to ensure the units perform with their original strength. In locations at other floor levels where such damage is observed with crack widths of 0.5 mm or more (in internal spaces), it is suggested that the cracks be epoxy injected and their location noted as part of a full building survey. Where the ribs are in an external environment we recommend that cracks over 0.5mm in width are epoxy injected, and all other cracks less than 0.5mm be painted over with a flexible industrial paint coating.

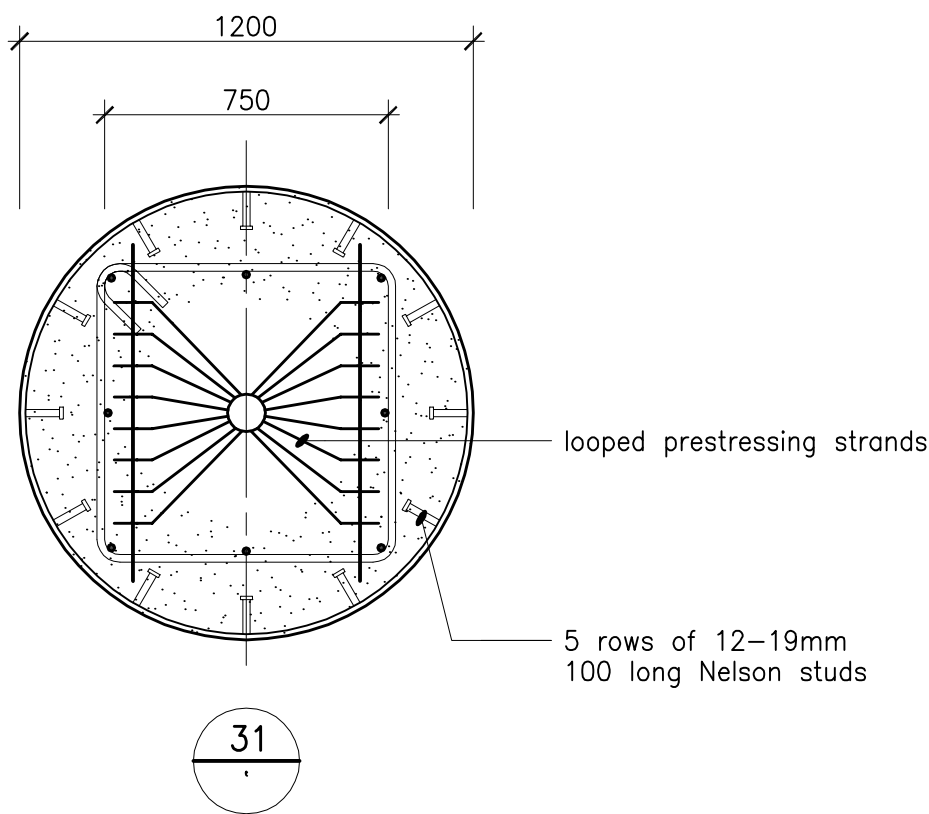
Inspection of the caissons containing the tie-down anchors found water had collected on top of the concrete plug in some locations. Further inspection of the tie-down encasement found water inside the pipe housing the post-tensioned tie-down strands, but not within the post-tensioned cable strand sheaths. A remediation detail for the encasement pipes, and concrete plug has been provided and indications are that the water ingress has been mitigated (see Appendix C. In the south-west shaft (referred to as Shaft 2 in site reports) some further water ingress was noted although at markedly slower rates, for which a further instruction to apply a concrete top seal over a hydrophilic-type perimeter strip that is embedded in a Xypex bonding agent (to help bond with the steel caisson) been issued.

- Chip out 40 DP x25mm chase around perimeter of previous plug repair concrete.
- Clean out chase and place 5mm strip of Kuniseal C-31DS waterstop around full perimeter. Butt ends as directed by supplier to form continuous strip
- Cover waterstop with Xypex Patch n Plug combined with Xypex Xycrylic Admix

Clean surface of concrete plug to remove all corrosion and weathering affected concrete.  
Clean surface of steel caisson shaft to remove all corrosion.  
Ensure surface preparations are appropriate for Xypex and Kuniseal application.

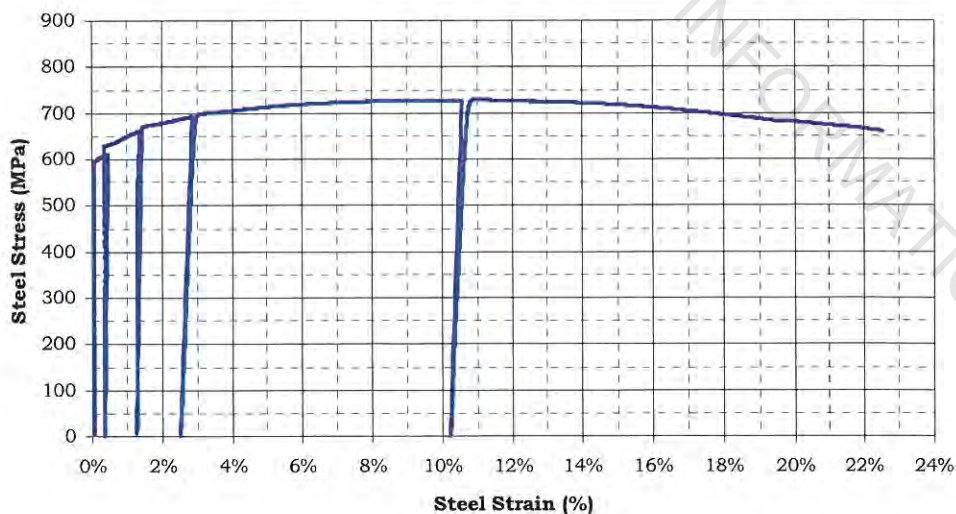
Figure 1 Materials Test Result for the Steel test coupon

It is our understanding that the steel used in the building complied with the requirements of Grade 500E reinforcement, as detailed in AS/NZS 4671. The recorded yield stress of the material was towards the upper limitation of allowable yield stresses for Grade 500E steel. The stress ratio ( $f_u/f_y$ ) of the tested steel sample was determined to be 1.21; sitting approximately mid-range of the allowable limits imposed by AS/NZS 4671. This value indicates that the steel has a good likelihood of spreading the zone of yield along the bar. The steel exhibited no significant yield plateau region during the testing.

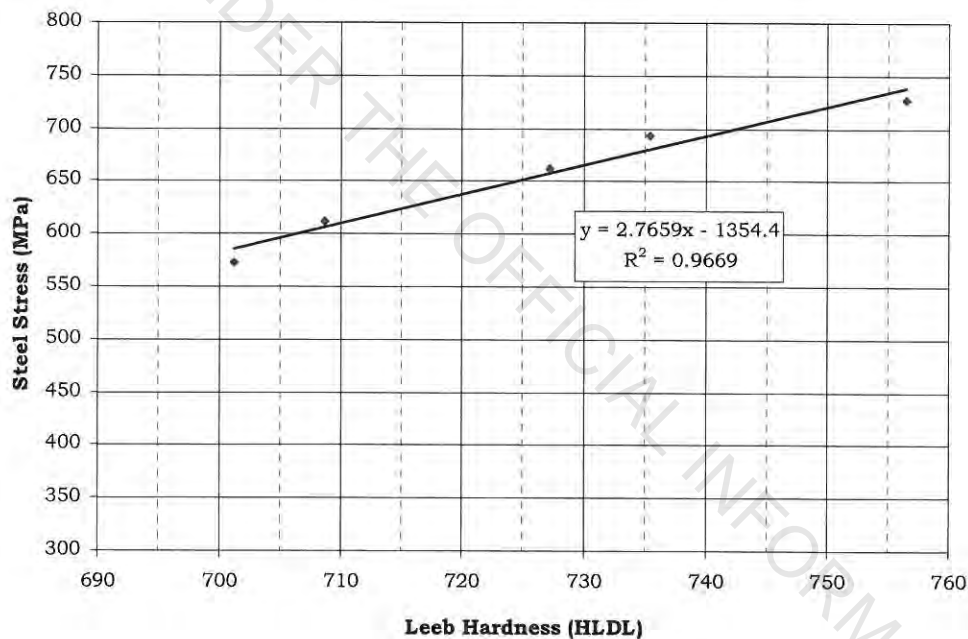
Figure 2 Correlation between Leeb Hardness and Steel Stress

The recorded Leeb hardness for the tested steel sample as a function of the imposed steel stress is presented in Figure 2. A series of 6 individual Leeb hardness test results were completed and the Truncated Mean determined to produce each

reported value of Leeb hardness. The results indicate a strong correlation across the plastic stress range.

It was noted that the general slope of the Leeb Hardness to Steel Stress plot was relatively low, indicating that the steel showed a limited range of hardness increase with an associated increase in steel stress. This is consistent with similar findings for other buildings with similar material properties. The low variation in hardness reduces the sensitivity of the tested samples and increases the associated uncertainties in the in-situ testing correlations.

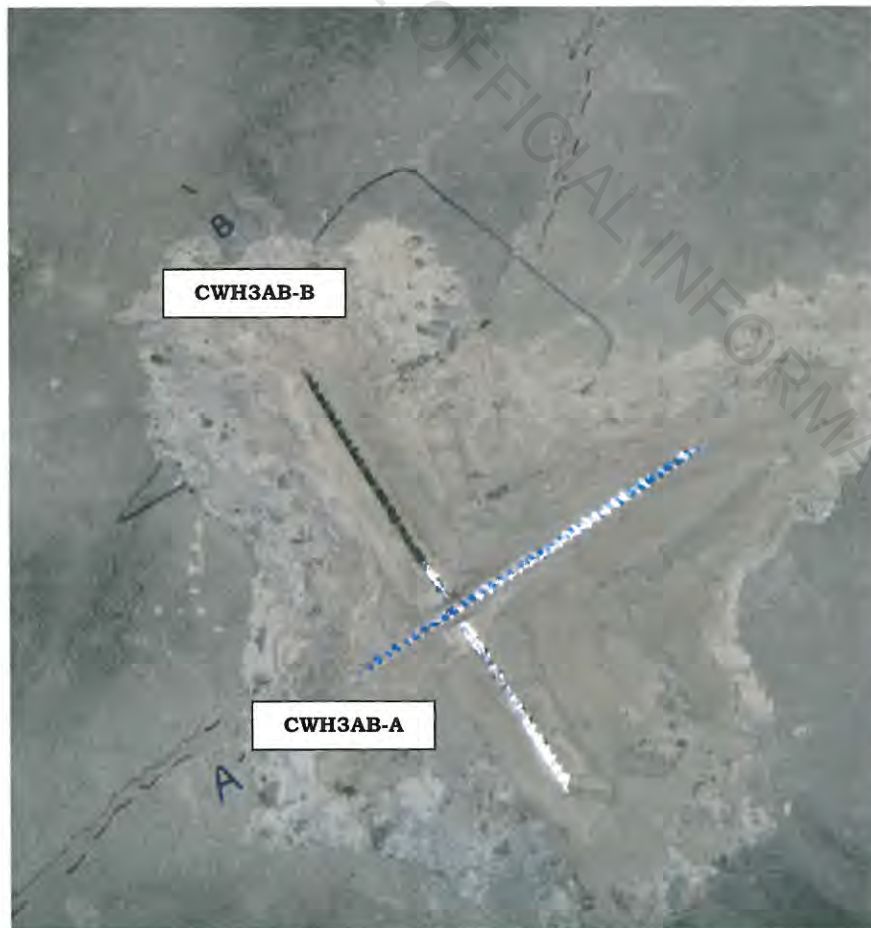
Figure 3 Test Location CWH3AB

Test Location CWH3AB was located near the window in room 3089 on the 3<sup>rd</sup> floor of the building. The test region was chosen to cross a single crack in the floor element. The cover concrete was removed exposing two bars, designated CWH3AB-A and CWH3AB-B respectively. Location CWH3AB-A did not cross the crack surface.

The hardness results for location CWH3AB-B showed minor variation in Leeb Hardness results. With full consideration for the uncertainty in the measured results, the maximum value of average potential induced strain was determined to be 0.8%, marginally exceeding the onset of strain hardening observed in the laboratory testing completed on the steel sample. It should be noted that this value occurred in the immediate vicinity as it intersecting with CWH3AB-A and as such the increased hardness value may have occurred due to variation in the support conditions.

The level of potential induced strain in the reinforcing bar suggested that the maximum potential loss of strain capacity could be 8% of the peak strain capacity (where peak strain is defined as the strain corresponding with the peak stress of the material).

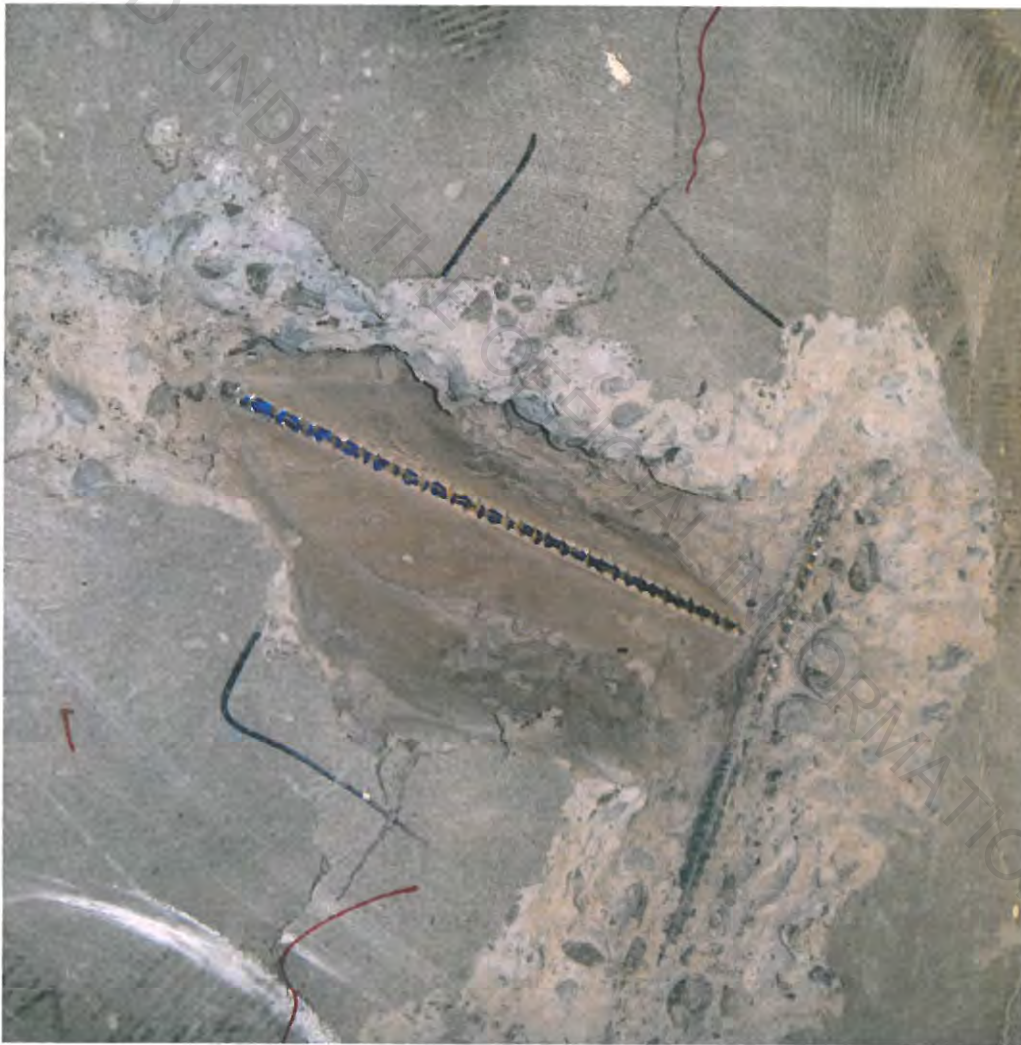
*Figure 6 CWH3A-A*

Test Location CWH3A was located towards the corridor in room 3089. The test region was chosen to cross a single crack in floor plate. The cover concrete was removed exposing two reinforcing steel bars (12 mm in diameter) in orthogonal directions. The steel bar crossing the noted crack was designated CWH3A-A.

The test results found minor increases in hardness of the steel in the area surrounding the concrete crack location, spreading for a length of up to 150 mm. With full consideration for the uncertainty in the measured results, the maximum value of average potential induced strain was determined to be 0.9% at segment 16. This corresponded to an estimated maximum potential loss of strain capacity of up to 10% of the peak strain capacity.

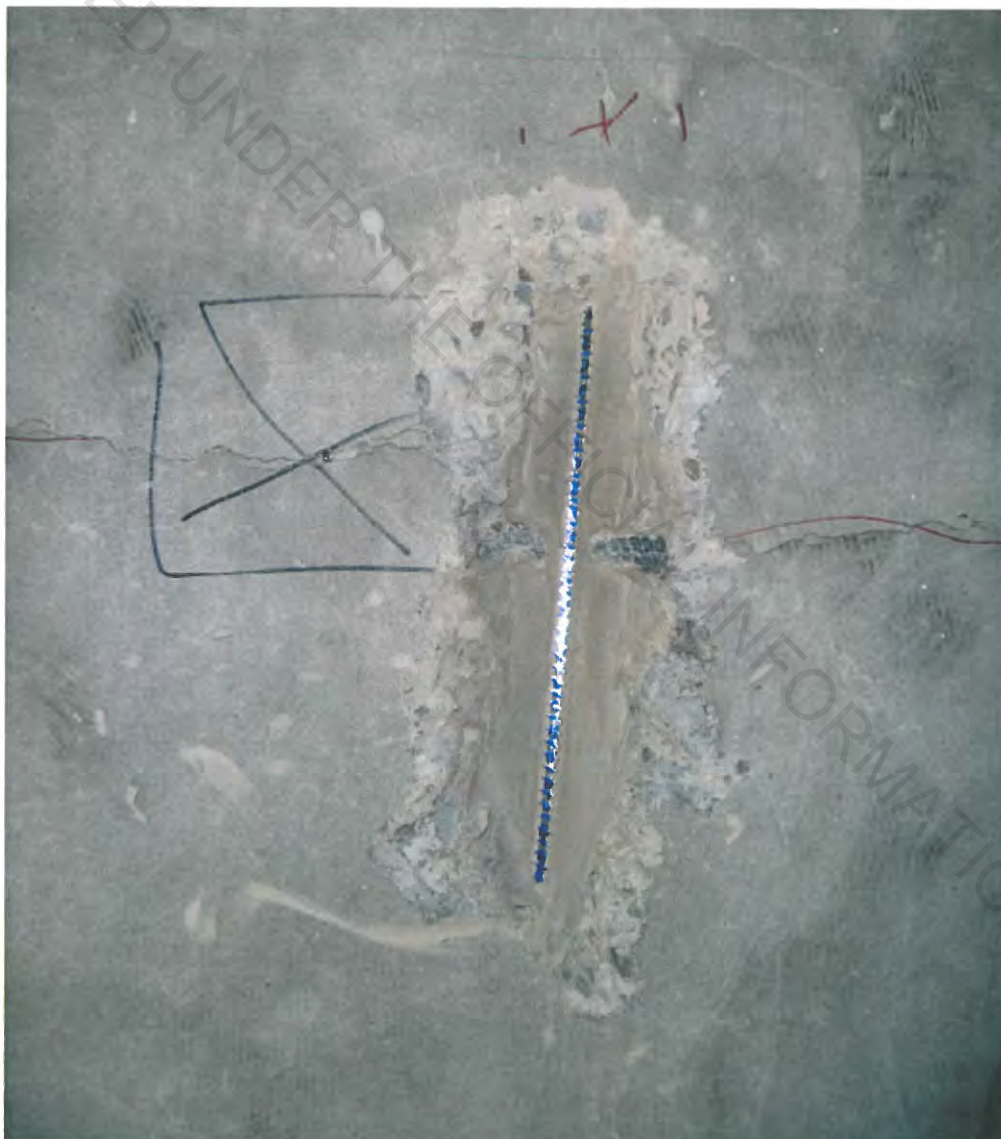
Figure 8 CWH3B-A

Test Location CWH3B was located in room 3089, towards the exterior side of the room. The test region was chosen to cross a single crack. Removal of the cover concrete exposed a single 12 mm reinforcing bar crossing the crack and a reinforcing bar of larger diameter running directly underneath the crack location.

The hardness results typically showed very little variation in hardness along the test region, with no noticeable increases in the area of the concrete crack. The results suggest that the steel did not reach the onset of strain hardening in any location and therefore sustained only minor loss of strain capacity as it crossed the crack location.

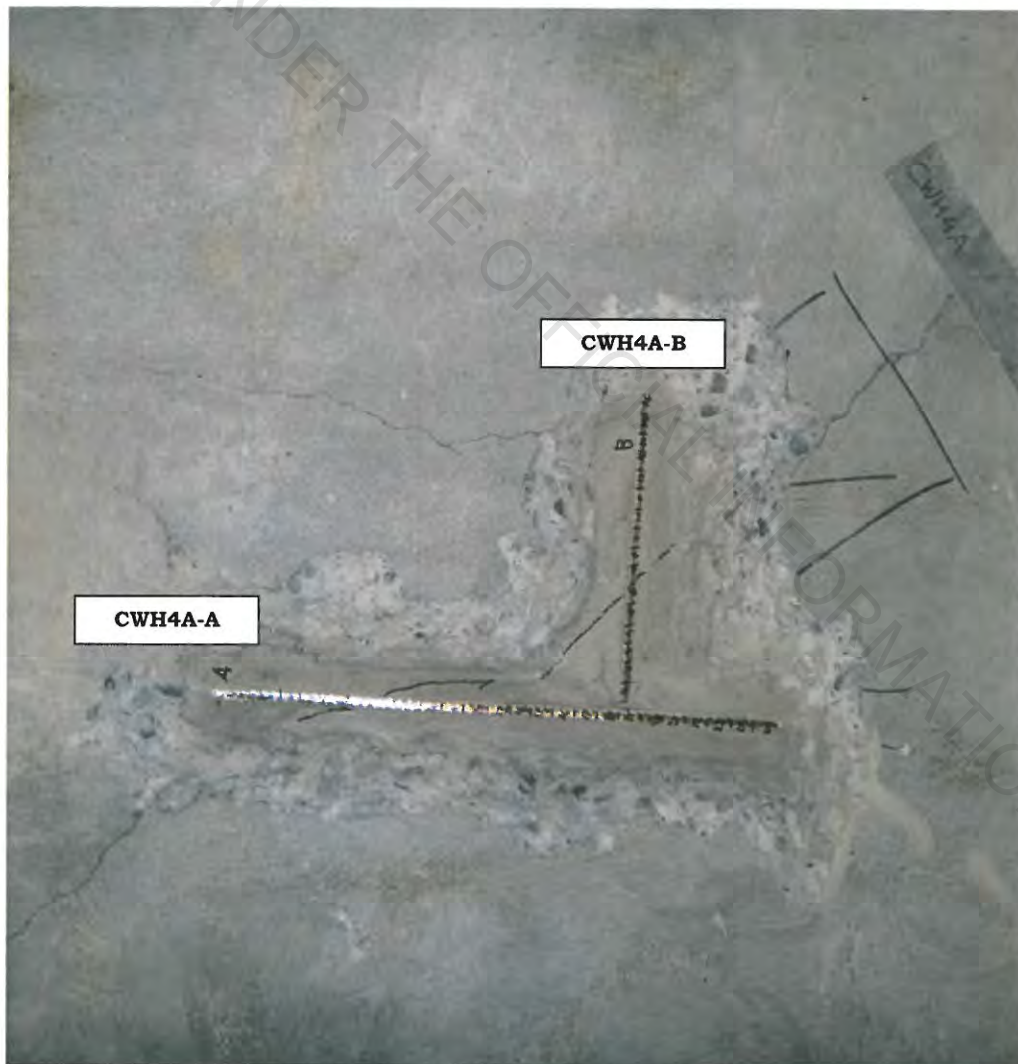
Figure 10 CWH4A

Test Location CWH4A was located near the entrance door to room 4072 on the forth floor of the building. The test region was chosen to cross a series of two diagonal cracks. The cover concrete was removed exposing two reinforcing bars, labelled CWH4A-A and CWH4A-B respectively.

The hardness results typically showed limited variations along the length of the steel, with minor increases noted at the crack locations. The maximum value of average potential induced strain in sample CWH4A-A was determined to be 0.7%, resulting in an estimated maximum potential loss of strain capacity of 6% of the peak strain capacity.

Test bar CWH4A-B was found to achieve a maximum value of average potential induced strain of 0.9%, resulting in an estimated maximum potential loss of strain capacity of 11% of the peak strain capacity.

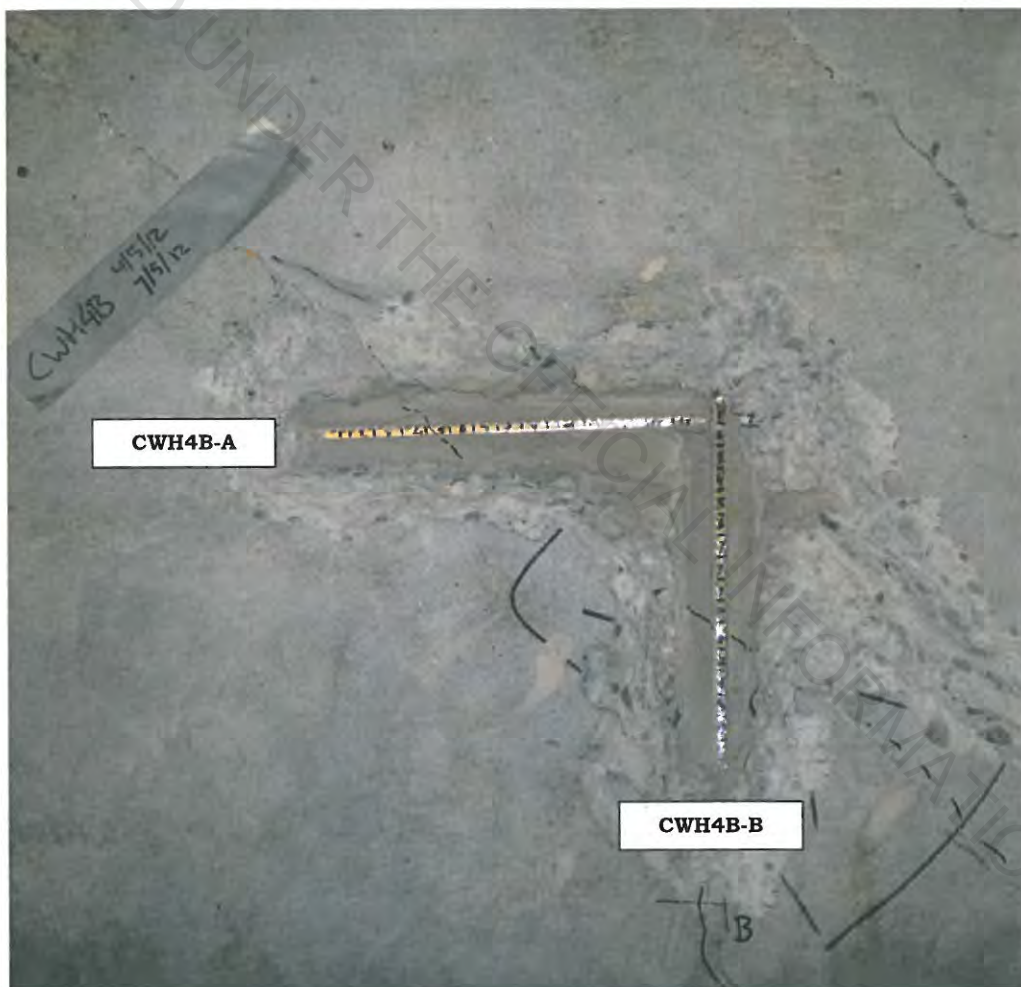
Figure 13 CWH4B

Test Location CWH4B was located in the far left hand corner of room 4072. The test region was chosen due to a number of cracks in the floor in the general vicinity. The cover concrete was removed exposing a two reinforcing bars, labelled CWH4B-A and CWH4B-B respectively.

The hardness results for both tested bars showed little variation in steel hardness in the area surrounding the crack location. With full consideration for the uncertainty in the measured results, the maximum value of average potential induced strain in CWH4B-A was determined to be 0.8%, whereas the results in CWH4B-B were found to be 0.6%. These results corresponded to an estimated maximum potential loss of strain capacity of less than 9% of the peak strain capacity in both locations.

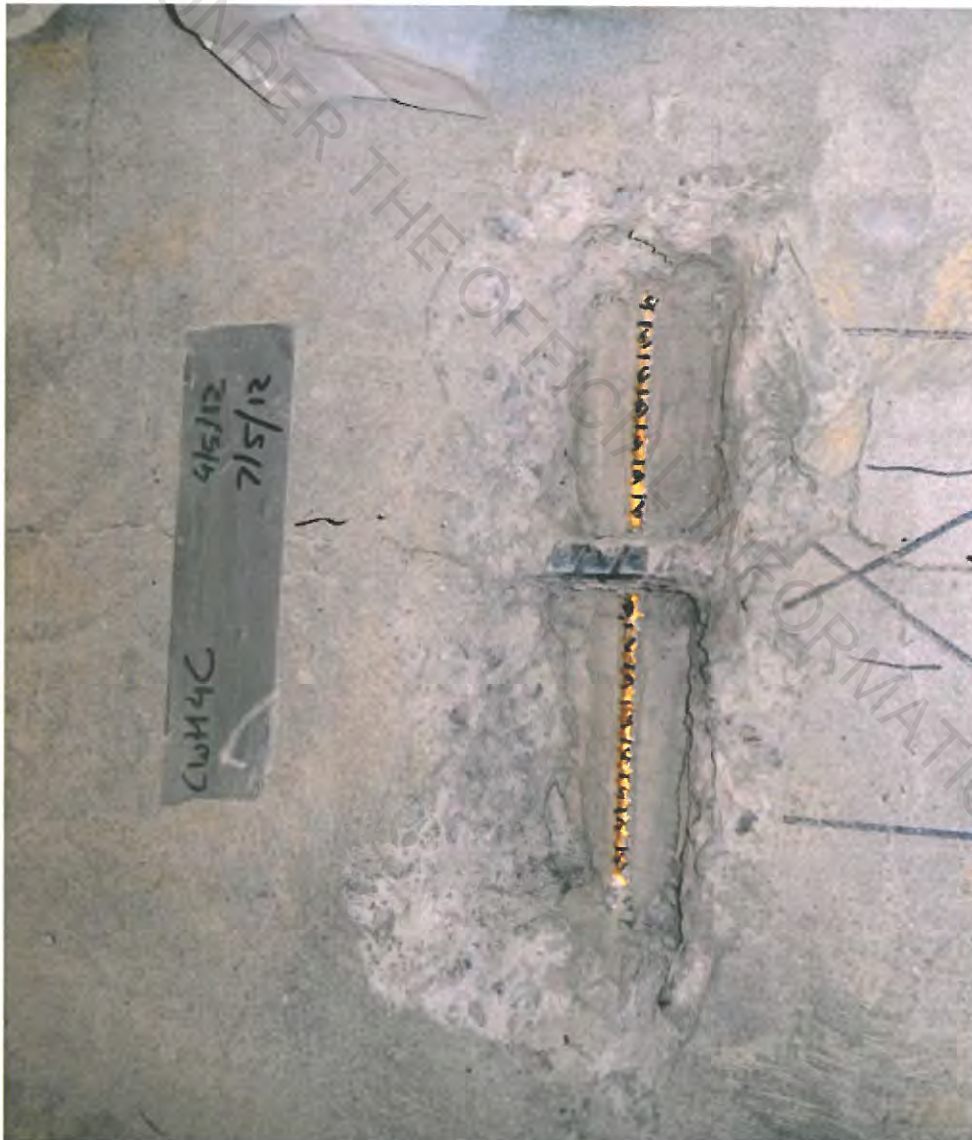
Figure 16 CWH4C

Test Location CWH4C was located in near the centre consol in room 4072. The test region coincided with a single crack in the floor. Removal of the cover concrete exposed a single 12 mm bar crossing the crack, and a larger diameter steel bar in the perpendicular direction located directly under the concrete crack position.

The hardness results typically showed no significant variations along in steel hardness along the test region. However, the location on the steel that was likely to have sustained the greatest variation in hardness (directly under the crack location) was obscured from testing by the larger diameter steel bar.

In no locations did the estimated potential average strain in the steel bar exceed the value of strain corresponding with the onset of strain hardening and as such the steel was not considered to have loss any significant strain capacity.

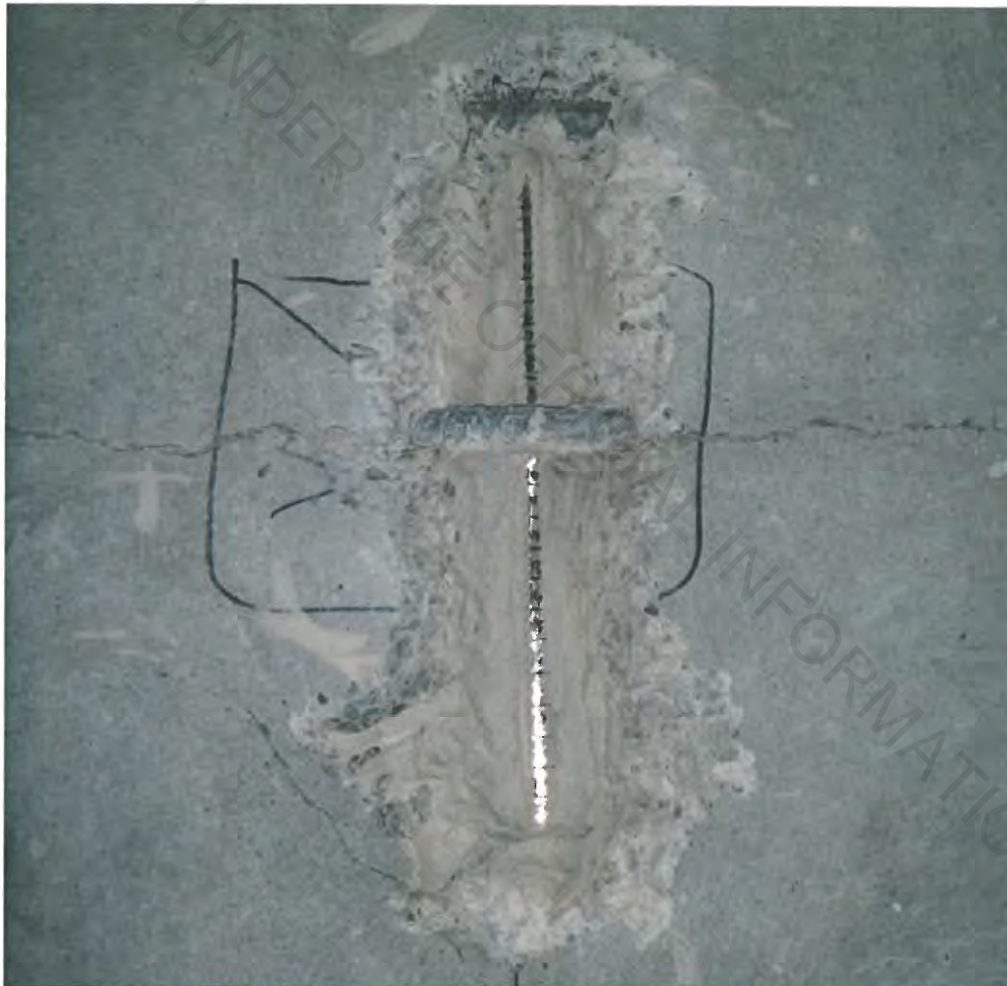
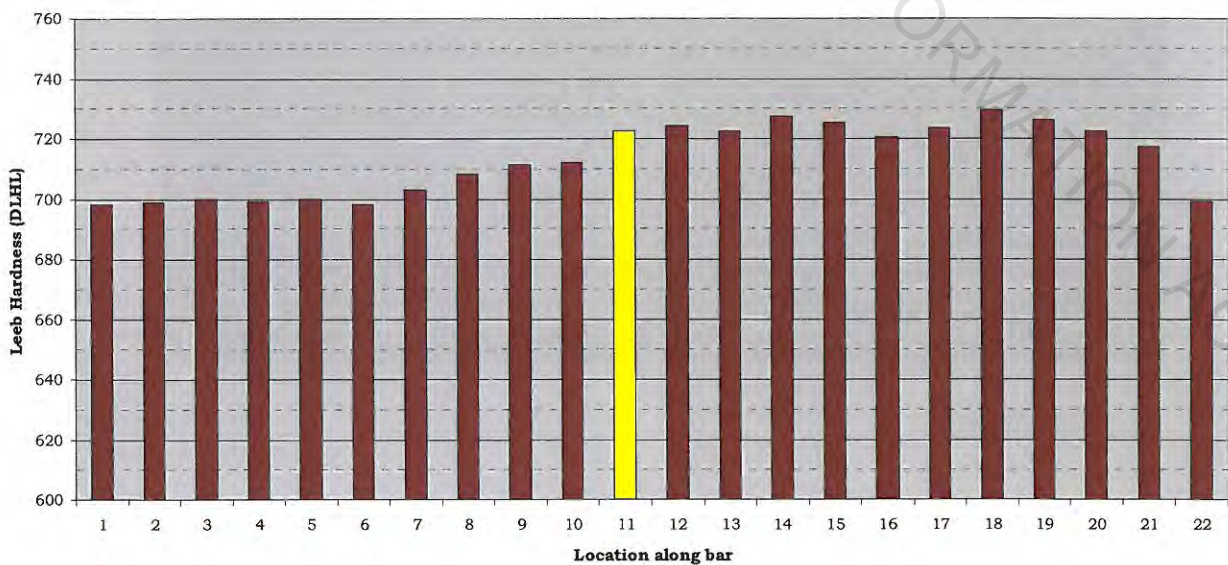
Figure 18 CWH4D-A

Test Location CWH4D was located towards the centre of room 4069. The test region crossed a single concrete crack. Removal of the cover concrete exposed a single 12 mm bar crossing the crack, and a larger diameter steel bar in the perpendicular direction located directly under the concrete crack position.

The hardness results showed an increase in recorded hardness at, and surrounding, the crack location. The results suggest that the steel had undergone inelastic deformations. With full consideration for the uncertainty in the measured results, the maximum value of average potential induced strain was determined to be 1.6% at test segment 18. This corresponded to an estimated maximum potential loss of strain capacity of 17% of the peak strain capacity (where peak strain is defined as the strain corresponding with the peak stress of the material).

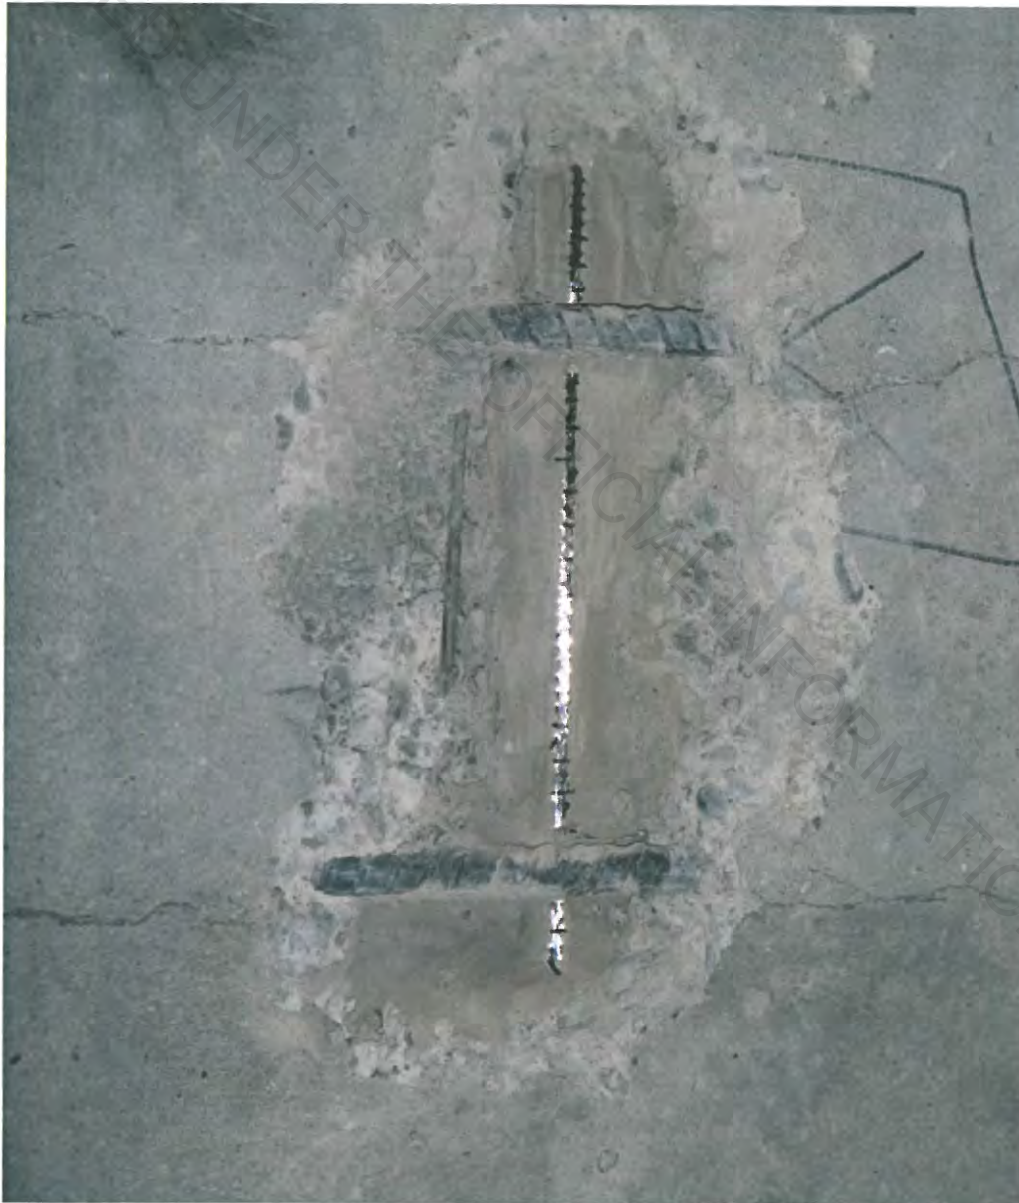
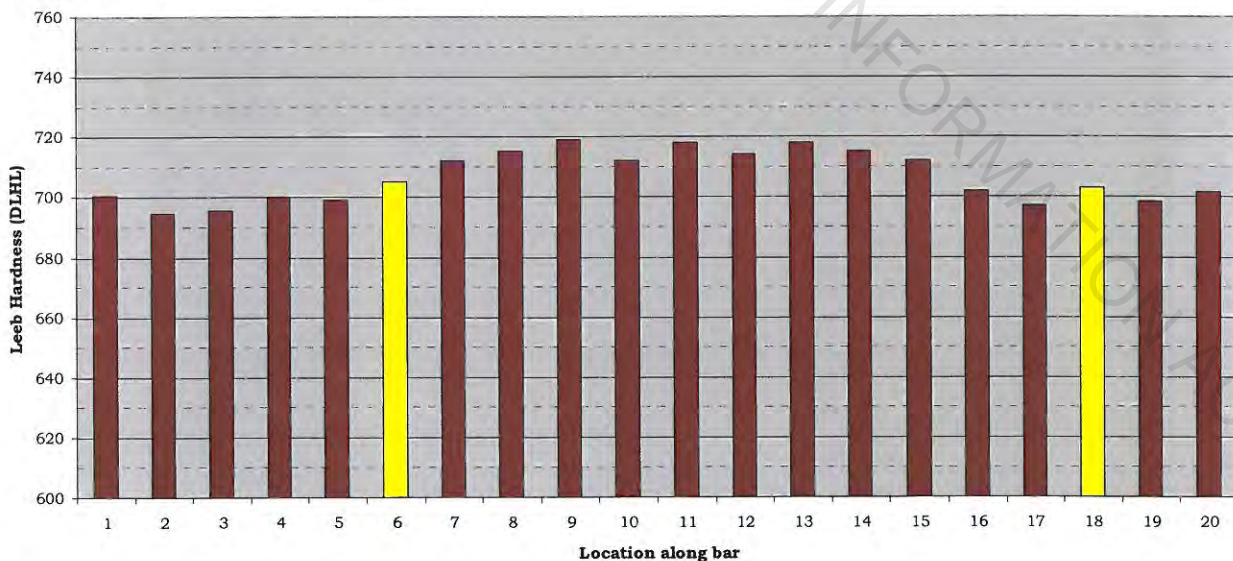
Figure 20 CWH4E

Test Location CWH4E was located under the bench (near the window) of room 4069. The test region crossed two parallel concrete cracks. Removal of the cover concrete exposed a single 12 mm bar crossing the crack, and two steel bars in the perpendicular direction located directly under each concrete crack position.

The hardness results typically showed an increase in the steel hardness between the two crack locations. With consideration for the uncertainty in the measured results, the maximum value of average potential induced strain was determined to be 0.8%, corresponding to an estimated maximum potential loss of strain capacity of 8% of the peak strain capacity.

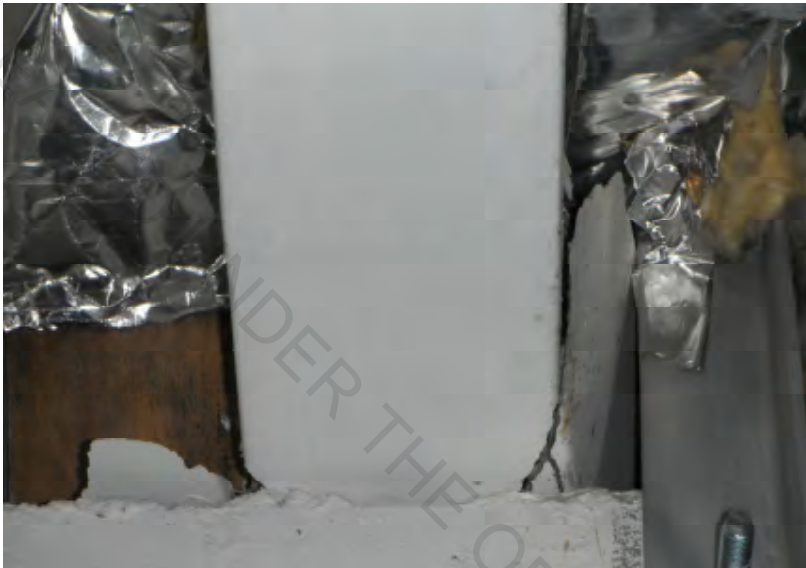
19/3/12.  
JOP

- Where side splitting of the units has occurred (see photo attached), a new seating will be required similar to the detail provided in Site Report 01 (19/3/2012) (see attached sketch). Each instance of this type of damage will need to be reviewed to ensure that the seating extends sufficiently to support the unit.

- NB, Prescan existing conc. beam & locate rebar.
- position epoxied anchors to note cut beam rebar.
  - So; space anchors to suit + respect clearances noted below
