Please find attached as **Appendix 1** the Earthquake Seismic Assessment Report for Christchurch Women's Hospital October 2013 and **Appendix 2** the Detailed Seismic Assessment Report for the Clinical Services Building October 2013.

EARTHQUAKE SEISMIC  
ASSESSMENT REPORT

REPORT 6 - CHRISTCHURCH WOMEN'S  
HOSPITAL

REV 2 - 7 OCTOBER 2013

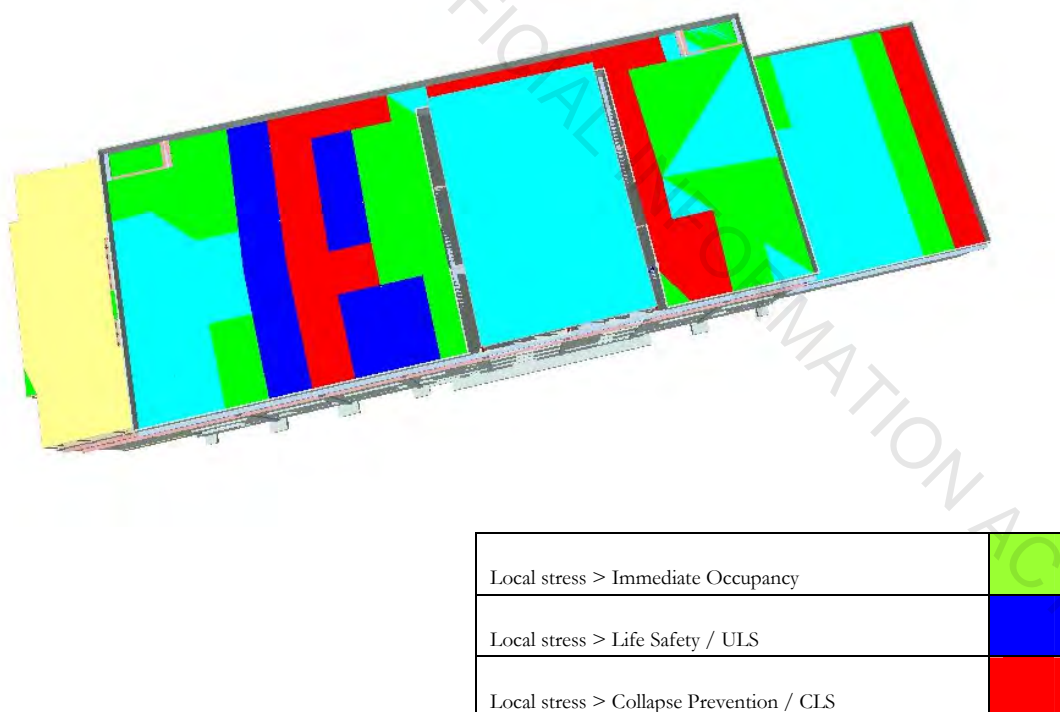
Figure 2-5: Roof Structure – R=0.7 (50%DBE)

The results of the NLTH indicate that the Clinical Services Building has the capacity to resist approximately 35% of the new ULS design earthquake for an IL3 building. (Note that this is equivalent to a building strength of 45% DBE for an IL2 building and 25% DBE for an IL4 building).

The capacity of the building is governed by the roof diaphragm and the face load capacity of the walls above Second Floor and also the floor under the radiation bunker.

The lower level roof and face loaded piers at the east end of building have the capacity to resist 40-45% DBE for an IL3 building. The longitudinal and transverse walls have the capacity to resist approximately 67% DBE (IL3).

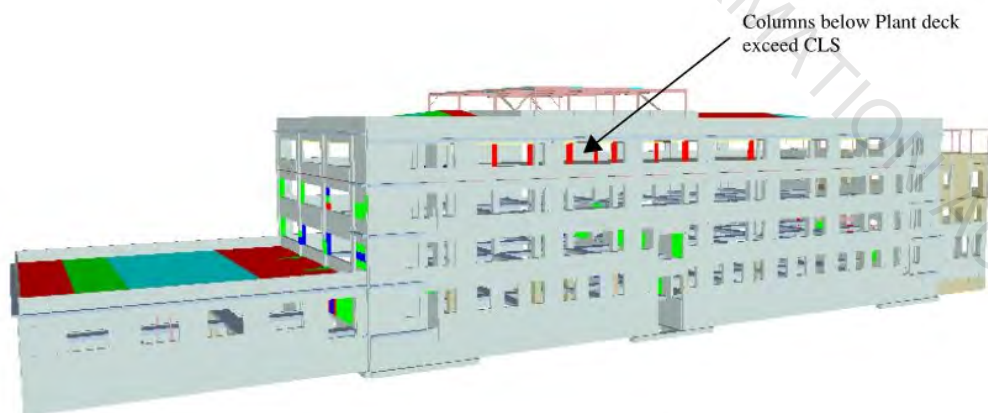
Figure 2-6: Columns Below the Third Floor – R=0.9 (70%DBE)

The results of the NLTH indicated that there was a critical structural weakness that could lead to collapse or partial collapse of the building. The element has been identified and assessed in accordance with the Engineering Advisory Group Draft Guidelines [9]. The Engineering Advisory Group Draft Guidelines recommend a margin over collapse is used to provide an acceptable risk of collapse. The Guidelines recommend a factor of 2 for qualitative assessments. NLTHA assessments are considered a full detailed assessment and provided a better estimate of capacity than a qualitative assessment. For NLTHA, the Guidelines do not specify a margin of 2, but do require an acceptable margin over collapse limits. As discussed in the Base Report, a factor of 1.8 is used as it is generally accepted that for well detailed new buildings there is a margin of at least 1.5 to 1.8 over the ultimate limit capacity. The following critical structural weakness has been identified:

- The first column below the Third Floor plant room fails at 55% DBE for an IL3 building however this is unlikely to lead to a partial collapse of the Third Floor. Sufficient columns will have failed to cause a partial collapse of the Third Floor at 60-70% DBE for an IL3 building. If there is to be a margin of 1.8 on collapse, the effective capacity of the pier is  $60-70/1.8 = 33-40\%$  DBE for an IL3 building.

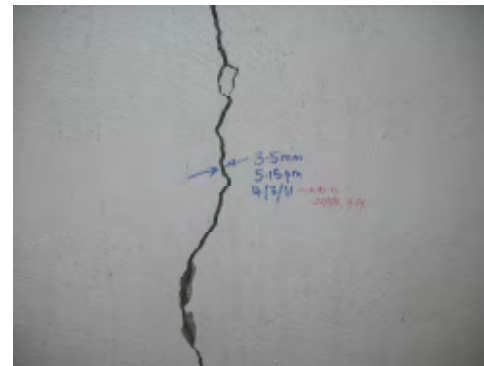
Damage	Locations	Recommendation	Example
1. Floor slabs			
1.1. Cracking between 0.2mm and 2mm	PLANT ROOM: Cracking throughout plant room floor up to 0.5mm and at steel column baseplates. Substantial cracking up to 3.5mm in slab upstands/ column baseplates.	Epoxy inject cracks in slab and upstand that are greater than 0.2mm in width where external and 0.3mm in width where internal. Refer to HCG Specification  REPAIRS COMPLETE 18/08/11

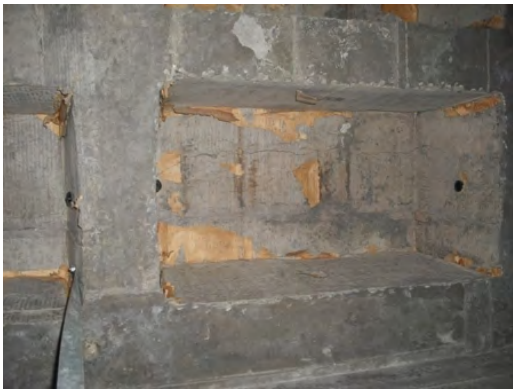
Damage	Locations	Recommendation	Example
1.4. Cracks up to 0.5mm in width at the junction between the original building and the extension to the east.	<p>LOWER GROUND, &amp; GROUND FLOOR:</p> <p>At junction between the original building and the extension to the east.</p>	<p>Inspect the floor joint between the original building and the extension to the east at Lower Ground, Ground, First and Second floor levels and epoxy inject cracks that are greater than 0.3mm in width.</p> <p>Refer to HCG Specification</p>

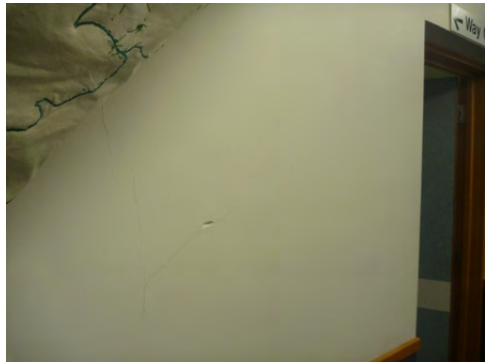
2.2. Cracking to the shear walls on the west face of the building where internal at Lower Ground Level	LOWER GROUND FLOOR: Diagonal cracks in the shear wall at Lower Ground Level and at the base of the piers and spandrels at Ground Level.	Inspect the walls on the west face of the original building at Lower Ground, Ground and First Floor and epoxy inject cracks in the walls that are greater than 0.2mm in width where external and 0.3mm in width where internal.  Refer to HCG Specification.

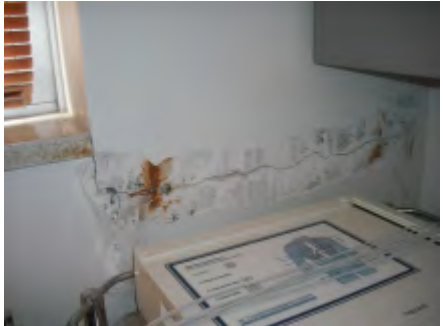
2.5. Cracking and corroded reinforcement in pier on south face of Second Floor	SECOND FLOOR: South wall pier near column 6, Second Floor	Non-earthquake damage but in a location that requires earthquake repair, therefore needs to be addressed as part of the repair. Break out concrete to expose reinforcing. Repair to be advised when reinforcing has been inspected.

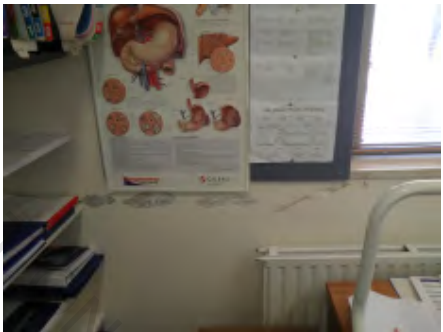
2.6. Cracking between 0.2mm and 2mm in the north and south exterior walls	SECOND FLOOR, LOWER GROUND, GROUND : South wall piers. North wall piers unable to be viewed due to cladding.	Inspect all piers and spandrels on the north and south faces of the Second Floor and epoxy inject cracks that are greater than 0.2mm in width. Refer to HCG specification

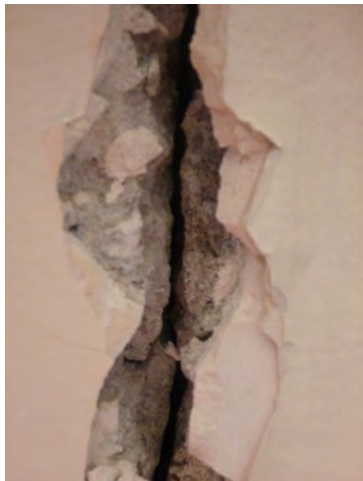
Damage	Locations	Recommendation	Example
2.9. Cracks up to 2mm wide in radiation bunker	SECOND FLOOR Radiation Bunker: Crack up to 2mm wide in what appears to be an original construction joint and diagonal cracks in bunker walls.	Epoxy inject all cracks that are greater than 0.3mm in width. Refer to HCG specification.

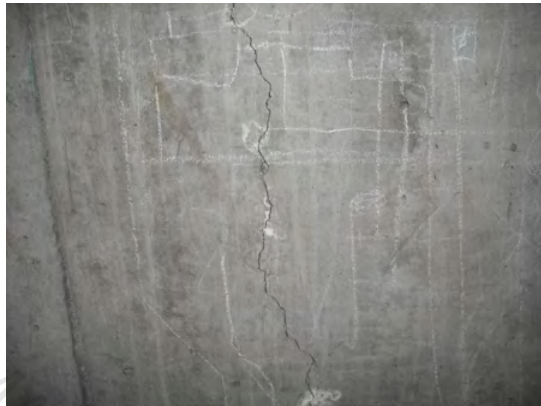
4.2. Cracks in service tunnel walls up to 3mm in width	Service tunnel walls	Inspect all walls and epoxy inject all cracks that are greater than 0.2mm in width. Refer to HCG specification.

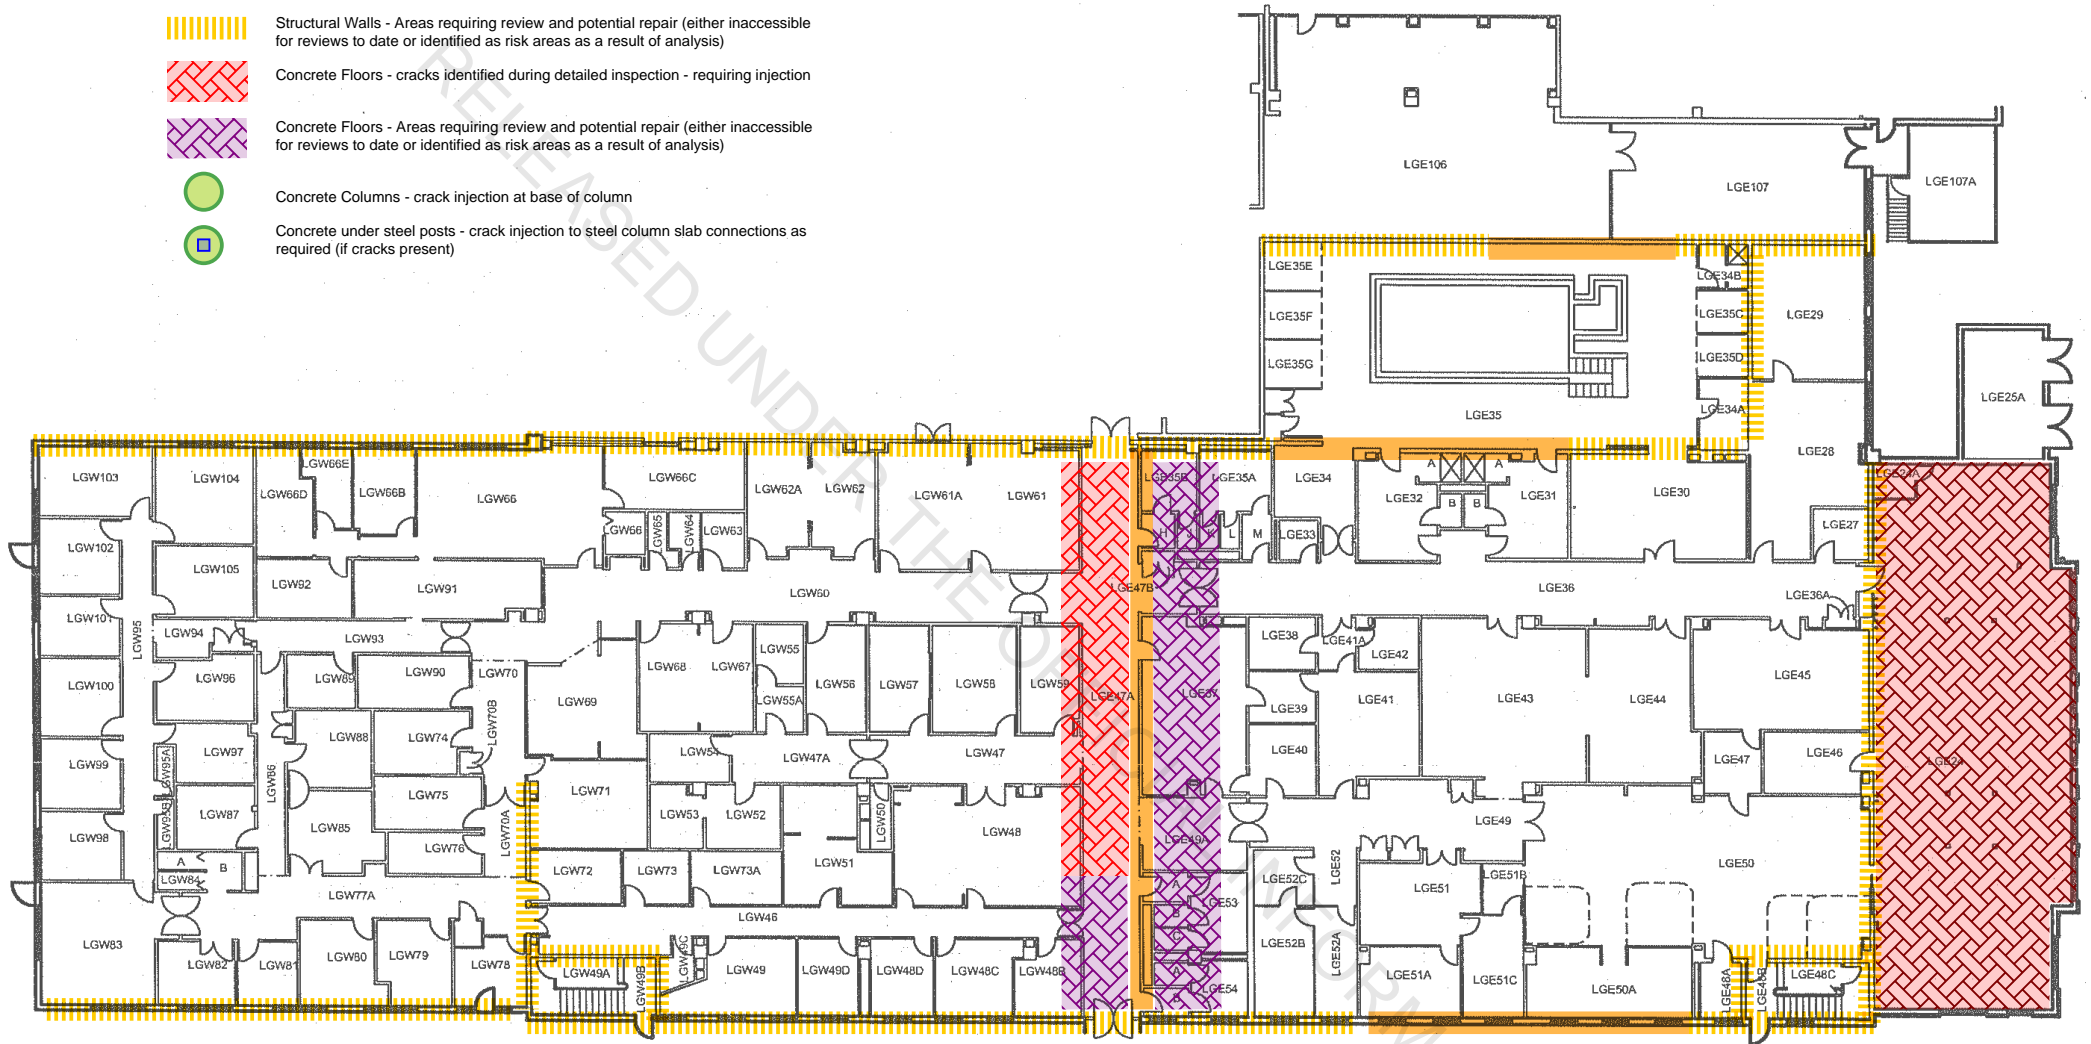
CDHB CSB  
Repair and Further Investigation Required  
General Layouts  
Lower Ground Floor Plan

Structural Walls - cracks identified during detailed inspection - requiring injection
-

Structural Walls - Areas requiring review and potential repair (either inaccessible for reviews to date or identified as risk areas as a result of analysis)
-

Concrete Floors - cracks identified during detailed inspection - requiring injection
-

Concrete Floors - Areas requiring review and potential repair (either inaccessible for reviews to date or identified as risk areas as a result of analysis)
-

Concrete Columns - crack injection at base of column
-

Concrete under steel posts - crack injection to steel column slab connections as required (if cracks present)

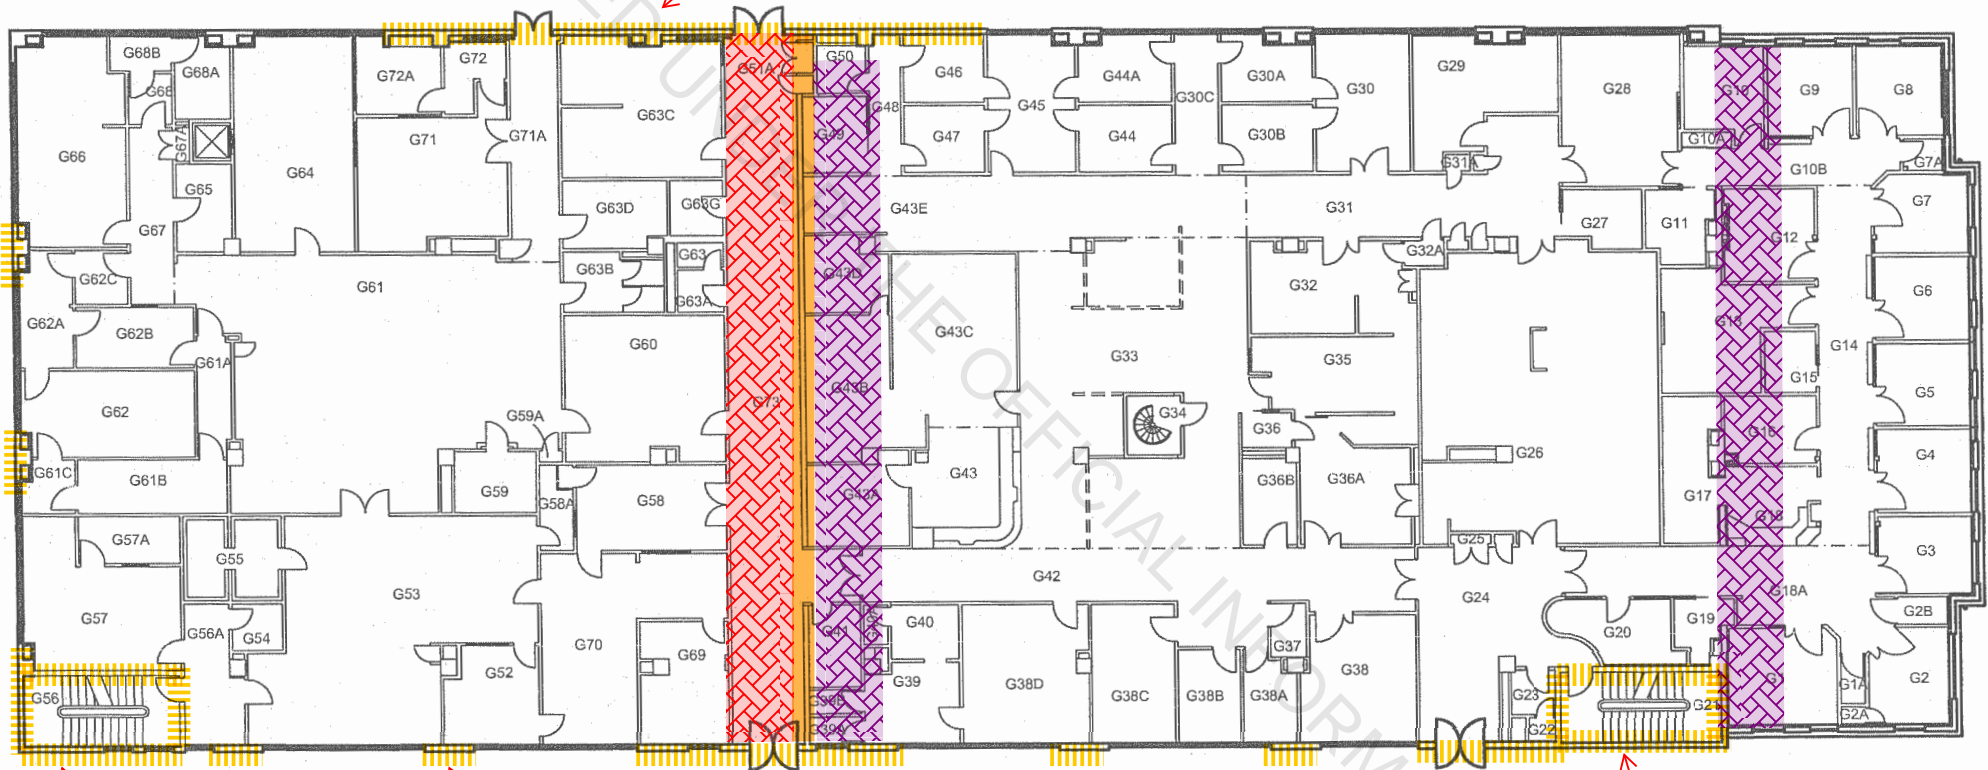
CDHB CSB  
Repair and Further Investigation Required  
General Layouts  
Ground Level Plan

North shear wall along interface

All stair walls

Piers between window opening (potential shear cracking)

Window opening corners over, (potential vertical cracking/spalling)

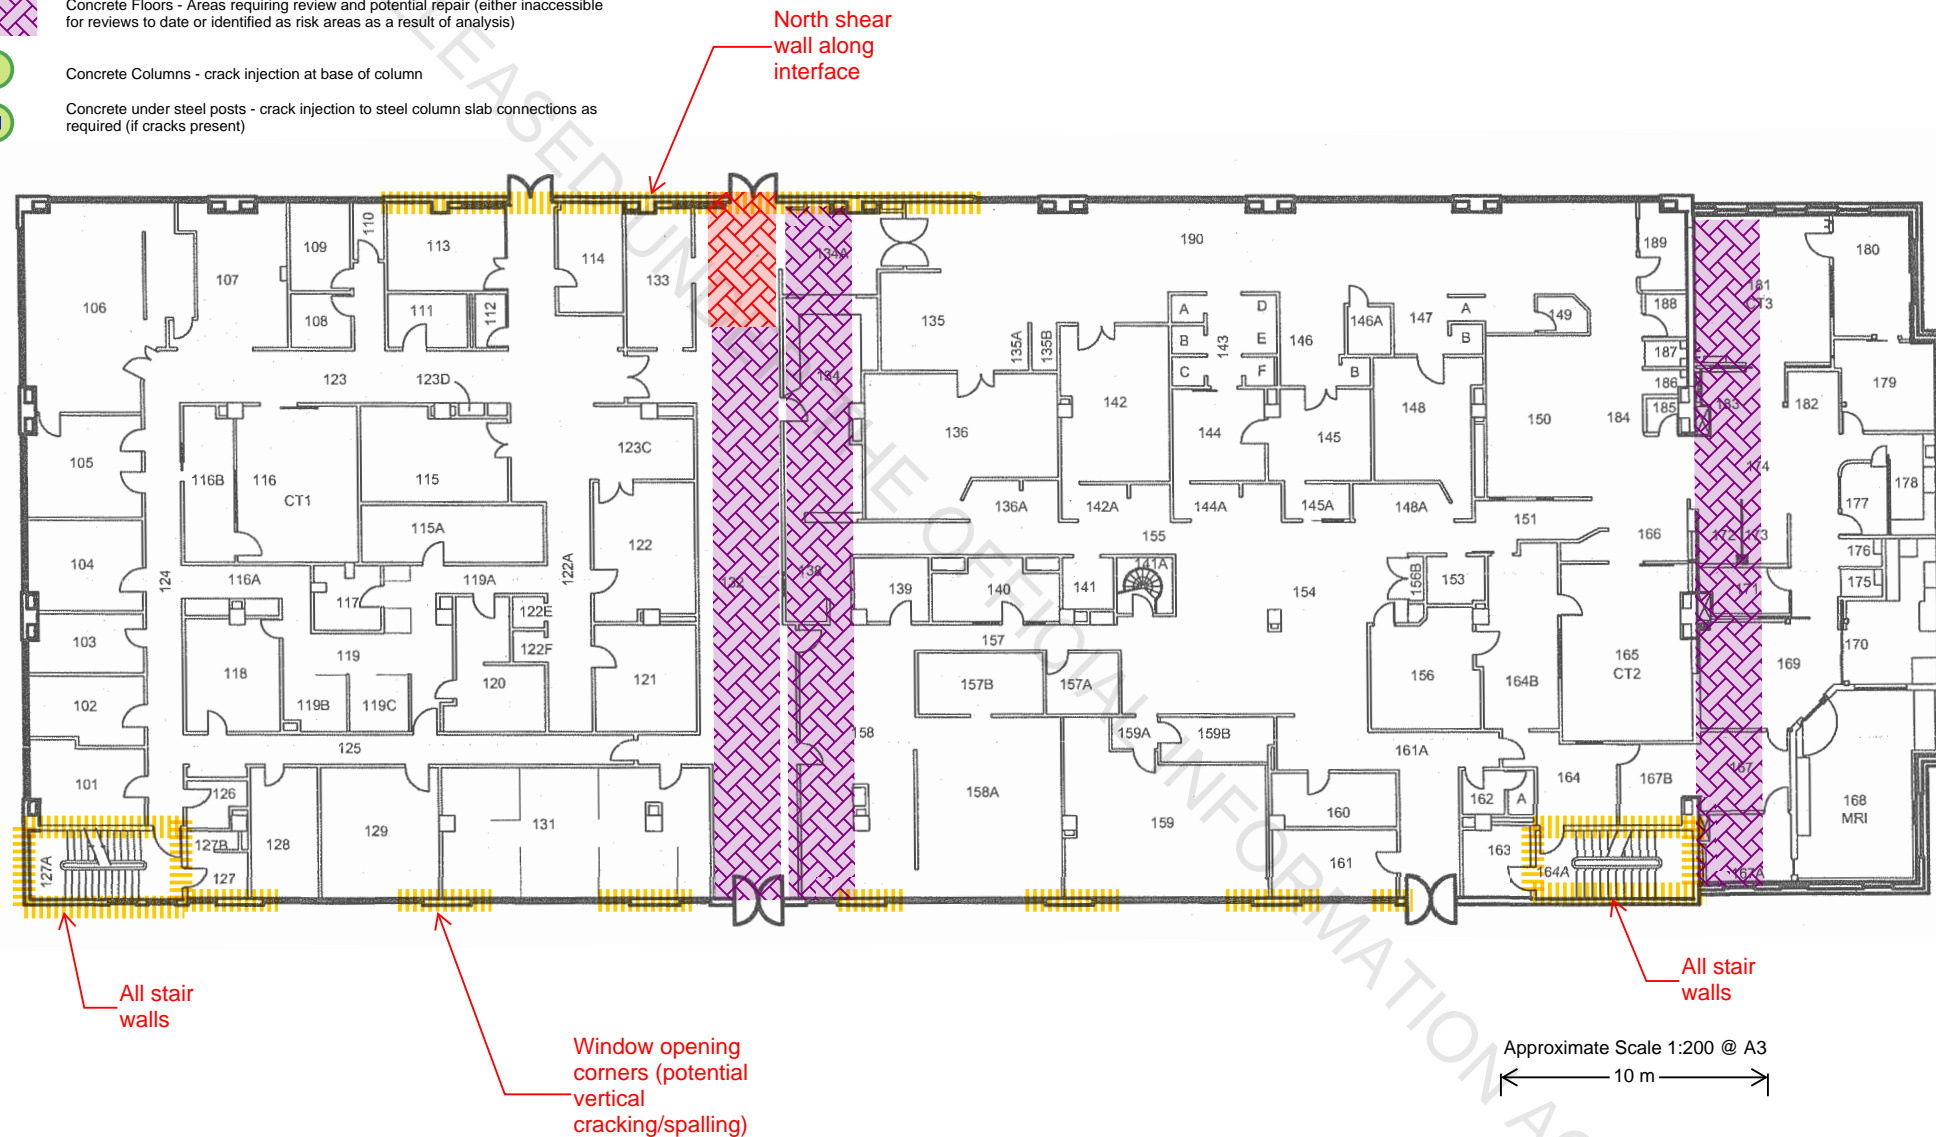
CDHB CSB  
Repair and Further Investigation Required  
General Layouts  
Level 1 Plan

Structural Walls - cracks identified during detailed inspection - requiring injection
-

Structural Walls - Areas requiring review and potential repair (either inaccessible for reviews to date or identified as risk areas as a result of analysis)
-

Concrete Floors - cracks identified during detailed inspection - requiring injection
-

Concrete Floors - Areas requiring review and potential repair (either inaccessible for reviews to date or identified as risk areas as a result of analysis)
-

Concrete Columns - crack injection at base of column
-

Concrete under steel posts - crack injection to steel column slab connections as required (if cracks present)

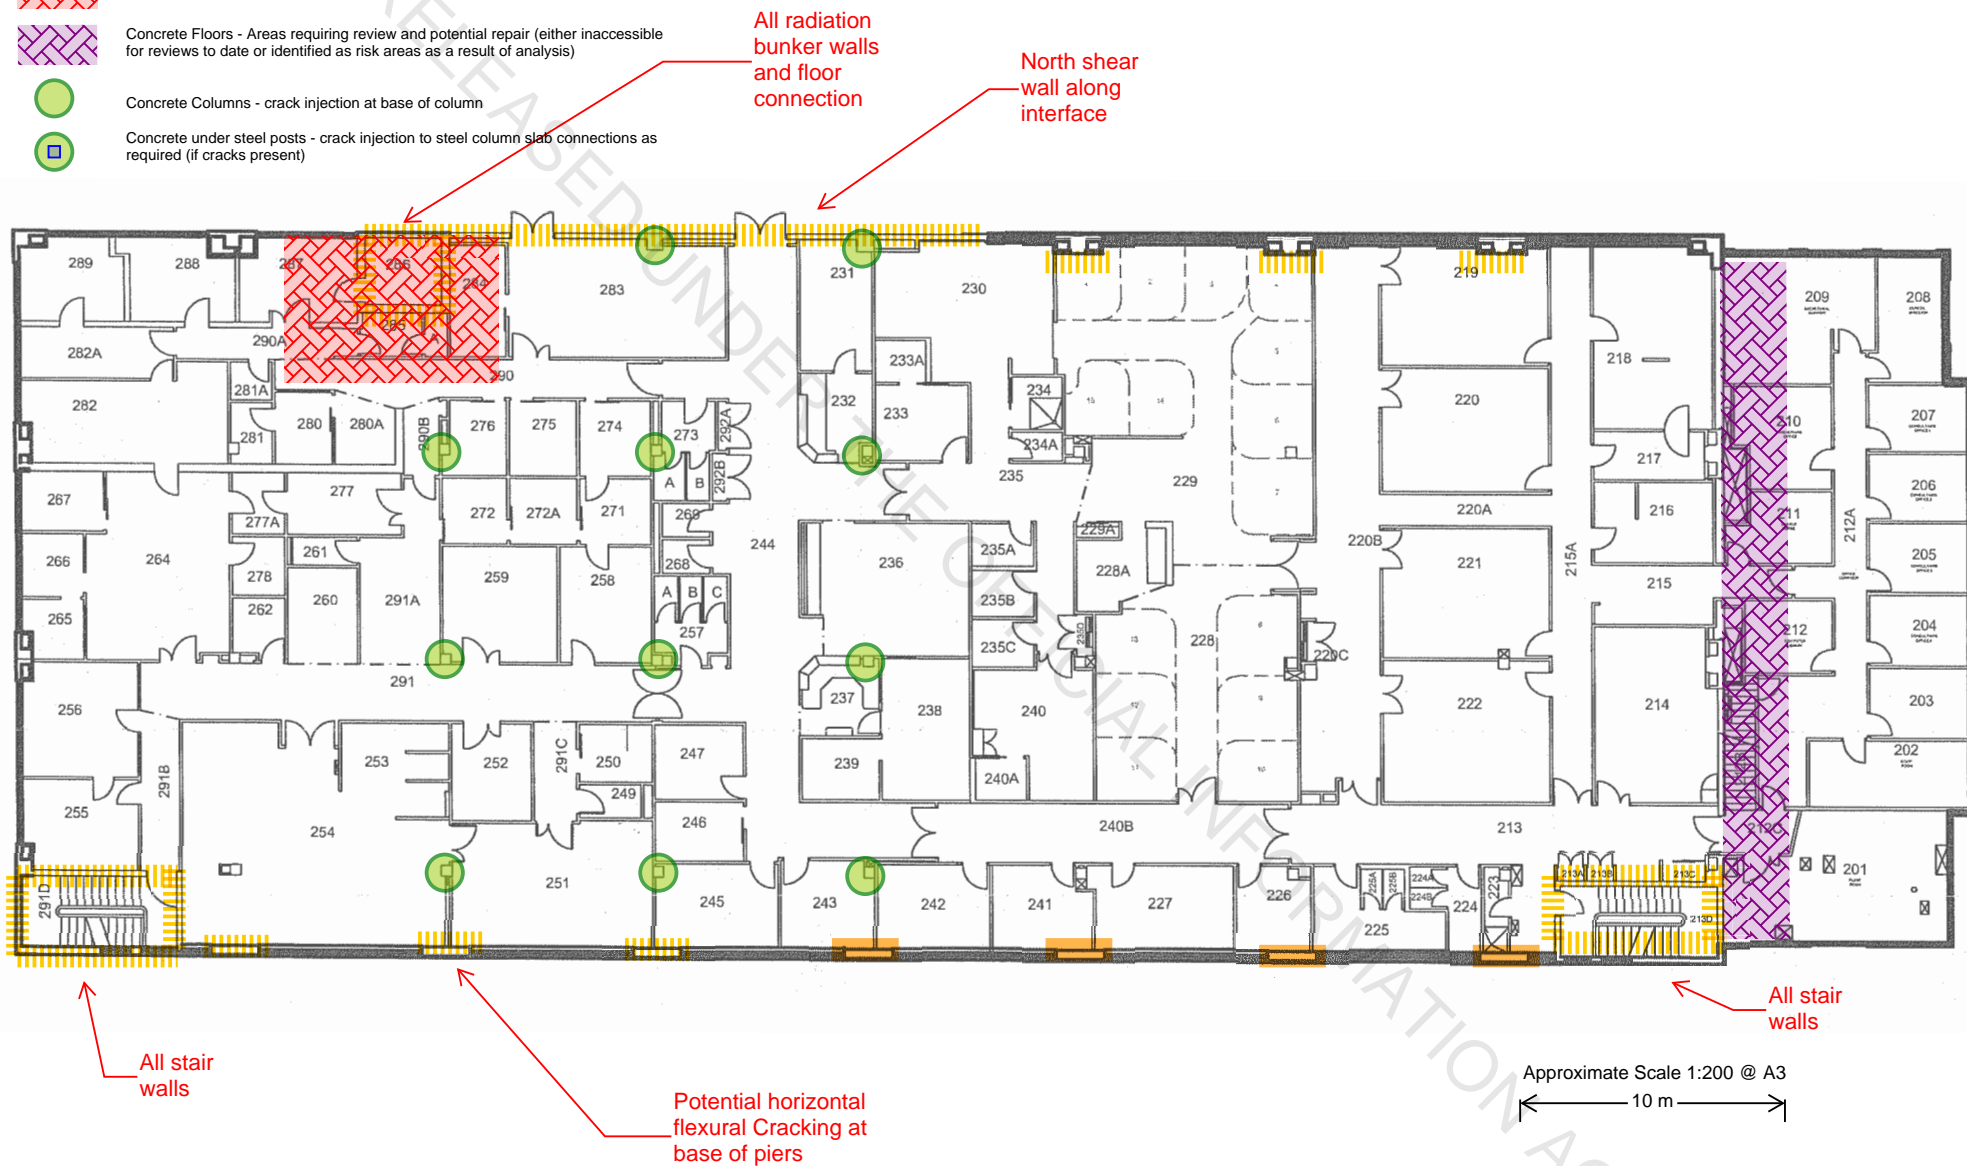
CDHB CSB  
Repair and Further Investigation Required  
General Layouts  
Level 2 Plan

Structural Walls - cracks identified during detailed inspection - requiring injection
-

Structural Walls - Areas requiring review and potential repair (either inaccessible for reviews to date or identified as risk areas as a result of analysis)
-

Concrete Floors - cracks identified during detailed inspection - requiring injection
-

Concrete Floors - Areas requiring review and potential repair (either inaccessible for reviews to date or identified as risk areas as a result of analysis)
-

Concrete Columns - crack injection at base of column
-

Concrete under steel posts - crack injection to steel column slab connections as required (if cracks present)

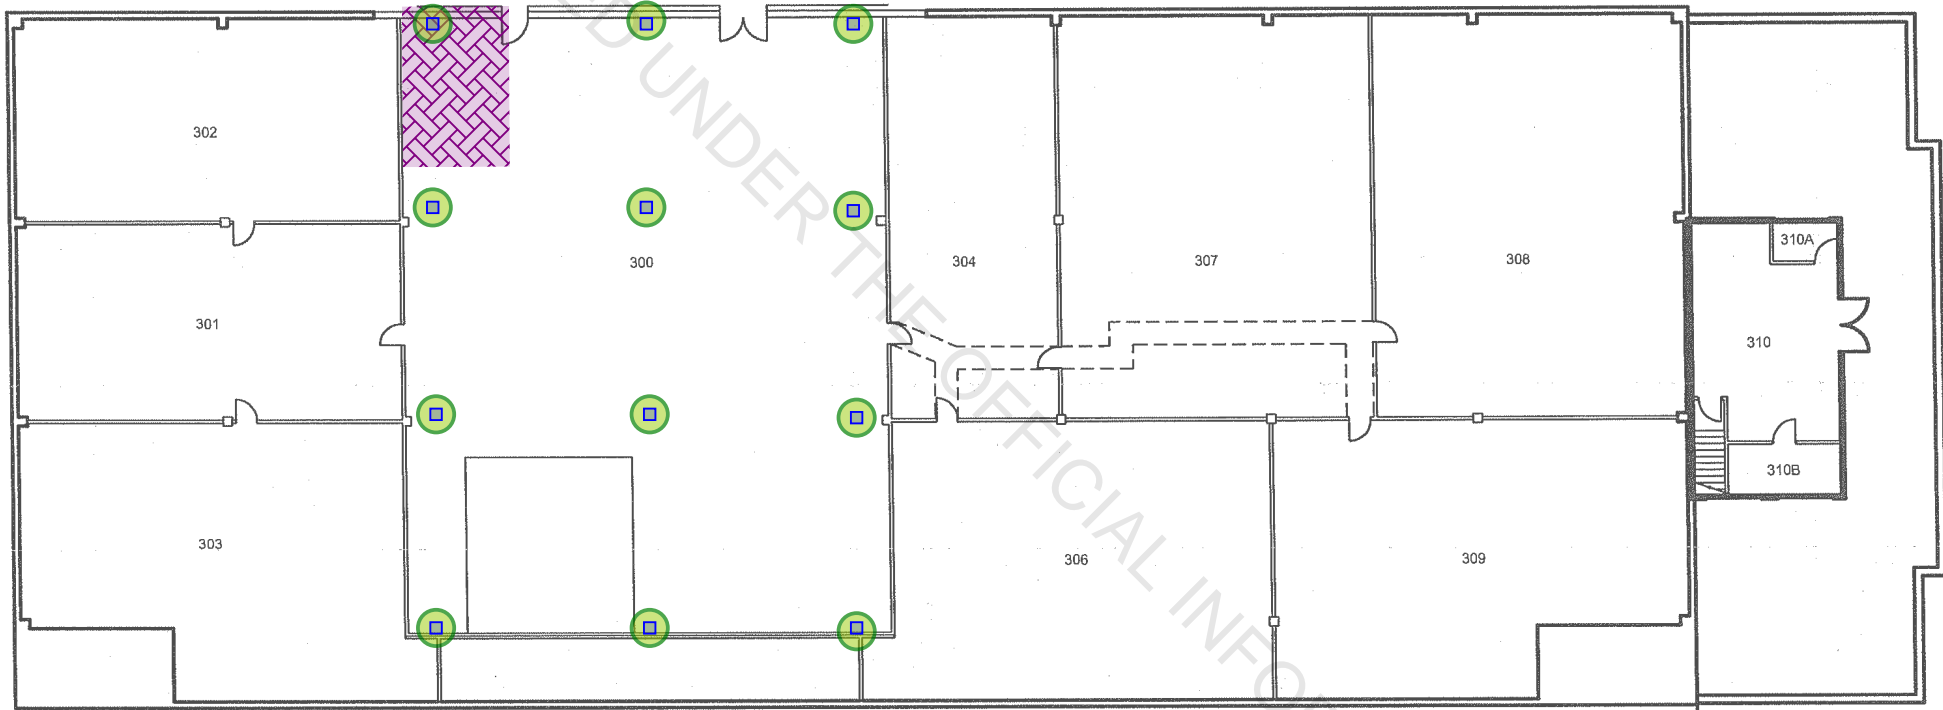
CDHB CSB  
Repair and Further Investigation Required  
General Layouts  
L3 Plant Floor Plan

Structural Walls - cracks identified during detailed inspection - requiring injection
-

Structural Walls - Areas requiring review and potential repair (either inaccessible for reviews to date or identified as risk areas as a result of analysis)
-

Concrete Floors - cracks identified during detailed inspection - requiring injection
-

Concrete Floors - Areas requiring review and potential repair (either inaccessible for reviews to date or identified as risk areas as a result of analysis)
-

Concrete Columns - crack injection at base of column
-

Concrete under steel posts - crack injection to steel column slab connections as required (if cracks present)

All stairwell walls

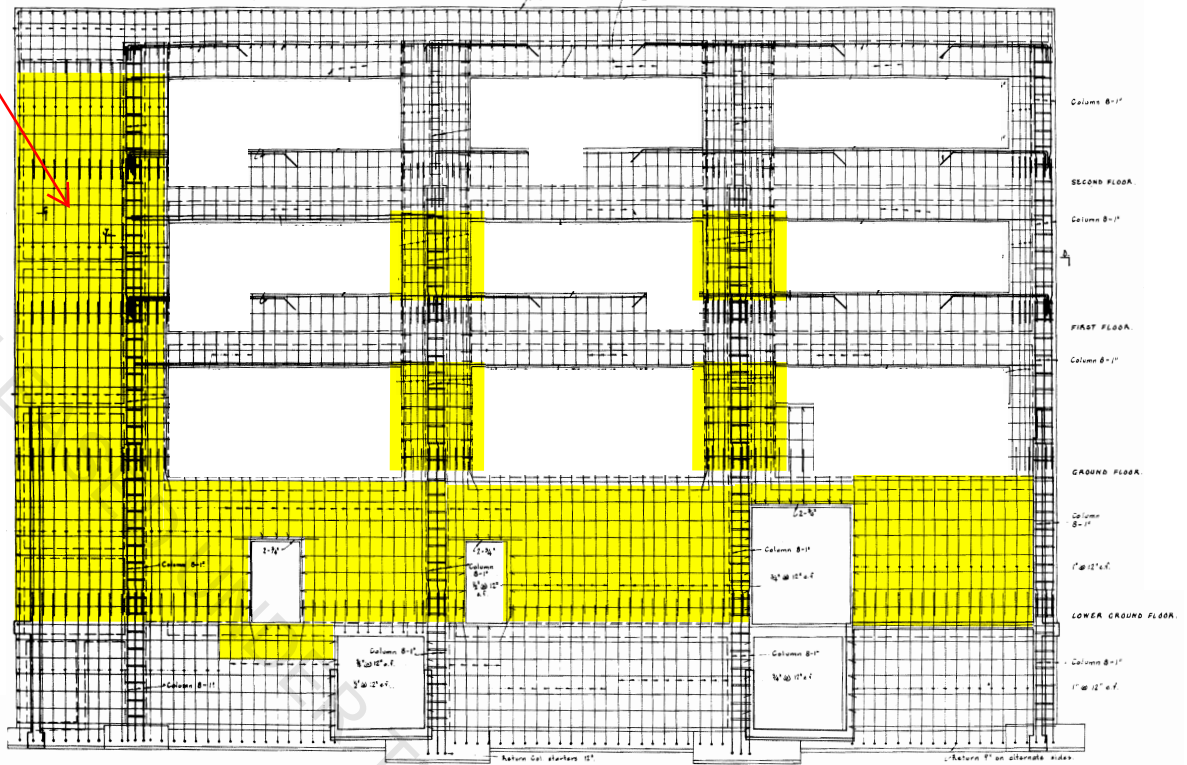
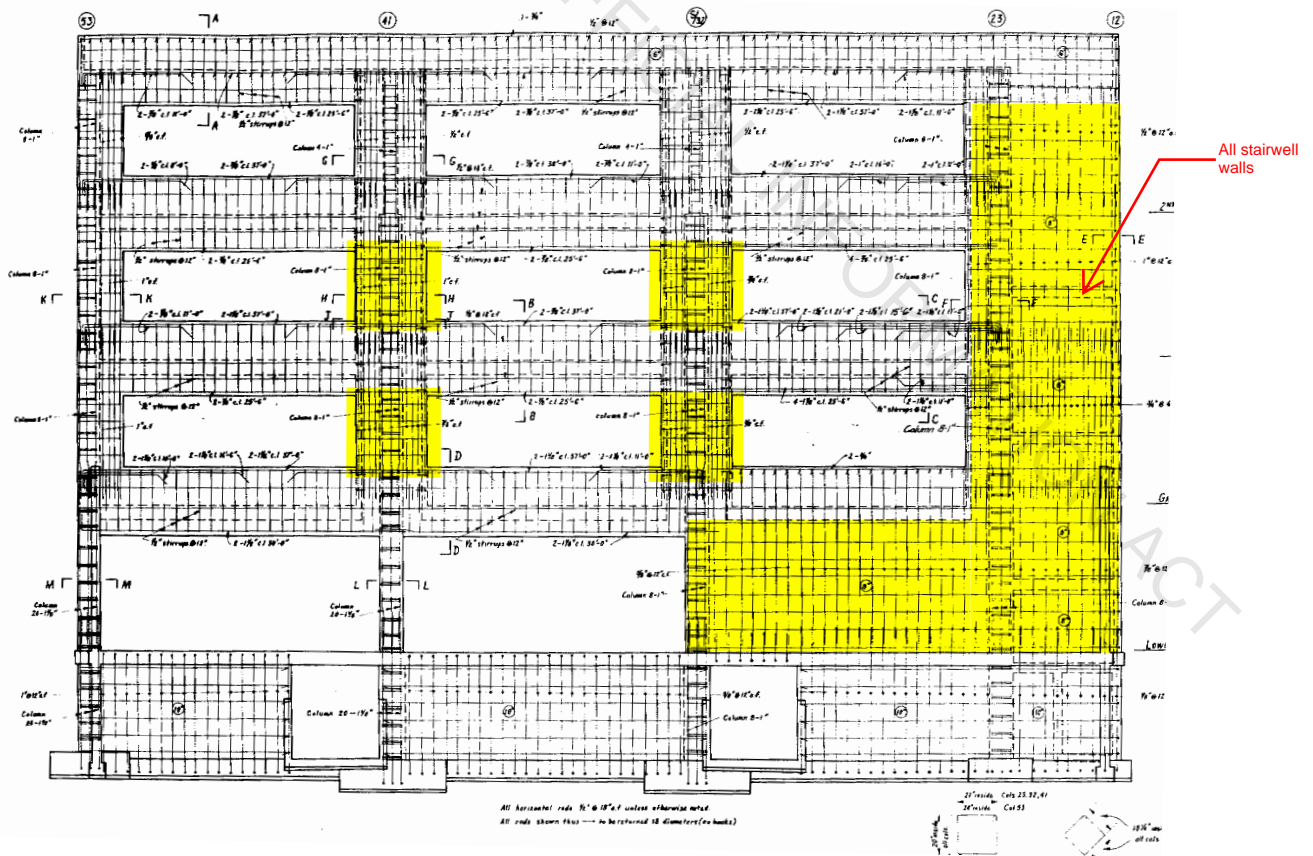
CDHB CSB  
Repair and Further Investigation Required  
General Layouts  
East/West Wall Elevations

Eastern Shear Wall (original east wall)

Western Shear Wall

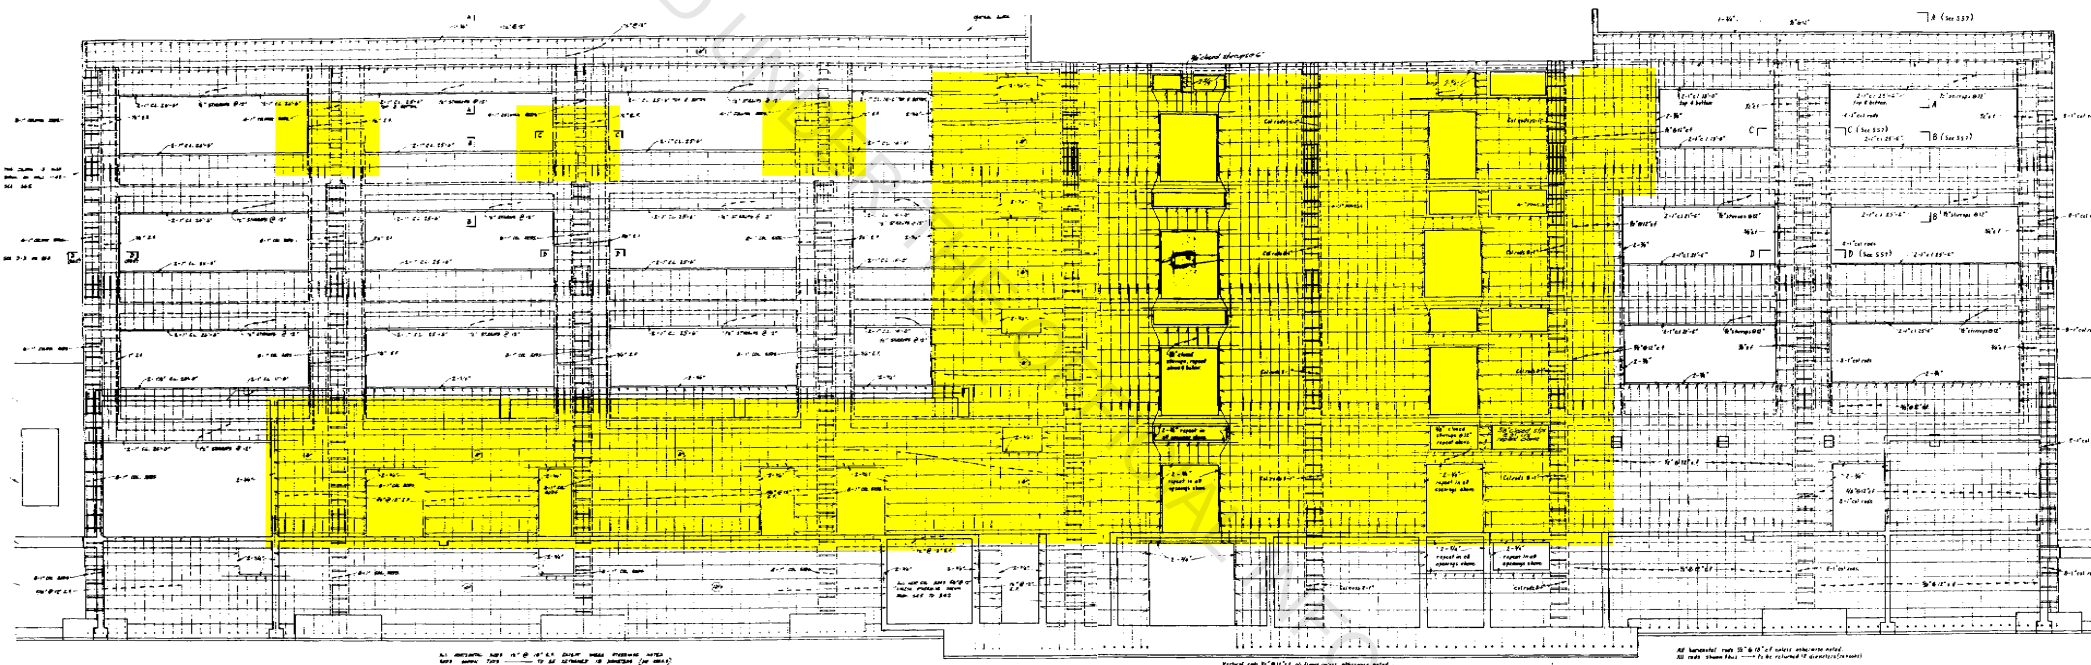
CDHB CSB  
 Repair and Further Investigation Required  
 General Layouts  
 North Wall Elevations

North Shear Wall (view from outside)

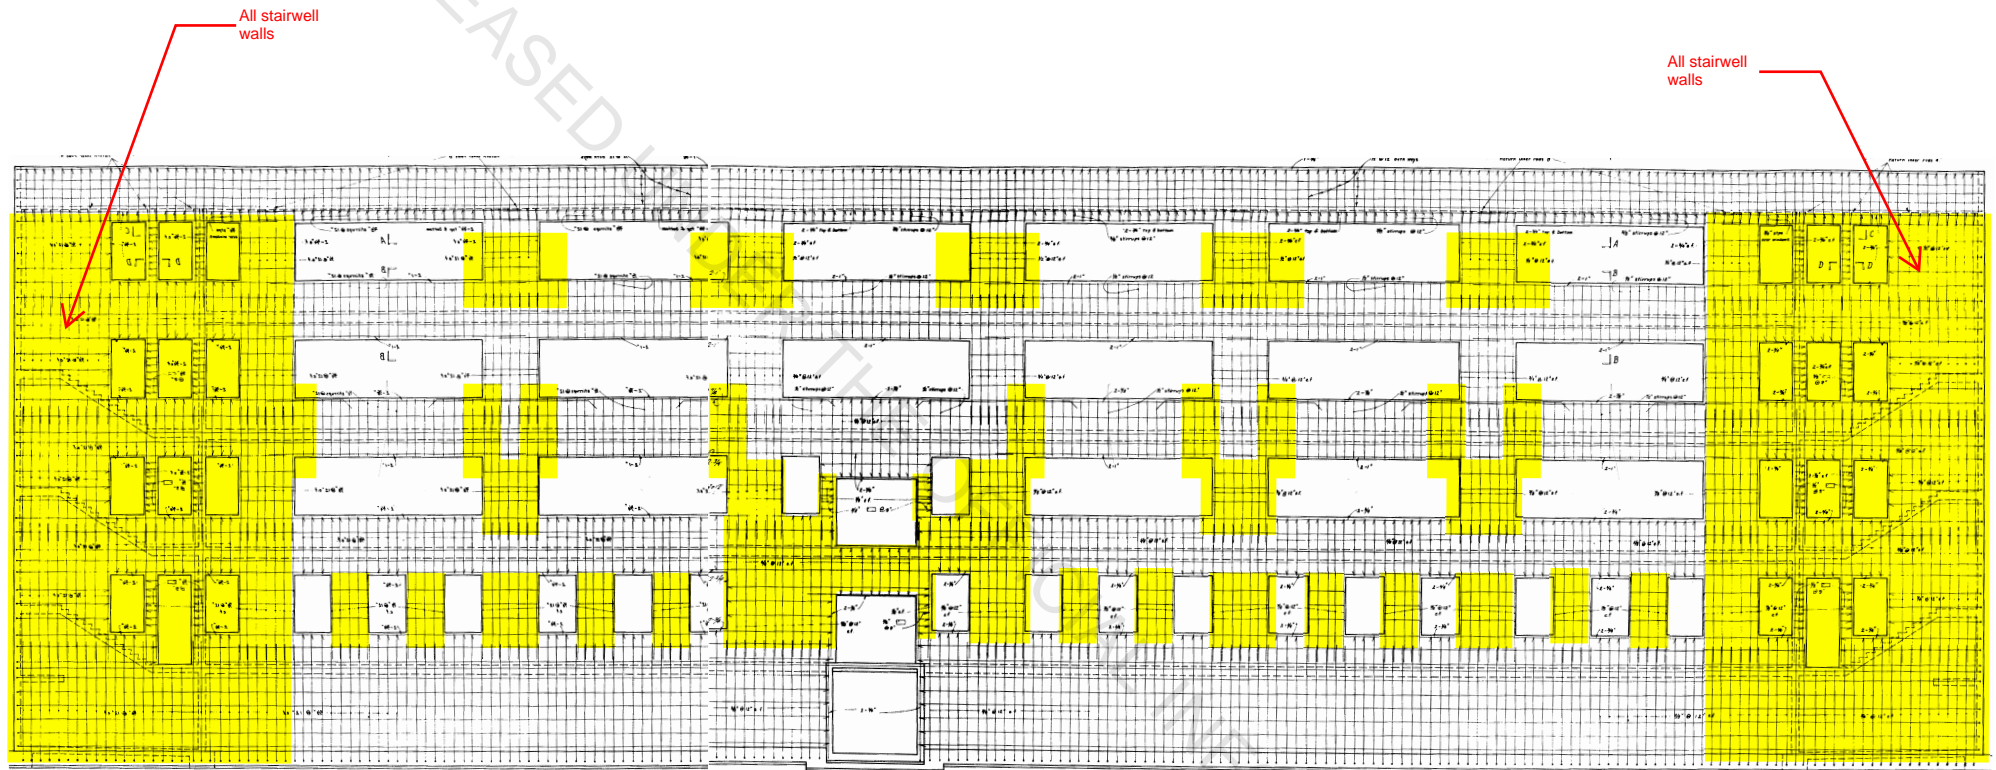
CDHB CSB  
 Repair and Further Investigation Required  
 General Layouts  
 South Wall Elevations

South Shear Wall (view from outside)

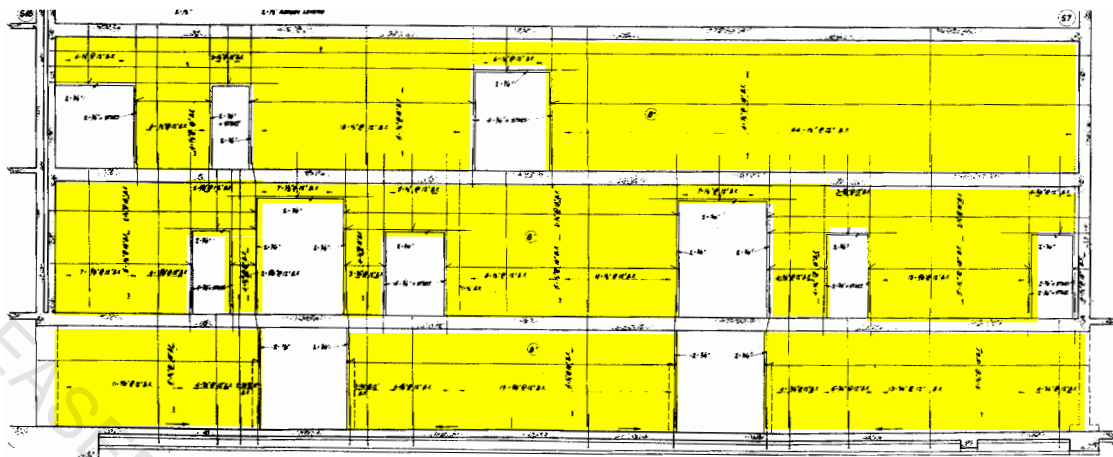
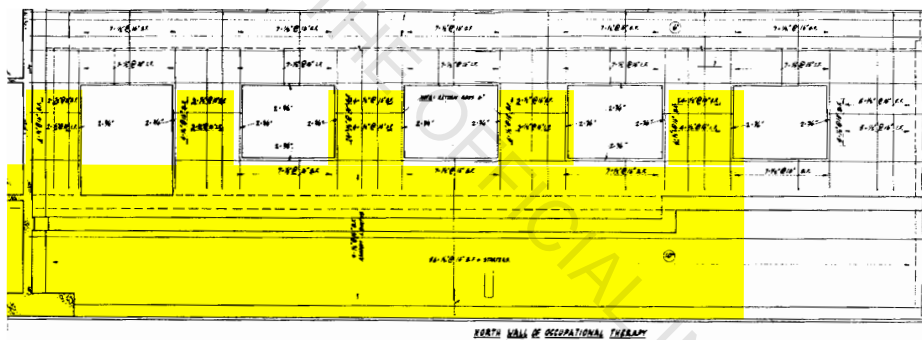
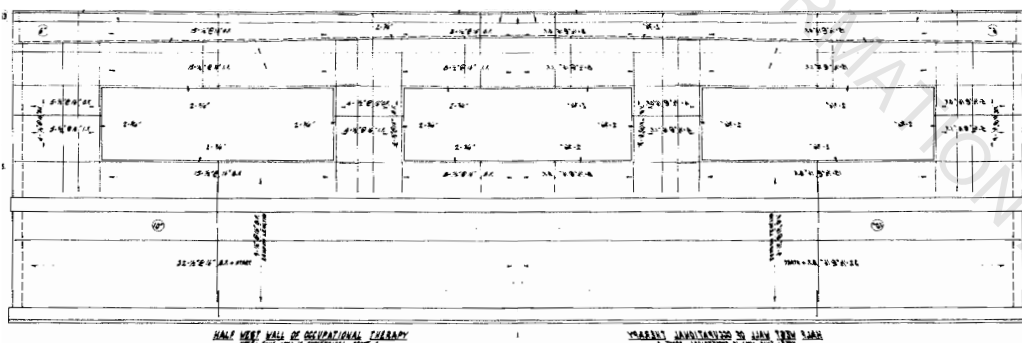
CDHB CSB  
Repair and Further Investigation Required  
General Layouts  
Single Storey/Central Wall Elevations

Central shear wall

North/South walls of single storey portion

West wall of single storey portion

Repairs to L1 diaphragm  
cracking adjacent central  
shear wall (generally within  
the column bay on either side  
of the wall). Epoxy inject all  
cracks > 0.3mm width. Refer  
seismic assessment report  
section 3.

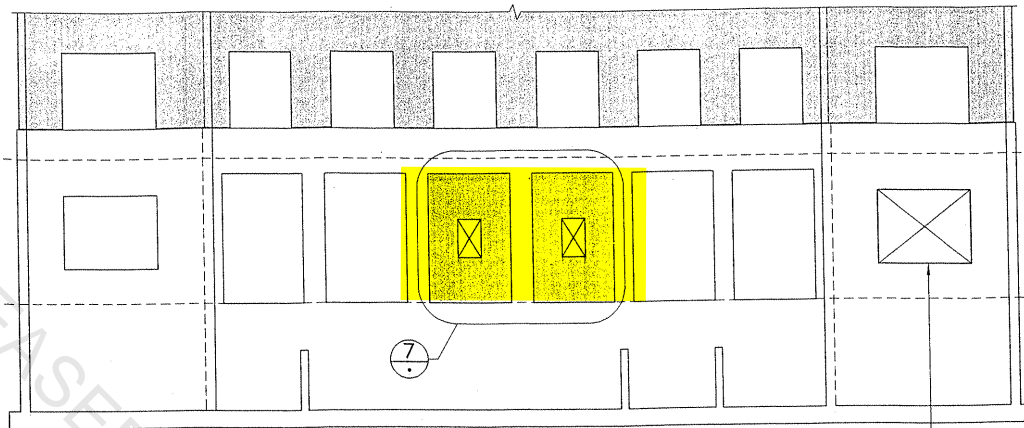
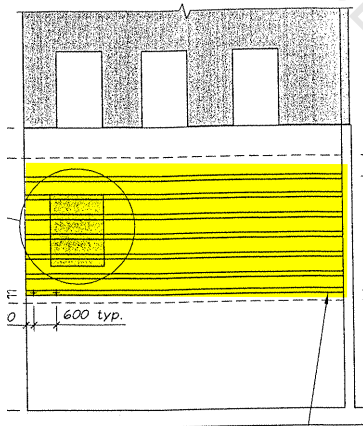
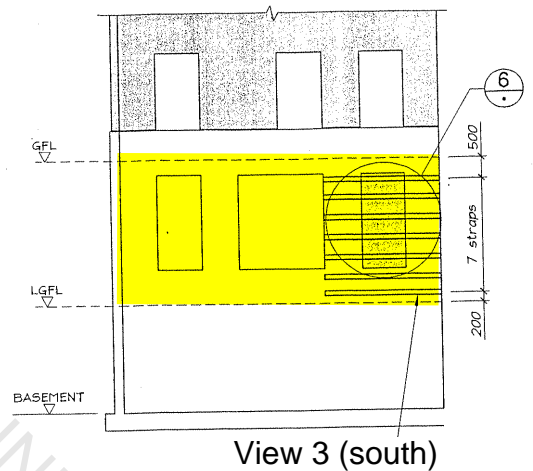
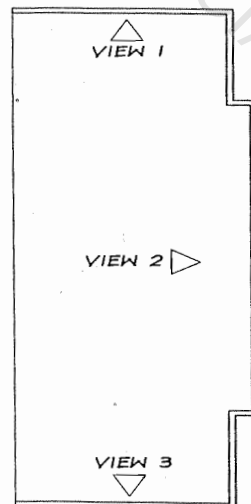
CDHB CSB  
**Repair and Further Investigation Required**  
*General Layouts*  
 Eastern Add-on Wall Part Elevations

View 2 (Far east wall)

View 1 (north)

View 3 (south)

Plan view of Eastern Add-on
