Please find attached as **Appendix 1** the Earthquake Seismic Assessment Report for Christchurch Women's Hospital October 2013 and **Appendix 2** the Detailed Seismic Assessment Report for the Clinical Services Building October 2013.

EARTHQUAKE SEISMIC  
ASSESSMENT REPORT

REPORT 6 - CHRISTCHURCH WOMEN'S  
HOSPITAL

REV 2 - 7 OCTOBER 2013

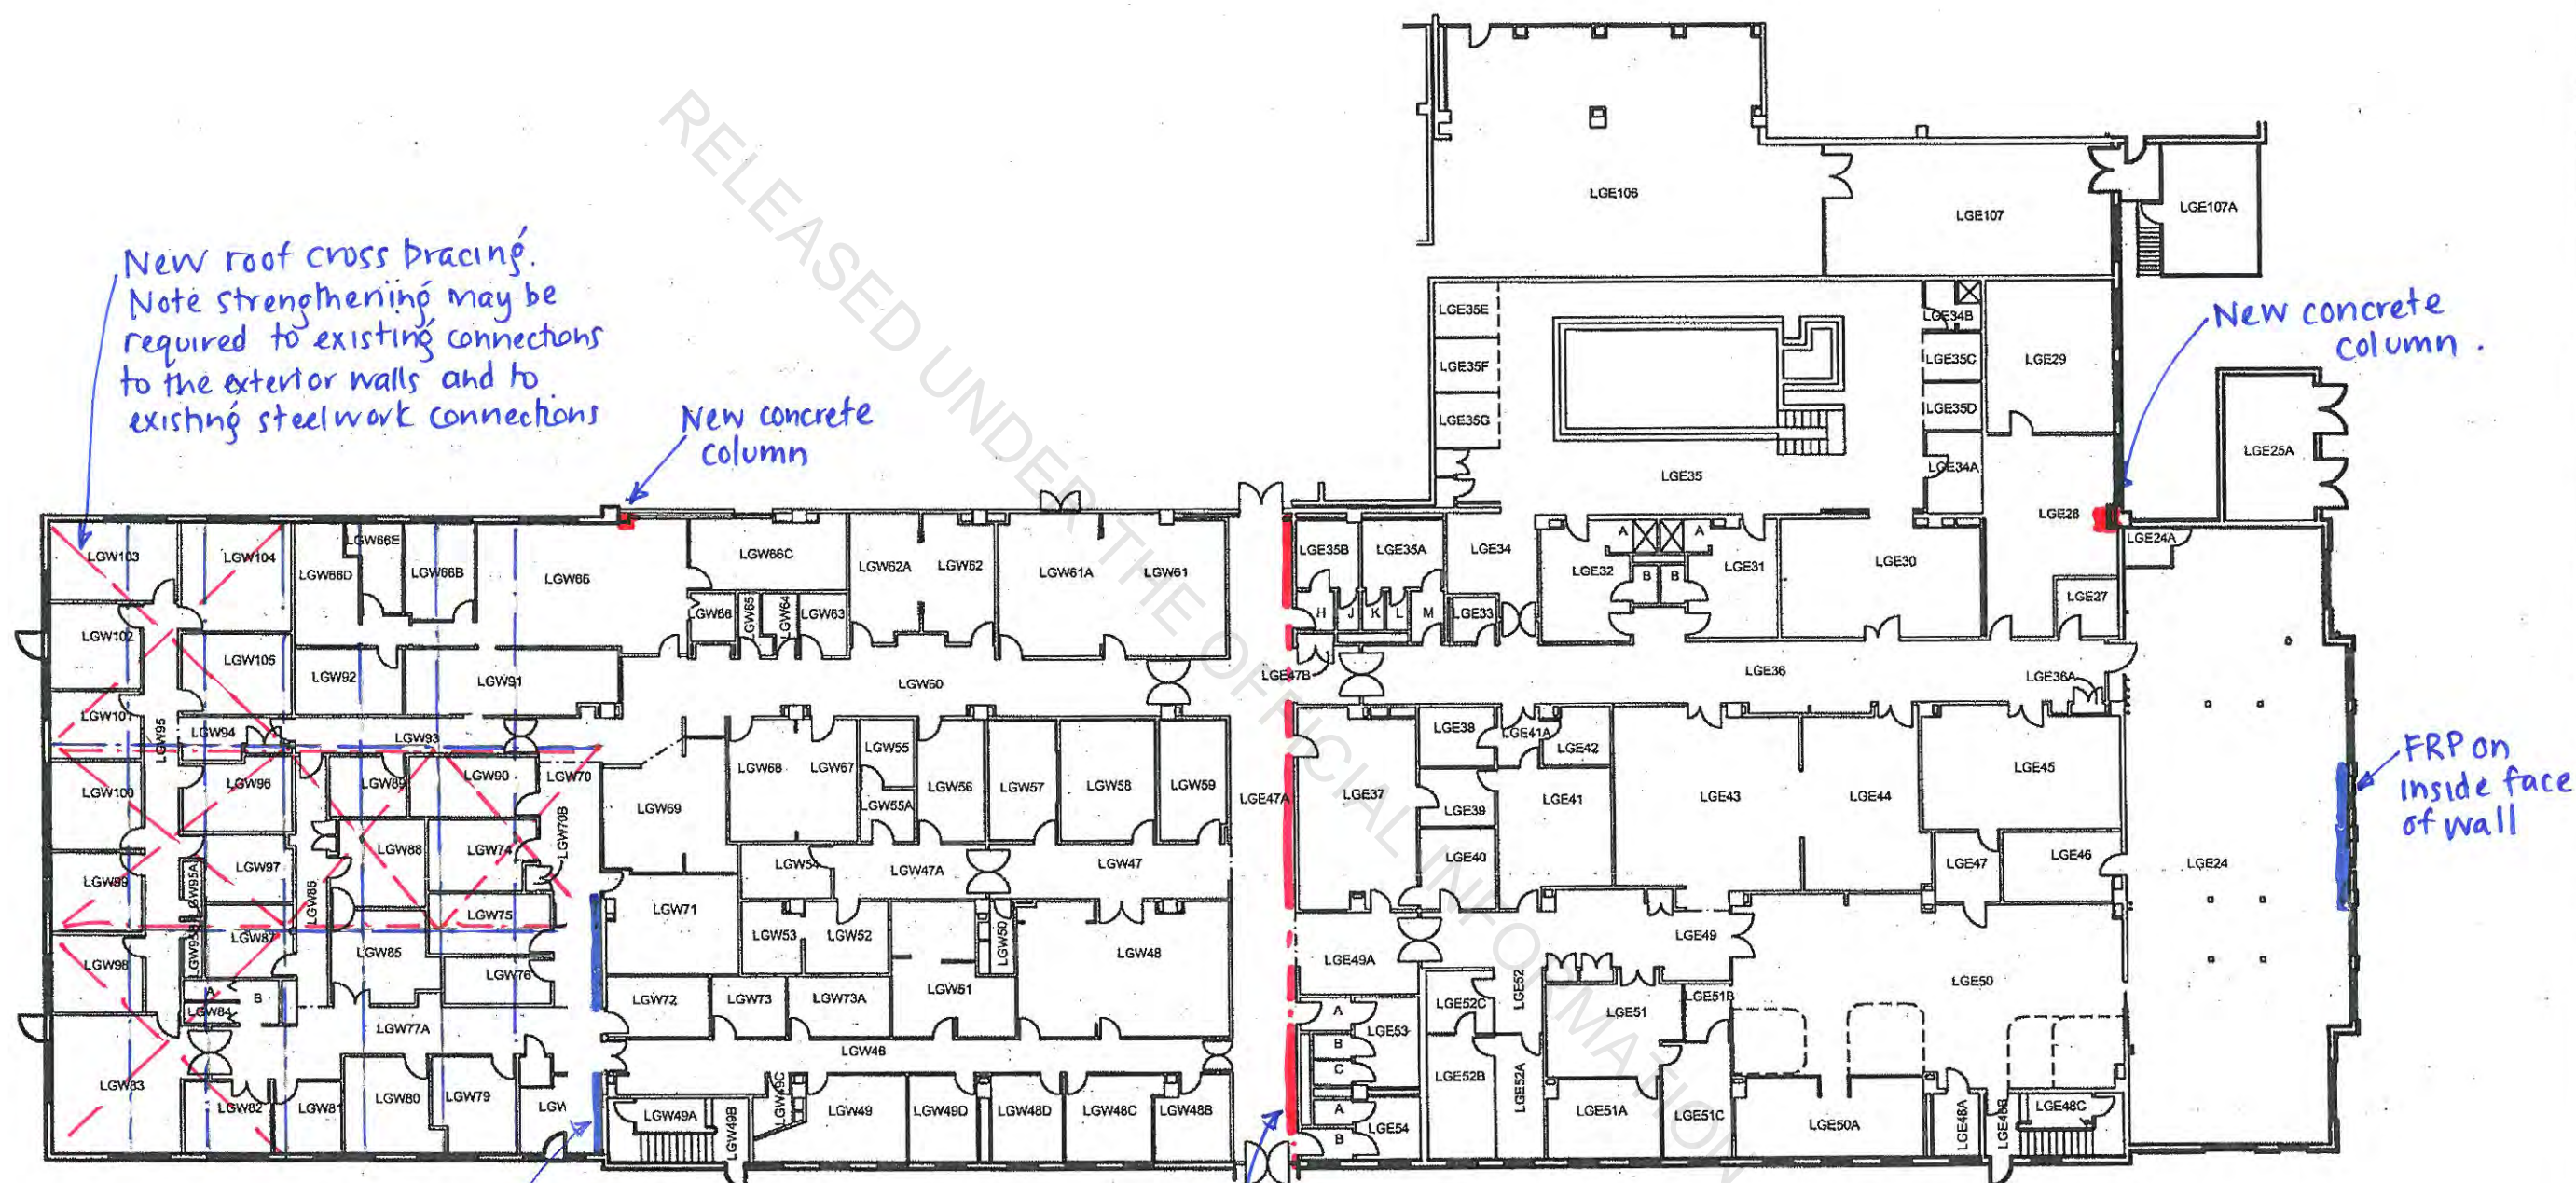
CHRISTCHURCH HOSPITAL  
RIVERSIDE CLINICAL SERVICES - LOWER GROUND FLOOR  
SPACE NUMBERING

Note: Work required to reduce the impact of pounding with Riverside Central not shown.

New concrete column

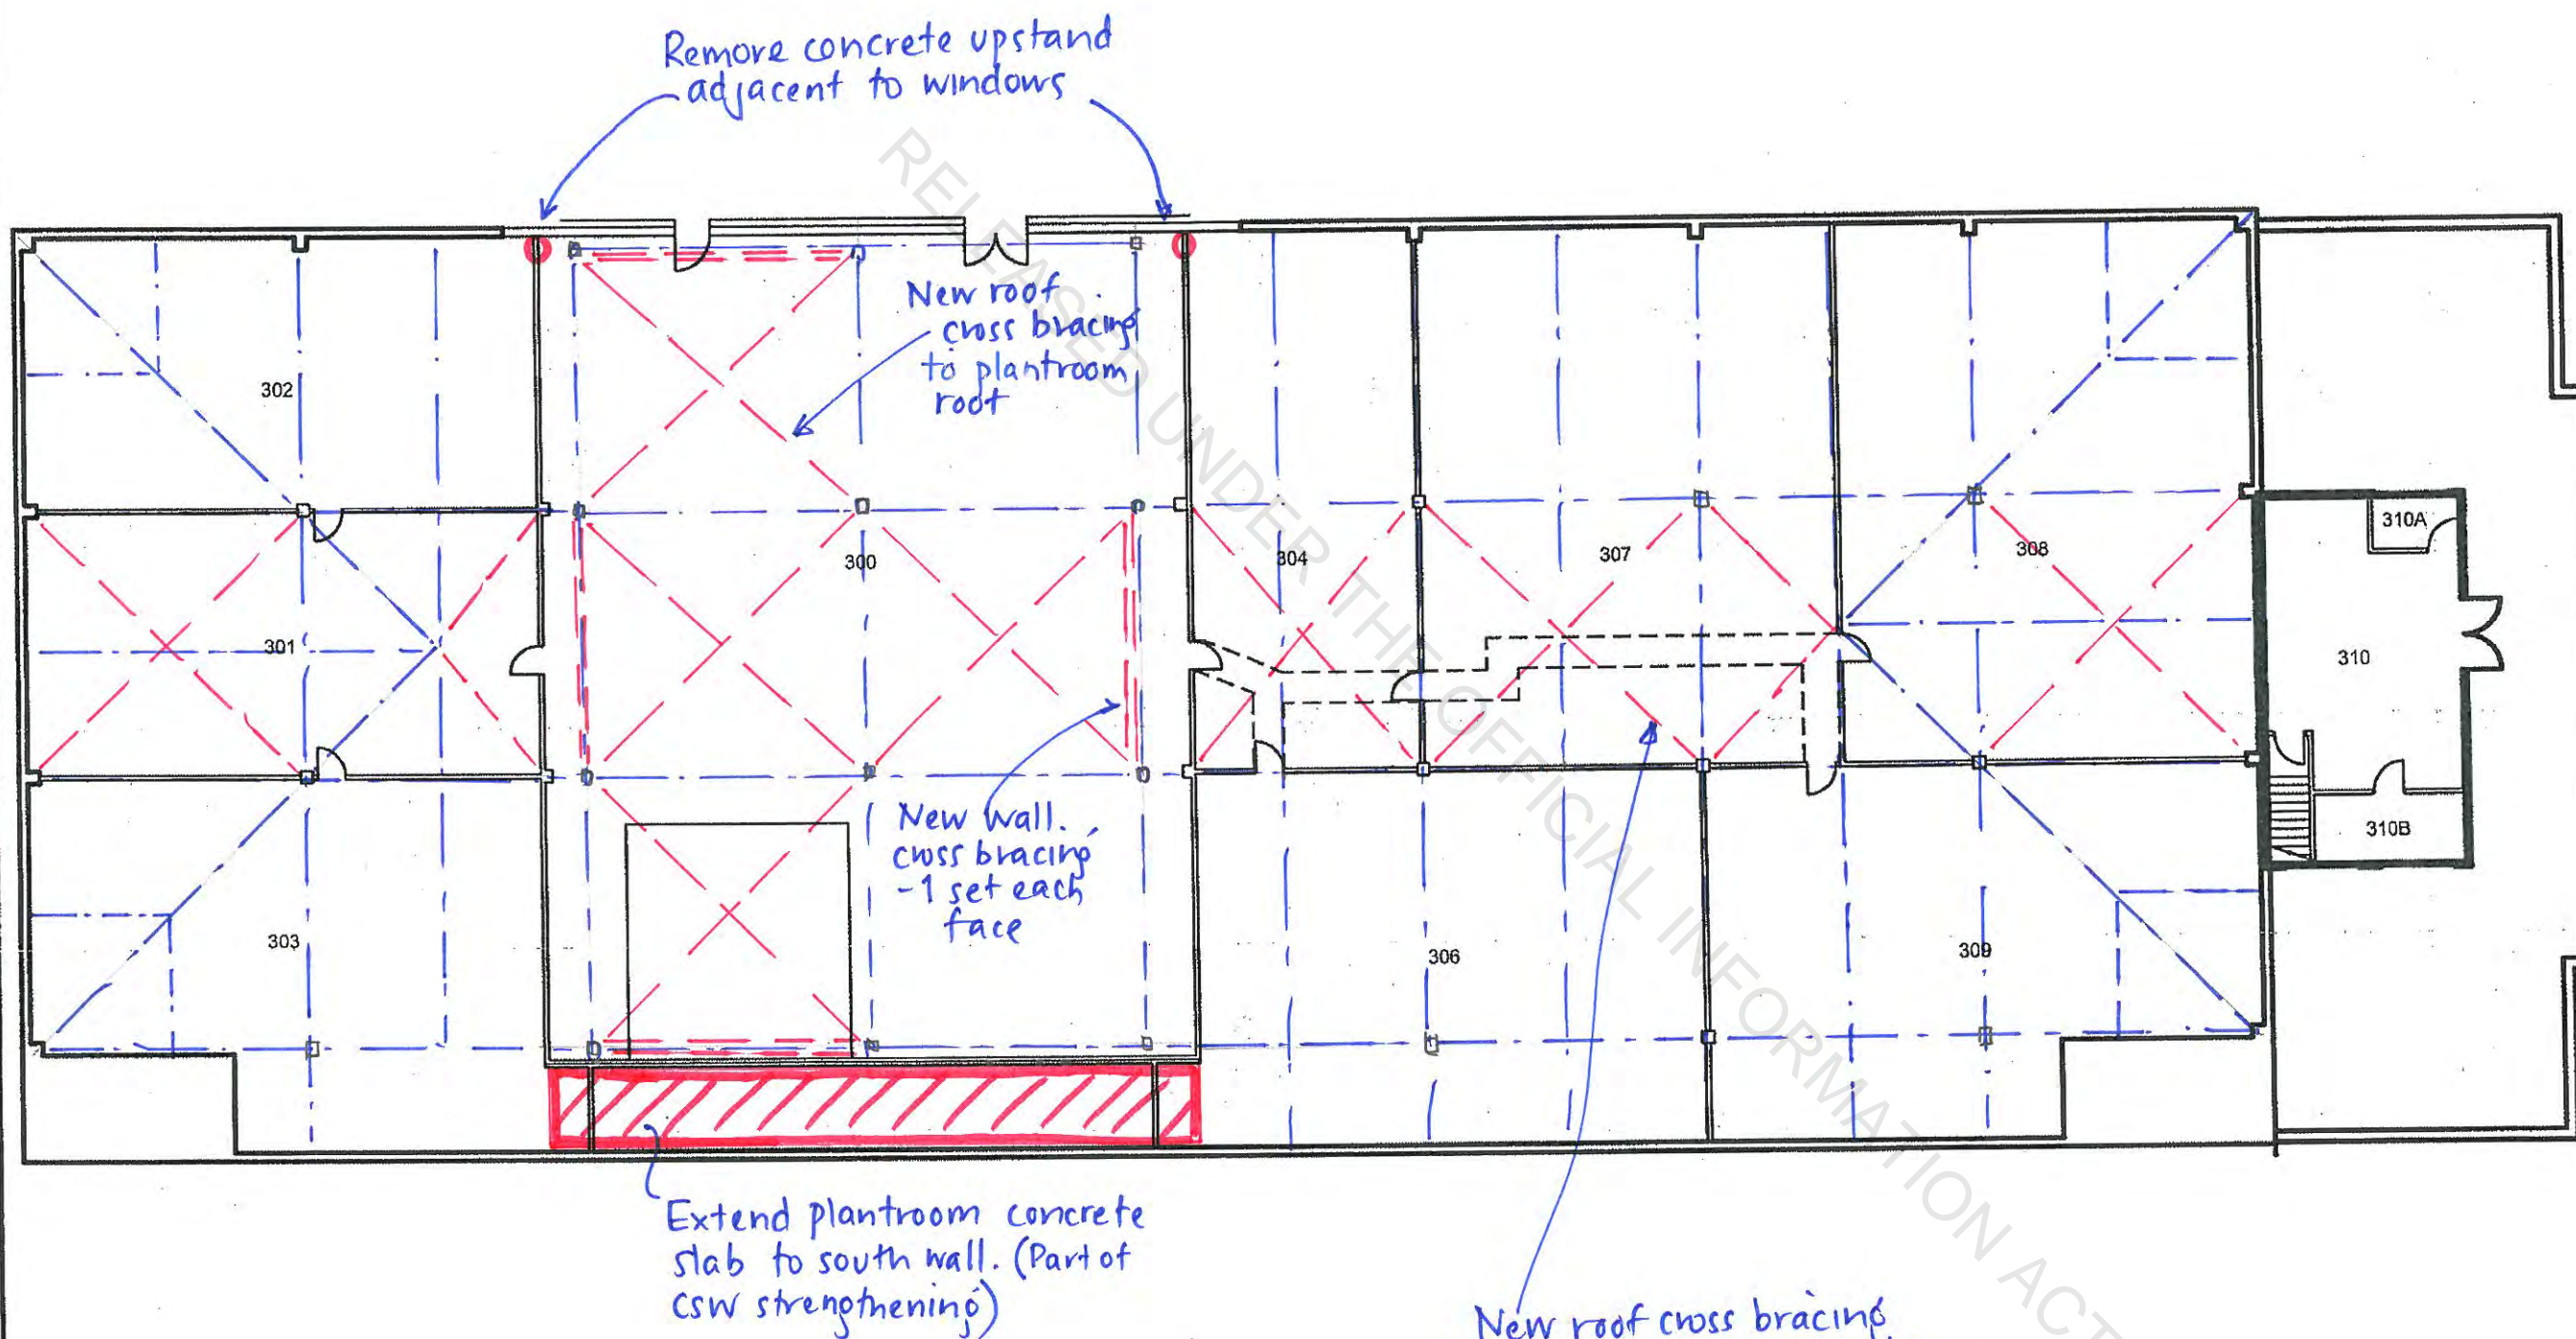
Note: Work required to reduce the impact of pounding with Riverside Central not shown

New roof cross bracing  
Note strengthening may be required to existing connections to the exterior walls and to existing steelwork connections.
