# RE Official Information Act (the "Act") request CDHB 9833 (Part two response)

# BURWOOD HOSPITAL CAMPUS - DETAILED SEISMIC ASSESSMENT REPORT

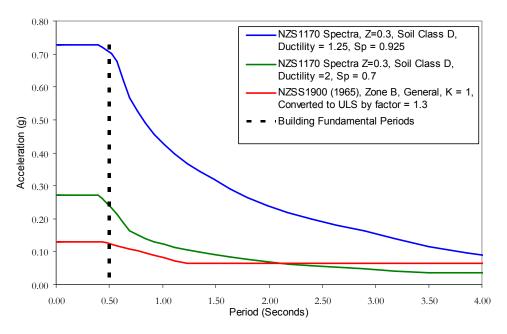
Figure 2-3: Comparison of Design Codes

A comparison between the Design Basis Earthquake (DBE) of NZSS 1900:1965 and NZS 1170:2004 for the site is plotted below. Based upon a fundamental building period below 0.50 seconds, the seismic demands on the timber framed superstructure and the concrete sub-floor structure have increased by approximately 210% and 560% respectively.

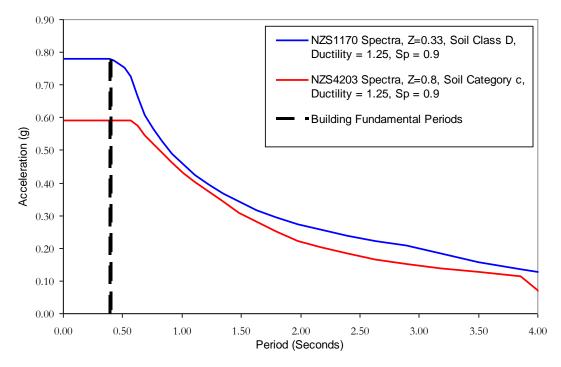
Figure 2-7: Comparison of Design Codes

A comparison of the Design Basis Earthquake of NZS 4203:1992 [10] and NZS 1170:2004[9] for the site is plotted below. Based upon a fundamental building period below 0.50 seconds, the seismic demands required by the loading code have increased by approximately 40% since 2001. As a result a building designed to 100% of the DBE at the time of construction would currently have a capacity to resist approximately 70% of the demands imposed by the current code level DBE.

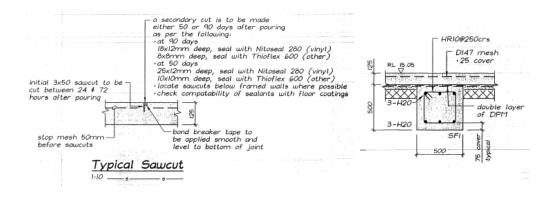
Figure 3-3: S.O.G. Construction Joint and Tie Beam Details

Where the concrete floor slab on grid line 11 in the northern corridor has separated, there are  $\sim$ 10mm cracks through the perimeter foundations beams in this location. Therefore, there is likely a discontinuity in the longitudinal reinforcing in these foundations beams at this location.

In general, there are reinforced concrete tie beams below the slab which tie the exterior footings together. The tie beams have been detailed in such a way that the double layer of DPM below the slab continues over the top of the tie beam and there is no hard connection between the two elements. See Figure 3-3.

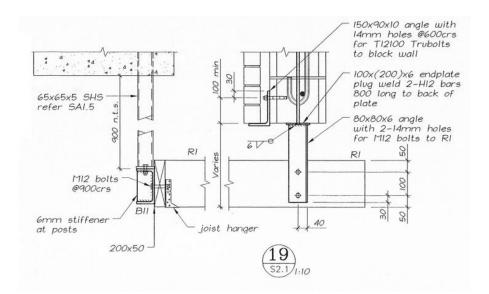
Figure 3-5: Hung Entry Detail

In general, the canopy structure and precast entry wall are seismically isolated from the main administration block. The one exception is the glass entry roof connection which is hung from the precast wall spandrel above (see Figure 3-5 below). At this location cracking has been noted to the underside of the spandrel due to the main block and the precast wall acted out of phase from each other.

It appears as though the residual deformation noted in the canopy structure and precast entry wall is a result of earthquake induced settlement/liquefaction in the vicinity of the ground on which the columns are founded. However, it is also possible that the deformation was caused by the main administration block pulling on the canopy/wall at the hanging glass entry connection.

In addition to the deformation noted, minor cracking has been noted at the base of the precast columns and to the precast elements of the architectural wall feature.

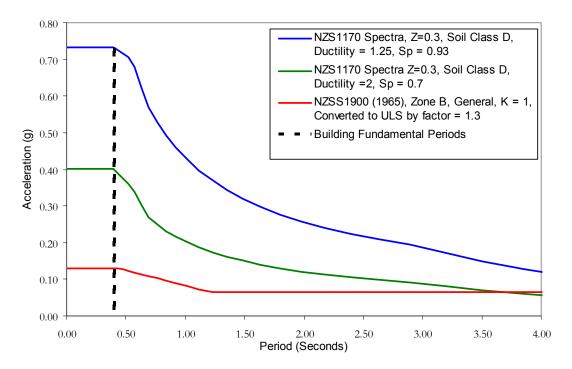
Figure 2-8: Comparison of Design Codes

A comparison between the Design Basis Earthquake of NZSS 1900:1965 and NZS 1170:2004 for the site is plotted below. Based upon a fundamental building period below 0.50 seconds, the seismic demands required by the loading code have increased on the concrete and steel portion of the structure by approximately 560% and 300% respectively since 1975.

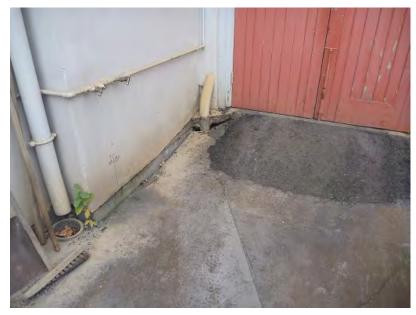
Figure 3-2: Evidence of Ground Fissures and Liquefaction

Settlement of the external pavement and coal store ramp has occurred along the western wall of the Boiler House due to ground fissures and liquefaction. The building does not appear to have settled in this area. This could be attributed to the deep foundations due to the presence of the undercroft. The settlement in the pavement is approximately 150mm from its original location.

The coal store crib wall was damage during the February 22<sup>nd</sup> event. Cribs were damage and the ramp had settled up to 140mm as per the Earthquake damage assessment report issued on the 27<sup>th</sup> of April [23]. Details were issued for rectification on the 4<sup>th</sup> of May 2011 [24] and 20<sup>th</sup> June 2011 [25]. These crib wall repairs were carried out along with re grading of the ramp to remove the step

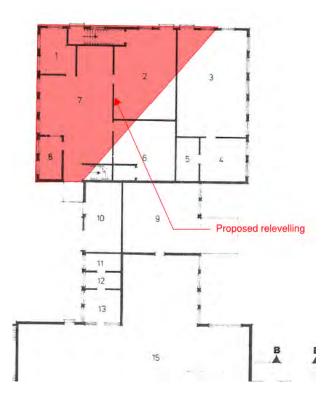
Figure 4-1: Foundation Plan – Damage Repairs

The level survey, completed by Fox & Associates, has indicated differential ground settlement of approximately 83mm across the length of the ground floor slab in the Maintenance Building. The worst differential settlement is concentrated at the east end of the building (see Appendix C for complete level assessment) with a grade of 1:200 which is outside the typical acceptable range and will need to be addressed to restore the function of the building. This can be achieved by re levelling.

If re levelling is to occur, the north west corner of the building would be proposed to be lifted up to the highest point of the building which is located roughly in the south east corner of the building. For the extent of the proposed re levelling see Figure 4.1 below. This would address the slope in the ground floor slab of the building as shown in Appendix C.

It needs to be ensured that re levelling works by use of underpinning grout or engineered resin do not create any "hard points" under the building. If "hard points" are created during the re levelling process the potential for future differential settlements can be increased. If this were to occur it would reduce the capacity of the building going forward.

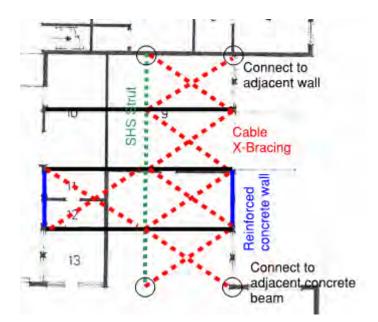
Figure 5-4: Plantroom – 67% Strengthening Recommended

**Plantroom** – The deflections which would be experienced during the design seismic event have been determined to be excessive and similarly the resulting strength demands on the portal frames. Is it likely that external finishes such as windows and walls may collapse due to these deflections, but it is unlikely that the roof would collapse. In order to reduce deflections and limit the demand on the portral frames, roof and wall bracing may be installed as shown in Figure 5-7. This concept may also be adopted in order to strengthen the structure in lieu of the fly bracing installations shown above, as it will tie the roof into the common concrete walls of the Maintenance Building and Boiler House.

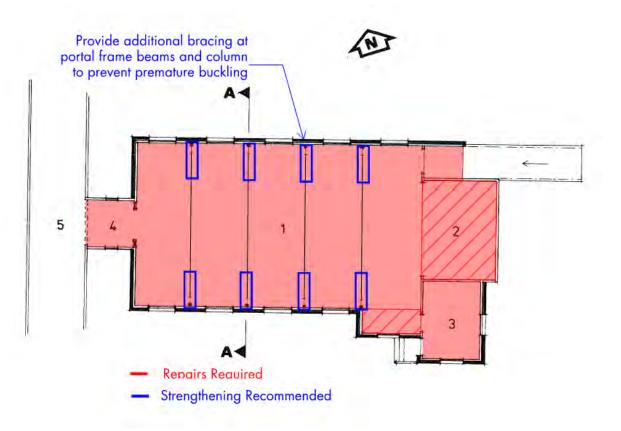
Figure 5-1: Reflected Ceiling Plan – Strengthening with Fly Braces

The internal steel portal frames in the North-South direction of the building had been assessed at approximately 35% DBE in their pre-earthquake undamaged state. The assessed percentage of the frames was governed by onset of lateral buckling of the portal frame beams and columns. The earthquake strengthening work included removing the existing heavy roof and replacing it with a light weight alternative. This reduced the load on the steel portal frames which form the primary lateral resisting elements in the north-south direction, increasing their capacity to approximately 45% DBE (IL2).

Fly braces were installed as part of the strengthening work during April-May 2014 to prevent lateral buckling of the steel frames. The capacity is now 80% DBE (IL2).

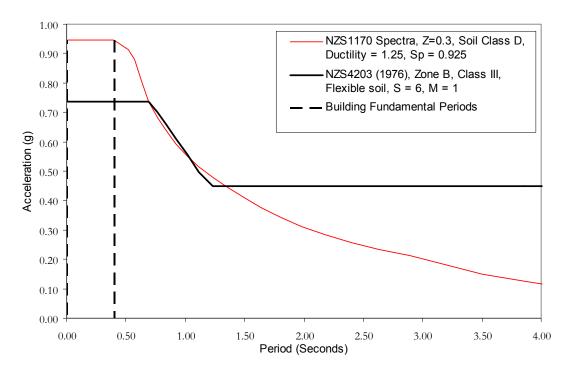
Figure 2-11: Comparison of Design Codes - NZS1170 (IL3) to NZS 4203 (IL2)

It is likely that the Engineering Services Building was designed originally to NZS 4203:1976 with an Importance Factor of 1 (i.e. equivalent to an Importance Level 2 Structure as defined in 1170:2004). As the Engineering Services Building provides services to Importance Level 3 buildings on the Burwood Hospital Campus it is assessed as an Importance Level 3 building as defined in NZS 1170:2004. A comparison between the DBE of NZS 4203:1976 (Importance Factor 1) and NZS 1170:2004 (IL3) for the site and type of construction are plotted below. Based upon a fundamental building period of approximately 0.40 seconds, the Engineering Services building capacity is equivalent to approximately 75%DBE in both directions based on a comparison of the likely design loads.

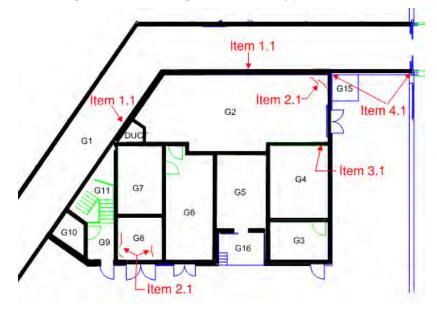
Figure 4-1: Ground Floor Plan – Required Repairs

Damaged Item & Location	Damage	Recommendations	Example Photograph
1. Foundations and Sub#Ioor Walls			
1.1 Sub#loor, service tunnel and partial basement walls	Cracking in concrete walls (typically less than 0.5mm)	Epoxy inject all cracks in concrete walls >0.2mm as per the HCG Repair Specification [3]. For cracks greater than 1mm, HCG to confirm the integrity of the existing reinforcement of the wall. If reinforcement is damaged, an engineered repair will be required.	
2. Concrete Roof and Floor Slabs			
2.1 Concrete floor slabs – ground floors	Cracking in floor slab in rooms G2 and G8	Epoxy inject all cracks in concrete walls >0.2mm as per the HCG Repair Specification [3]. For cracks greater than 1mm, HCG to confirm the integrity of the existing reinforcement of the wall. If reinforcement is damaged, an engineered repair will be required.

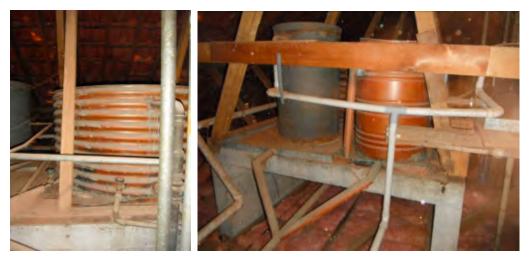
Figure 2-9: Existing Water Tanks

In the second storey attic space of the West Wing are several water tanks. Based upon observations completed to date there appears to be little or no fixings / lateral bracing of the water tanks.

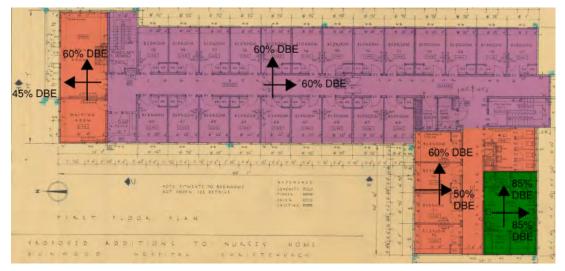
Figure 2-17: First Floor Ceiling Diaphragm - %DBE (IL2)

At the roof level, the ceiling diaphragm in the north-south direction has typically been assessed at 60% DBE (IL3 - 45% DBE) based upon the strength of the existing ceiling linings. The exception is at the north sitting room and the south toilet / washrooms. In the sitting room there is no transverse bracing walls to reduce the diaphragm span other than the timber partition wall. The span between the perimeter walls is also too far for the concrete wall to span out-of-plane, which has led to the assessed capacity of 45% DBE (IL3 - 35%).

In the south bathroom area, most of the brick walls have been removed while a plywood ceiling diaphragm and strapping across ceiling framing has been installed to take the out-of-plane loads of the remaining brick wall and to tie in the external concrete wall. This has brought the capacity of this part of this this section up to 85% DBE (IL3 - 67%).

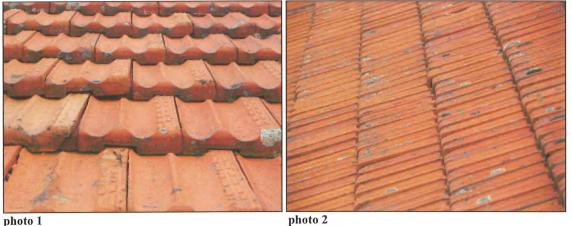
photo 3

Photo's 1,2&3 are on the west side of the roof and show typical movement of the tiles but this could not be classed as excessive.

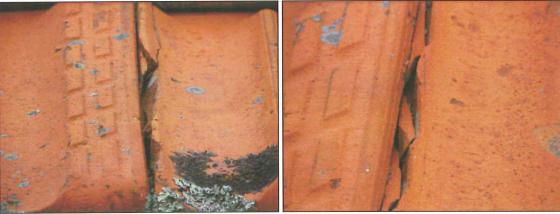
photo 4

Photo's 4&5 are in the same area and show damage to the drainage channels, some of which are obviously more recent than others.

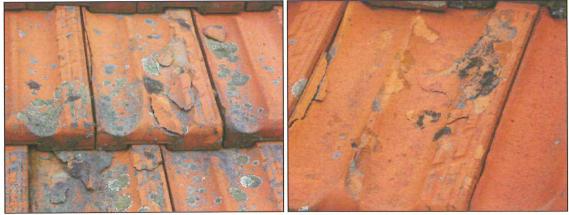
photo 6

Photo's 6&7 are also in the same area and this is caused by frost damage.

These photos are typical of most of the roof and although a lot of the damage cannot be attributed to the earthquake, the mere fragile state of the roof will make it very difficult to access the roof to effect repairs.

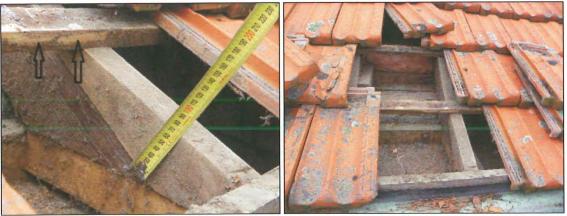
photo 8

Photo 8 is an example of the timber forming a 125mm bell cast at the bottom of the roof that would need to be removed it the roof was replaced with long run iron. What is not very clear in the photo is substantial amount of borer in the 50x25 tile batten and one would have to assume that this would have to be widespread. Photo 9 is wider shot of the same area.

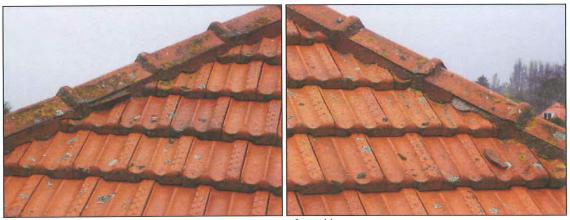
photo 10

Photo's 10&11 are of the north gable end and show where the ridge tiles and pointing have broken away.

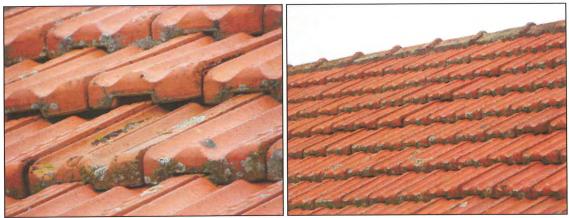
photo 13

The east side of the roof was harder to access but the condition of the roof is similar. Photo's 12&13 are up above the children's play area and can't be accessed easily but there signs of reasonable movement on this face.

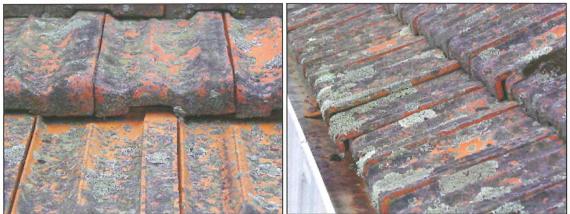
photo 15

This will help disguise any roof leaks that may be occurring, and because of the structure, it makes it very difficult to wire tie the tiles, only about every second tile on every row was tied, which is normal. Unfortunately, this allows more shuffling or dancing of the tiles to occur. This can be seen in photo's 15 & 16.

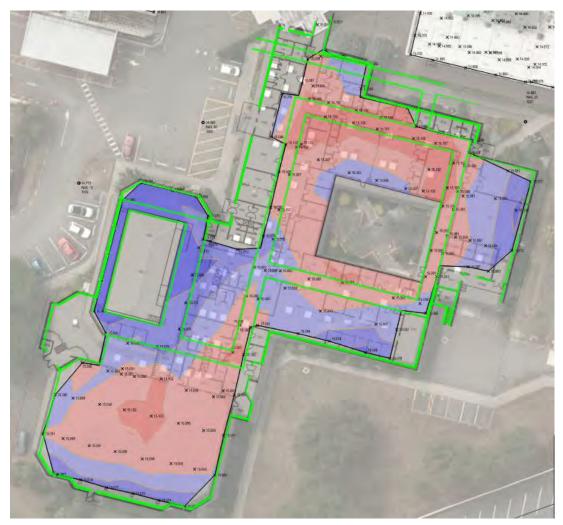
Figure 3-1: Level Survey measurements with sub-floor service tunnel locations super-imposed in green

A detailed survey of the ground floor levels in the Physical Medicine Block was conducted by Fox & Associates and issued on 24<sup>th</sup> November 2011 [6]. The purpose of the level survey was to measure the slopes in the ground floor as a result of earthquake induced differential ground settlement. The results of the survey are included in Appendix C and are shown in Figure 3-1. Areas of dark red are the highest, with areas of dark blue the lowest.

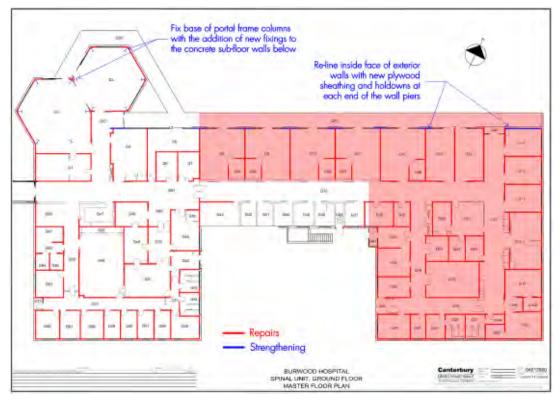
Figure 5-1: Ground Floor Plan – Strengthening Recommended

**Exterior Wall Bracing** – Along the north end of the building the existing wall bracing provided does not meet the minimum requirements of NZS 3604:2011 [13]. In order to achieve the minimum wall bracing requirements, and increase the assessed capacity of the building, the wall bracing along this end of the building will need to be strengthened. The proposed strengthening would be to replace the inside face of the exterior wall linings with new plywood sheathing. Additional fixings to the concrete sub-floor walls would also be required in conjunction with the strengthened bracing walls. This would include additional fixings to the elevated ground floor slab and addition holdowns at either end of the wall openings. The proposed additional bracing locations have been included in Figure 5-1 below.

**Steel Portal Frame** – The steel portal frames have been assessed at 60% DBE for drift and at 75% DBE for strength. In order to improve the seismic performance of this section of the building the base of the columns could be fixed through the installation of additional fixings to the concrete sub-floor walls below. This would result in reducing the drift of the portal frames and as a result increase the assessed %DBE of the building.

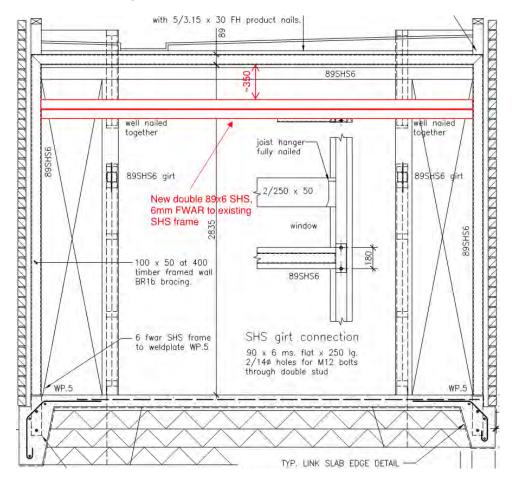
Figure 1: SHS Bracing Member to Reduce Drift

The corridor section of the building has been assessed at 80% DBE for strength but only 40% DBE for drift. This means that the corridor is likely to experience an undesirable level of displacement during shaking and non-structural items such as wall linings may be damaged during smaller earthquakes.

One option to bring the drift capacity up to 67% DBE is to add two 89x6 SHS sections which would be welded across the frame, approximately 350mm below the top SHS (estimated to be just above ceiling level), as shown in Figure 1 below. These should be welded all round using a 6mm fillet.

An assessment of the services present in the ceiling space should be carried out before further development of this option.

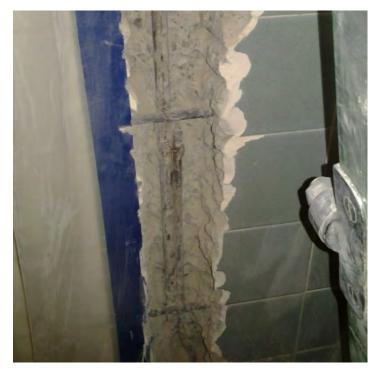
Figure 2-15: Vertical Wall Reinforcing Lap

Destructive testing was completed to determine indicative lap lengths for the vertical reinforcement as this information could not be ascertained off of the existing drawings. The investigations revealed a straight contact lap of approximately 380mm (likely a specified 12" lap).

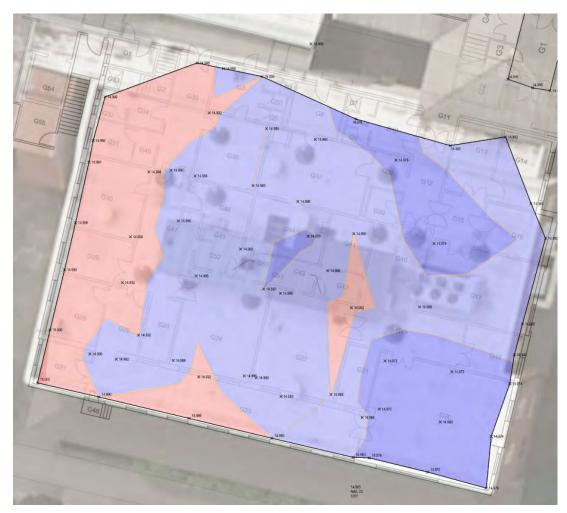
Figure 3-1: Level Survey

**Original 1959 Construction** – The level survey completed for the elevated concrete floor slab of the original 1959 construction indicates high points in the slab over the partial basement and services tunnels below. It is believed that this is a result of the partial basement and service tunnels being founded in deeper and stiffer material than the surrounding foundation elements. The maximum height differential in the concrete floor slab was measured to be 22mm over the length of the original 1959 construction. The worst case slope noted in the elevated slab is a drop of 14mm over a length of 5.5m (0.25% or 1:400).

**1988 Additions –** The level survey completed for the elevated timber floors of the corridor addition on the south end of the building indicate a maximum elevation change of 28mm over the length of the south corridor. The worst case slope noted in the floor framing is a drop of 12mm over a 4.1m length (0.29% or 1:340). This is within the typical acceptable range for residential timber framed construction.

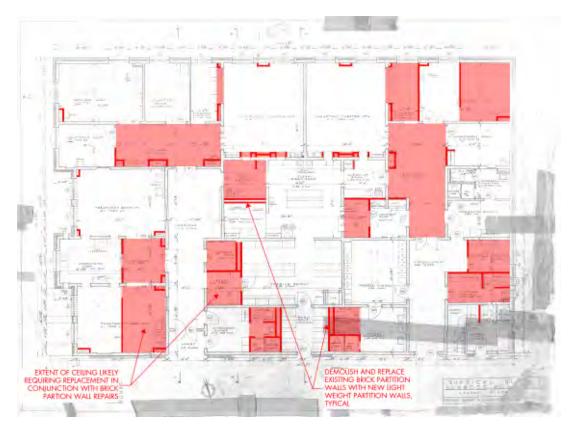
Figure 4-1: Ground Floor Plan - Required Repairs

All brick walls on the ground floor level have been either removed or secured with timber studs to 67% DBE.

Alternatively timber framing can be used to encapsulate the brick walls such that the timber walls restrain the seismic weight of the brick walls.

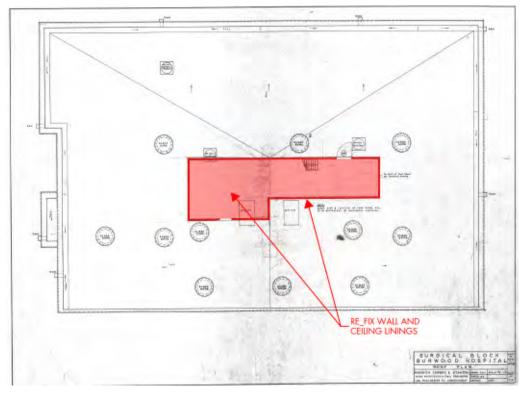
Figure 4-3: Roof Plan - Required Repairs

- **Damage to roof tank room** Damage to the "Hardie Board" wall and ceiling lining fixings was observed. General aging and weather-related damage was also noted to the exterior weatherboard linings.

The wall and ceiling linings of the tank room have been damaged in locations and require repair, primarily at the Hardie Board lining fixings. Based upon the movement observed it is believed the wall and ceiling lining fixings have been damaged throughout. This has resulted in a reduction to the ongoing strength and stiffness of all the bracing walls and the ceiling diaphragm. In order to reinstate the pre-earthquake strength and stiffness to these elements, the repair recommendation is to remove all cracked or damaged sections of the wall linings and replace them with in kind material. All existing internal wall and ceiling linings to remain are to be re-fixed to the existing timber framing.

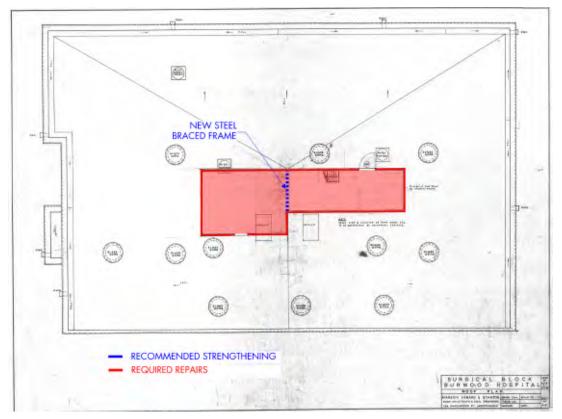
Figure 5-1: Tank Room – Strengthening Recommended

Additional Wall Bracing – The pre-earthquake and post-earthquake repair assessed capacities of the roof diaphragm and wall bracing of the tank room on the roof are approximately 40% DBE and 50% DBE respectively. In order to bring the assessed capacity above 67% it is recommended that new wall bracing be added in the north-south direction. The additional bracing could be added internally or externally with the use of steel braces fixed to the roof framing and the concrete slab below. In addition to providing additional wall bracing, the length of the ceiling diaphragm would be reduced and thus increasing its assessed capacity as well. See Figure 5-1 for the additional proposed bracing locations.

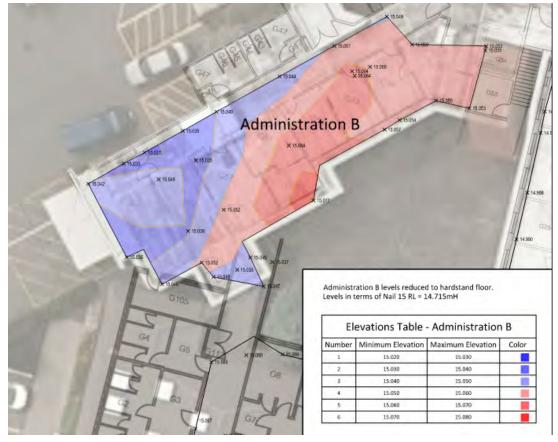
Figure 3-1: Maori Health Unit – Level Survey

While the permanent slopes noted in the ground floor are within the typical range for residential timber framed construction, they may be deemed unacceptable by CDHB based upon the building function. If the slopes are deemed unacceptable, re-levelling of the ground floor could be achieved through the use of mechanical jacking. A discussion on re-levelling options is included in Section 4.2.

For the extent of the differential settlement noted to the building see Figure 3-1 below and the level survey included in Appendix C.

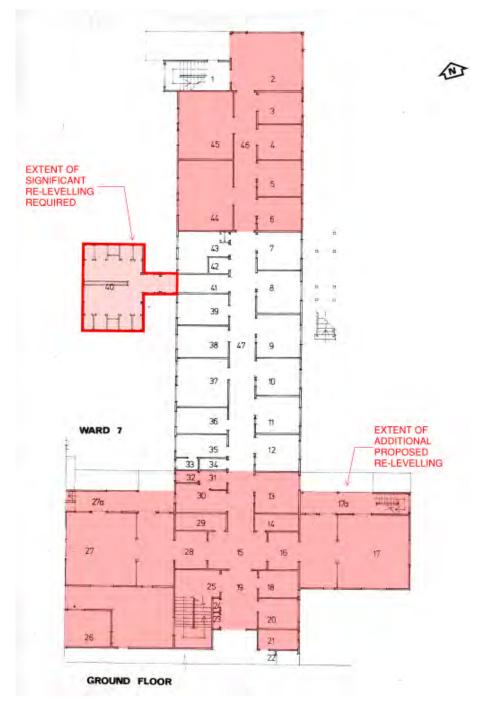
Figure 4-1: Foundation Plan – Damage Repairs

It is estimated that the building foundations have settled a total of 110mm - 200mm overall with a differential settlement of approximately 50mm noted across the length of the East and West Connecting Wings. The differential settlement is particularly noticeable at the link between the Main Wing and the Toilet Block Extension, were a there is a drop in the ground floor of approximately 40mm over a 1m length (1:25 or 4% slope).

During the re-levelling process there is a risk that addition damage could occur to the buildings linings, exterior block veneer, etc. and appropriate contingencies should be provided.

For the extent of the work proposed see Figure 4-1 below.

It should be noted that re-levelling the building through the use of mechanical jacking will not reduce the potential for future differential settlements. The ground conditions under the building will remain roughly as they were prior to the earthquakes. Based up the geotechnical report provided by Tonkin & Taylor [4] the potential for future total and differential settlements at the building site would remain between 0 to 20mm for a SLS event, and between 160 to 250mm for an ULS event.

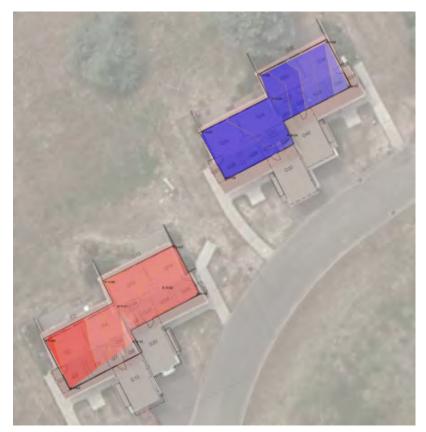
Figure 3-1: Milner Lodge - Level Survey

A detailed survey of the ground floor levels of the Milner Lodge buildings was conducted by Fox & Associates and issued on 18<sup>th</sup> April, 2012 [3]. The survey indicates a earthquake induced differential ground settlement has occurred on the site, resulting in a worst case permanent drop in the elevation of the ground floor slab of approximately 50mm over a 10 m length of the building (1:200 or 0.5% slope). This is on the edge of the typical acceptable range for standard occupancy buildings of timber framed construction, however given the nature of the patient group occupying the building, CDHB may wish to pursue re-levelling of the building. A discussion on how this could be achieved has been included in Section 4.2.

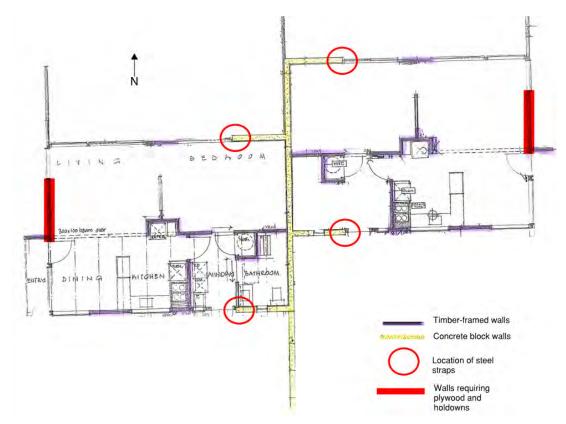
Figure 5-1: Location of steel straps between block wall and headers

The connection between the header and the block wall is insufficient and as such the ceiling diaphragm is not properly engaged. The limited capacity of this connection means the load path to the block walls is incomplete. To strengthen the system, new steel straps should be installed on each side of the header beam to top of block wall connection. These would be bolted to the block wall and nailed into the timber header. This will provide the required tensile capacity to tie the two elements together and improve the performance of the structure. A strap of approximately 1.5 m is required in each location as shown in Figure 5-1.

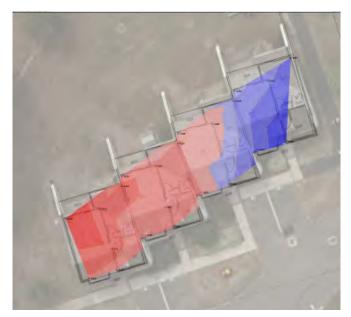
Figure 3-1: Tapper Units – Level Survey

A detailed survey of the ground floor levels in the Tapper Units was conducted by Fox & Associates and issued on 18<sup>th</sup> April, 2012 [5]. The survey indicates a permanent slope in the ground floor from west to east along the length of the building. The total measured drop in the ground floor is approximately 83mm. The worst case localized drop in the elevation of the ground floor slab is approximately 19mm over a 3.8 m length, resulting in 1:180 slope in the ground floor slab (0.55%).

Based upon observations on site, including the extensive ground damage in the direct vicinity of the building, it is believed the slopes in the ground floor slab are primarily earthquake induced.

The total differential settlement noted across the footprint of the building, and the associated slope in the slab on grade, exceeds the minimum typical acceptable value for standard occupancy buildings. As a result remediate of the floor levels is likely required to restore the functionality of the building. A discussion on the options available to re-level the building have been included in Section 4.2.

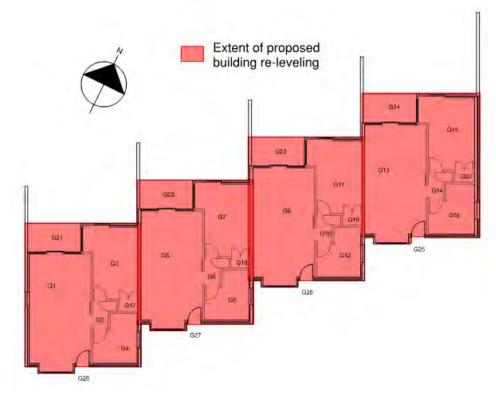
Figure 4-1: Foundation Plan - Re-Levelling Repairs

Besides the slopes noted in the ground floor framing, the differential settlements observed will have resulted in some reduction in the capacity of the building, along with a reduction in the buildings ability to undergo future differential settlements before the onset of more severe damage.

The permanent slopes in the ground floor slab can be remediated through re-levelling of the building. This would entail lifted the entire structure up to the highest point located in the north-west corner of the building. For the extent of the proposed re-levelling see Figure 4-1 below.

The two primary re-levelling options available include the use of either mechanical jacking or underpinning grout. There are advantages and disadvantages of each solution which extend beyond structural performance, and need to be considered by CDHB. These include continuity of operation, degree of re-levelling accuracy, risk of damage to existing foundation system and/or superstructure, and the willingness of the re-levelling sub-contractor to provide a producer statement, amongst other items.

The building could also be re-levelled through the use of mechanical jacking under the existing foundations. In this scenario the existing foundations would be jacked up to level, with the void created under the footings filled with cementicious grout.

With either option it is likely the existing slab on grade will be required to be partially demolished and replaced in conjunction with the re-levelling of the existing foundations. This is due to access requirements to the underside of the foundations. It is also likely that parts of the interior fit out will be required to be demolished and replaced as well.

It should be noted that neither option is expected to increase the seismic performance of the building or reduce the potential for future differential settlements. Instead the options presented are designed to re-level the building without making the future performance of the building any worse than it was prior to the earthquakes. To improve the future performance of the building, and reduce the potential for future differential settlements, would likely require the entire footprint of the building to be either piled or the ground under all the existing footings improved to the appropriate depth. Further geotechnical investigations would be required into the type and depth of ground improvement required.

During the re-levelling process there is also the risk that additional damage could occur to the building linings, exterior block veneer, etc. Appropriate contingencies should be provided.

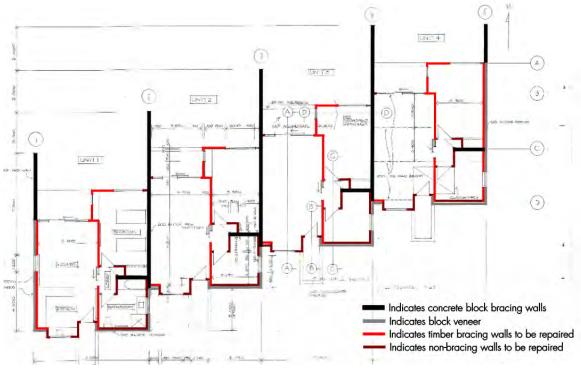
Figure 4-2: Extent of Timber Frame Wall Repairs

The interior wall linings to the timber framed bracing walls have been damaged in locations and require repair. Based upon the movement observed it is believed the wall lining fixings have been damaged throughout. This has resulted in a reduction to the ongoing strength and stiffness of all the bracing walls.

In order to reinstate the pre-earthquake strength and stiffness to the bracing walls, the repair recommendation at these walls is to remove all cracked or damaged sections of the wall linings and replace them with new gypsum board sheathing. The new gypsum board sheathing is to be fixed in accordance with GIB 'ezybrace' GS2-N specifications (or equivalent). A new finish is then to be applied to all interior walls.

All repairs to wall bracing are to be completed after any re-levelling to the building has been completed.

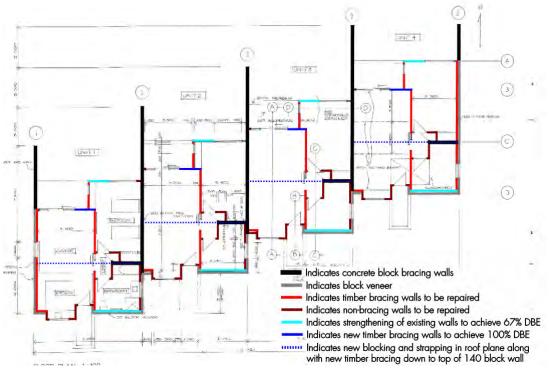
Figure 5-1: Recommended Strengthening

Upon completion of the repairs the assessed capacity of the building will still be below 33% DBE, and therefore still considered 'Earthquake Prone'. The Christchurch City Council Earthquake Prone Building Policy requires that applications for Building Consents, for repairs, ensure structural strength. The policy also requires that earthquake prone buildings be strengthened to resist a target of 67% of the new code loads.

The proposed timber bracing wall locations to be strengthened have been included in Figure 5-2 below. The new linings proposed are to be plywood based upon the lateral load resisting capacity required and are to be fixed as per 'Ecoply' recommendations. These linings will likely be required to be applied on the exterior face of the building due to the presence of plumbing on the interior face of the southern wall recommended to be strengthened. On the north side of the building the internal wall linings are to be repaired as per the recommendations in Section 4.3. Additional fixings down to the foundations will be required in conjunction with the new wall linings. This includes the addition of hold-downs at either end of the bracing walls to be strengthened.

Additional strengthening to achieve 100% DBE could be achieved by extending the existing timber framed wall on the north side of the building, noted in Figure 5-1. This would require the removal of a window adjacent to the existing sliding glass door.
