RE Official Information Act (the "Act") request CDHB 9833

DETAILED SEISMIC ASSESSMENT REPORT

CHRISTCHURCH HOSPITAL

Detailed Seismic Assessment Update Riverside Central Building

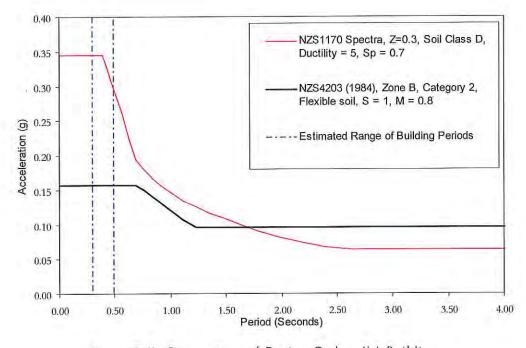
Figure 2-7: Comparison of Design Codes, IL4 Building

A comparison of the load levels for the Parkside Buildings represented by NZS4203:1984 and the current loadings standard, NZS1170.5:2004 [8], incorporating the recent increase in seismicity for Christchurch, is plotted in Figure 2-7.

The comparison assumes the buildings were detailed for a high level of ductility. The buildings have fundamental periods between 0.3 and 0.5 seconds, therefore, the comparison of design codes indicates that the Parkside buildings should have the capacity to resist between 45 and 55% of the current Design Basis Earthquake (DBE) loads.

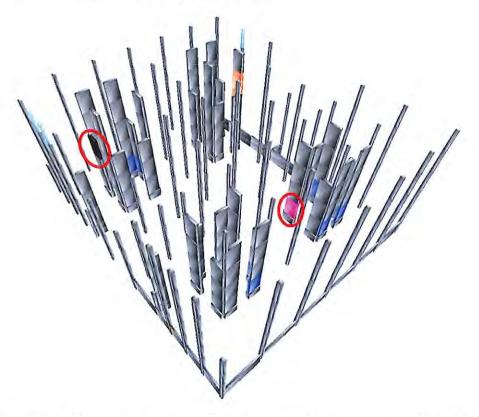
Figure 2-9: Elements that exceed Collapse Limit State capacity at 89 % DBE (IL4) - View from North-east Corner (beams and floors not shown for clarity)

The Collapse Limit State is reached at around 89% DBE loads for an Importance Level 4 building. A screen shot of the NLTHA model indicating elements that have exceeded CLS limits is shown in Figure 2-9 (critical elements circled). There are two elements that exceed their CLS criteria,, one of these is a wall at Lower Ground Floor that exceeds flexural rotation limits (shaded pink and circled). The other element is a wall at level 1 that exceeds shear capacity in combination with having high axial loads (shaded black and circled). The elements shaded orange and pale blue are ones that are likely to sustain some damage, but are not considered critical to the stability of the structure. It can be seen that several other core walls have elements shaded purple/dark blue between the Lower Ground and Ground Floor levels; this means they have exceeded their ULS limits but not yet their CLS limit.

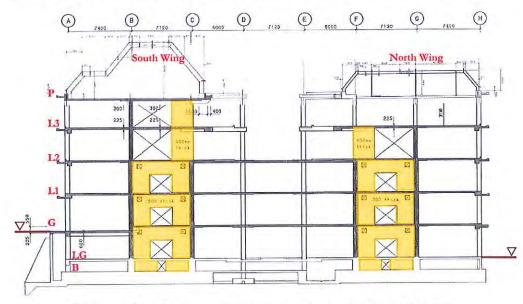
Figure 2-13: Section looking west through Parkside Block A

As noted above, and can be seen in Figure 2-12, the building drifts are significantly higher above Level 2. This is because there is a change in the structural system above this level. Between the Basement and Level 2 the lateral loads are primarily resisted by core walls connected by beams, above Level 2 the number of walls halve and there are not linking beams between them. A cross-section through Block A indicating this discontinuity in structure up the building and the differences between the north and south wings can be seen in Figure 2-13.

The NLTHA also indicates that the drifts at Level 3 of the south wing are higher than the north wing. This is because the Plant Level of the south wing is concrete, and heavier than the plant level of the north wing which is light-weight. This additional concrete level results in additional load on the southern half of the building; however, there is no increase in structure to account for this.

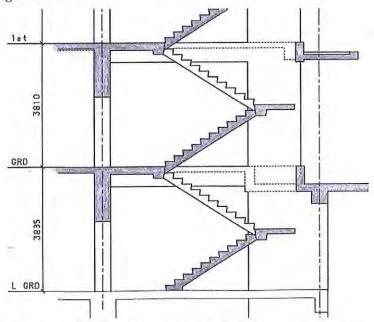
Figure 2-14: Section through typical reinforced concrete stair

The stairs are constructed of reinforced concrete; they zigzag between each floor level and, prior to the Canterbury Earthquakes, they did not have a mid height landing support. The stairs flights acted as tension/compression struts to support themselves under gravity loads. The stairs were rigidly connected floor to floor and because of this they were damaged as the building moved in the recent earthquakes.

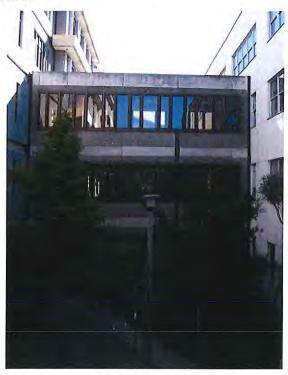
Figure 2-18: Photo of east side of Link Bridge out from Block B (Clinical Services on right)

The link bridges to Clinical Services extend out from Blocks A and B. Lateral loads are resisted using a combination of the concrete floor slab with drilled and epoxied starters and bolted steel beams on the east and west faces of the link bridges. Figure 2-18 shows the link bridge that extends out from Block B.

The capacities of the link bridges to cantilever horizontally from the Parkside Blocks are given in Table 2-4. The higher levels have lower capacities due to the increase in demand up the height of the building. The capacity of Level 2 governs both bridges and makes them considered Earthquake Prone.

As discussed in Section 2.2.11, pounding of the link bridges with the adjacent Clinical Services Building is likely to occur at 72 % DBE loading. This may compromise the lateral resisting system of the Link Bridges and as such the capacity at the onset of pounding is divided by a margin of safety of 1.8. This results in a capacity of only 40 % DBE (or 48 % DBE if divided by 1.5).

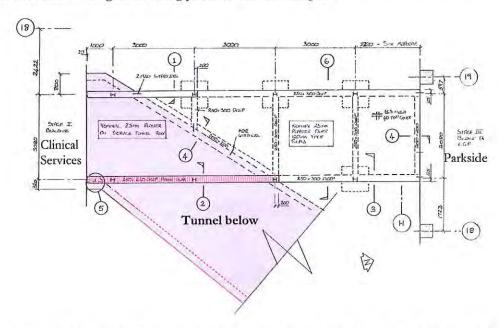
Figure 2-19: Lower Ground Floor Plan of Link B indicating location of tunnel below

The Lower Ground level of the Block B link sits on top of a service tunnel (see Figure 2-19). Because of this, several of the link columns are not supported by concrete pads (which are typical), but instead are supported by the tunnel, and the reinforced concrete up-stand beams that span over the tunnel. Review of these beams indicates that the east beam has insufficient capacity to resist the maximum design gravity load case. The capacity has been estimated as 85 % of current design loads using probable material strengths.

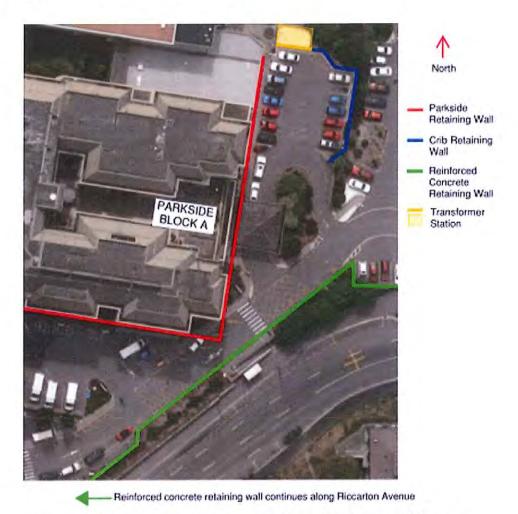
Figure 2-21: Retaining Walls around Christchurch Hospital Campus

There are several other retaining walls around the site, that are not specifically connected to the Parkside building nor support the building itself. However, these walls do affect the functionality of the area surrounding the Parkside buildings. As such, they have been included in this assessment, and are shown in Figure 2-21 below.

The analysis of all the retaining walls showed that the concrete Crib retaining wall to the east of Block A (shown in Blue in Figure 2-21), retaining the Emergency Department car park, has the capacity to resist approximately 45% DBE of IL2 level loads. The driveway retaining wall (shown in Green in Figure 2-21) is of lower height than the crib retaining wall and is constructed of reinforced concrete. These walls are doubly reinforced concrete cantilever walls of similar construction to the Parkside retaining walls as they were built about the same time. Analysis shows that these walls have the capacity to resist 70% DBE loads at IL2 level.

A small transformer station has been constructed to the north-west of the crib retaining walls (shown in yellow in Figure 2-21). The existing crib retaining wall was removed in this location to construct the transformer station. HCG have acquired copies of the original drawings for the transformer room and are currently assessing its lateral capacity and the capacity of the retaining walls. A separate report will be issued on the capacity of the transformer.

Potential strengthening of the crib walls has been considered and involves horizontal ties installed to the crib wall and back under the carpark behind. In addition, a reinforced concrete skin is proposed to be installed to the face of the crib wall. The extent of strengthening requirements depends on the level to which the crib wall is desired to be strengthened, which could differ from the strengthening level for the Parkside buildings.

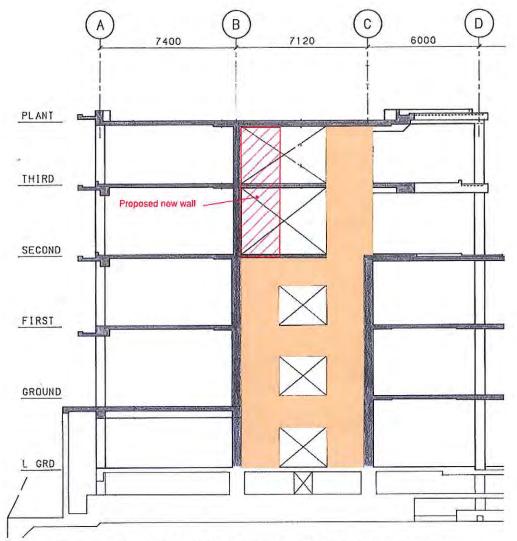
Figure 5-1: Typical Shear Wall Layout with Proposed New Wall.

From Level 2 and above the wall layout of the shear cores typically reduces from two walls coupled together on each face of the core to one cantilever wall on each face of the shear core, refer Figure 5-1 below. This reduces the stiffness of the building above Level 2 and increases the drifts expected in a scismic event. Currently the drifts at the roof level are predicted to be as high as 2.5% (the code limit) in specific locations. The increase in displacements due to the reduced stiffness above Level 2 can clearly be seen in Figure 5-2 below.

The development of the strengthening options for the stairs and precast cladding panels has shown that strengthening to 67% IL4 can not be readily achieved above Level 2 due to the large drifts above Level 2. As such the building is required to be strengthened and stiffened in all Blocks to reduce these drifts and allow the stair and precast cladding panel strengthening solutions to work. Several solutions for strengthening the building above Level 2 have been proposed to date, some have been investigated and found to not produce the required reduction in drifts required by the stairs and precast panels. The solution investigated and proposed herein involves adding a second cantilever concrete wall into each shear core wall above Level 2, as shown in red in Figure 5-1. A steel braced frame option instead of concrete walls could be considered during Developed Design. This strengthening is required for all Parkside Blocks but further analysis may determine that Block C does not require additional walls due to the fact that it does not have an additional concrete plant level above third floor.

Adding the new walls to each side of the shear core above Level 2 increases the stiffness of the building and reduces the displacements. Figure 5-3 shows the reduced displacements when the building is strengthened above Level 2 with new walls. As can be seen, the interstorey drift of the upper levels is now in line with the drifts of the lower levels.

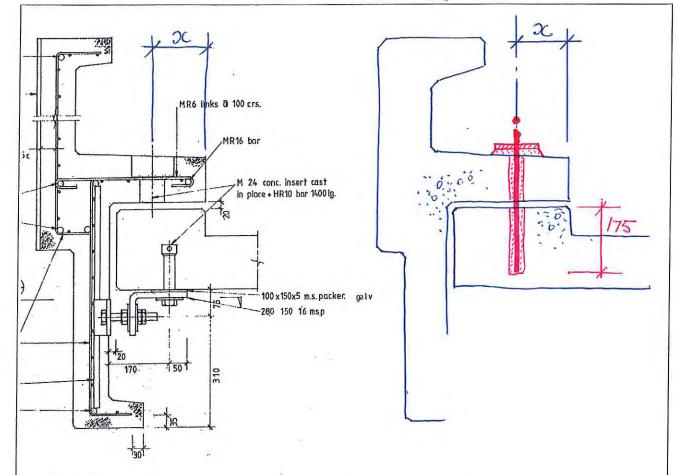
SKETCH # SK 102

Section
PANEL TYPE \$43 OR SIM EXISTING DETAIL @ PARAPET.

REMEDIAL FIXING TO BE APPLIED BESIDE DAMAGED FIXING.

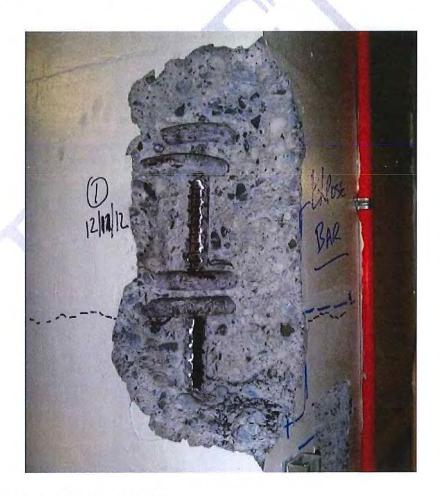
Figure 3 Test Location 109356-1

Maximum Potential Loss of Strain Capacity (% peak): 12-16

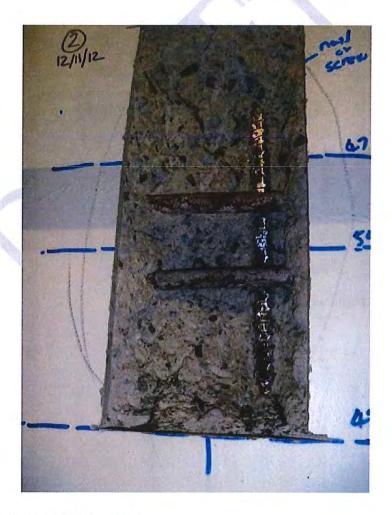
Figure 5 Test Location 109356-2

Maximum Potential Loss of Strain Capacity (% peak): 14-24

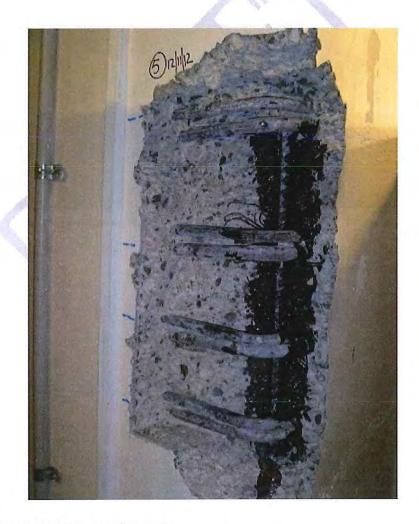
Figure 11 Test Location 109356-5

Maximum Potential Loss of Strain Capacity (% peak): 20-30

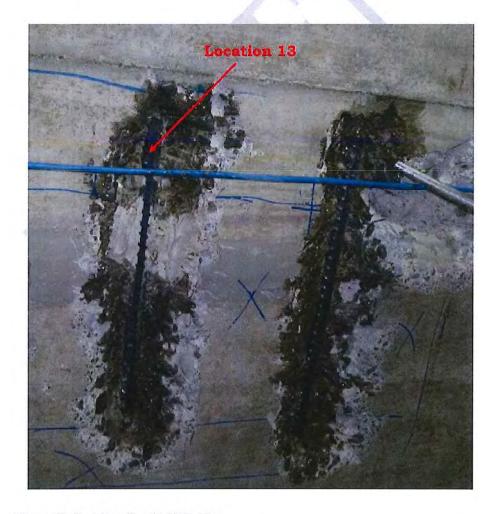
Figure 17 Test Location 109356-13

Maximum Potential Loss of Strain Capacity (% peak): 15-21

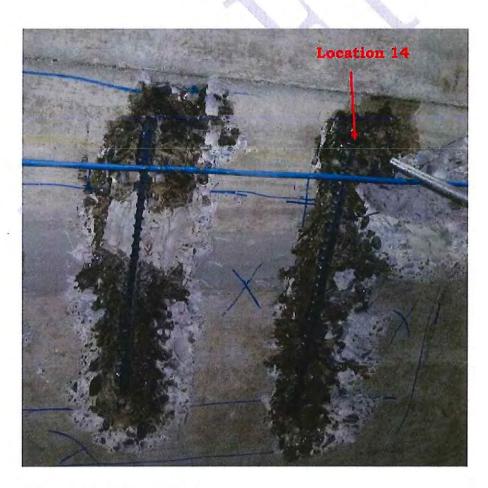
Figure 19 Test Location 109356-14

Bar was noted to have variable support conditions along the length of the bar resulting in increased scatter to the recorded results and less certainty in the derived results

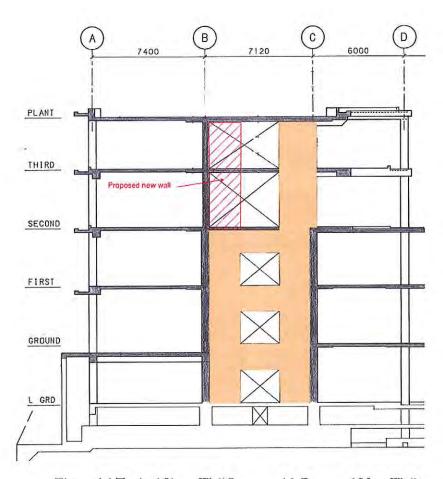
From Level 2 and above the wall layout of the shear cores typically reduces from two walls coupled together on each face of the core to one cantilever wall on each face of the shear core, refer Figure 1-1 below. This reduces the stiffness of the building above Level 2 and increases the drifts expected in a seismic event. Currently the drifts at the roof level are predicted to be as high as 2.5% (the code limit) in specific locations.

Figure 1-1: Typical Shear Wall Layout with Proposed New Wall.

The development of the strengthening options for the stairs and precast cladding panels has shown that strengthening to 67% II.4 can not be readily achieved above Level 2 due to the large drifts above Level 2. As such the building is required to be strengthened and stiffened to reduce these drifts and enable the stairs and precast cladding panels to be strengthened. Several solutions for strengthening the building above Level 2 have been proposed to date, some have been investigated and found to not produce the required reduction in drifts required by the stairs and precast panels. The solution investigated and proposed herein involves adding a second cantilever concrete wall into each shear core wall above Level 2, as shown in red in Figure 1-1. A steel braced frame option instead of concrete walls could be considered during Developed Design.

Adding the new walls to each face of the shear core above Level 2 increases the stiffness of the building and reduces the displacements to a level where the stair and panel strengthening solutions can accommodate the interstorey drift.

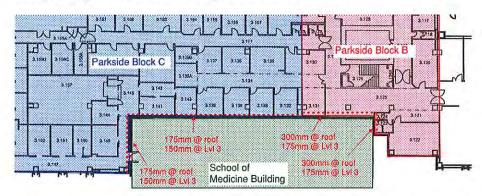
Figure 1-2: Seismic gap requirements between Parkside B&C and School of Medicine Building

To prevent the Parkside Buildings pounding with the School of Medicine Building at 67 % DBE loading the gap between the buildings needs to be increased at the Parkside Plant Room Level and Level 3. Figure 1-2 below shows the required seismic gaps if no strengthening of the Parkside buildings is undertaken.

If the Parkside buildings are strengthened the pounding is expected at approximately 62% IL4 DBE loading This reduces the requirements in Parkside B to approximately those of Parkside C. The reduction in seismic gap requirements to Parkside C is small and within the margin of error and safety factors already included in the calculations. These numbers are based on the analysis model of Parkside A extrapolated to the other Parkside Blocks. Specific analysis of Parkside C may show a reduction in the seismic gaps required.

along the north elevation of the building will be required to be removed. The easiest way to achieve the required seismic gap is to cut back the slab overhang in Parkside Blocks B & C. The main structural elements are set back from the edge of the building and hence cutting back the slab can be achieved without compromising the main structural elements of the building. The work will involve alterations to consulting rooms and corridors shown in Figure 1-2.

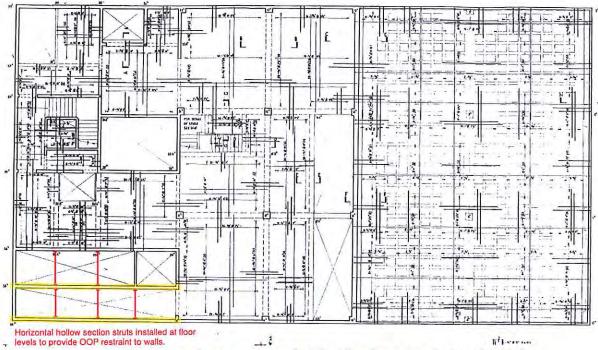
Figure 7: Typical floor plan showing proposed strengthening to upgrade out-of-plane deficiency to walls as highlighted

- Emptying water tanks at Level 7 or relocating to the basement or Lower Ground Floor of the structure. Current seismic performance is governed by the load carrying capacity of spandrel beams supporting the water tanks, and can be directly improved with a reduction in seismic mass and vertical load carried by the beams.
- Bracing of unrestrained perimeter wall panels. Walls around lift core and service riser are currently unrestrained over the high of the building and present an earthquake prone deficiency under face loading.

Proposed strengthening to unrestrained wall panels consists of a series of steel hollow section struts provided at floor levels to tie the walls back into the main floor slab diaphragm behind the lift core. Through site investigation we have confirmed both access and potential availability of space between lift shafts and risers. Further coordination will be required with services as the strengthening scheme is progressed.

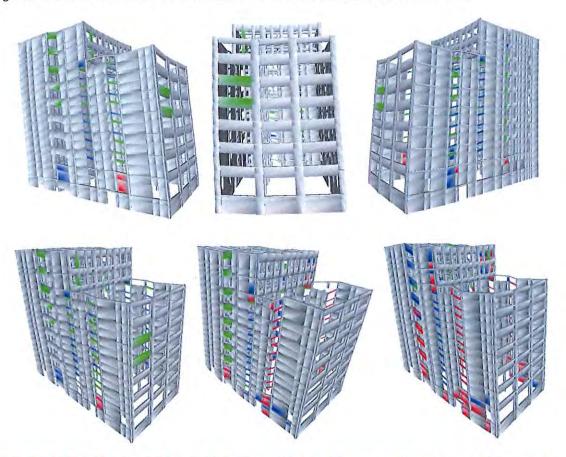
Figure 21: Graphics from a sample of records illustrating general mechanism of response.

Most elements remain within CP limits. Extensive hinging occurs in the north perimeter frame, and to the coupling beams of the east and west elevations. Localised areas of basement and lower ground wall undergo significant inelastic action.

The global modelled behaviour meets 85/1.80 = 45% NBS for MCE shaking (CP criteria).

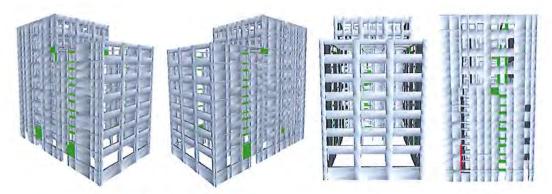
Figure 24: Element Damage State – 52% ULS Shaking for average response with primary components in X and Z direction respectively

All beams were within LS criteria for 52% ULS shaking (shown green in Figure 24).

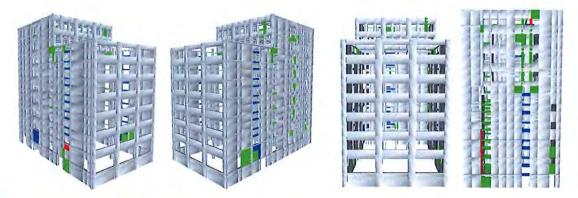
Figure 25: Element Damage State - 70% ULS Shaking for average response with primary components in X and Z direction respectively

Other than a small number of columns on the south elevation, the onset of IO limit exceedance begins at approximately 60% ULS shaking. All columns were generally within LS criteria in the 70% ULS runs (Figure 25). Beyond 70% ULS shaking we observed a disproportionate increase in inelastic demand resulting in strength degradation in the north elevation columns and potential loss of vertical load carrying capacity (Figure 26)

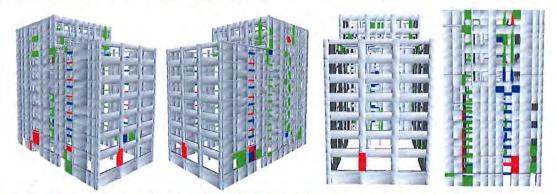
Figure 26: Element Damage State - 85% ULS Shaking for average response with primary components in X and Z directions respectively

At 85% ULS shaking (Figure 26), a significant number of perimeter coupling beams exceeded LS limits. This indicates damaged to the point that beam strength was significantly degraded. Observed coupling beam deficiencies are considered non-critical given that beam strengthen degradation will not be the sole contributor to global collapse of the structure.
