### RE Official information request CDHB 9881 and WCDHB 9161

## Condition Assessment of Hospital Buildings

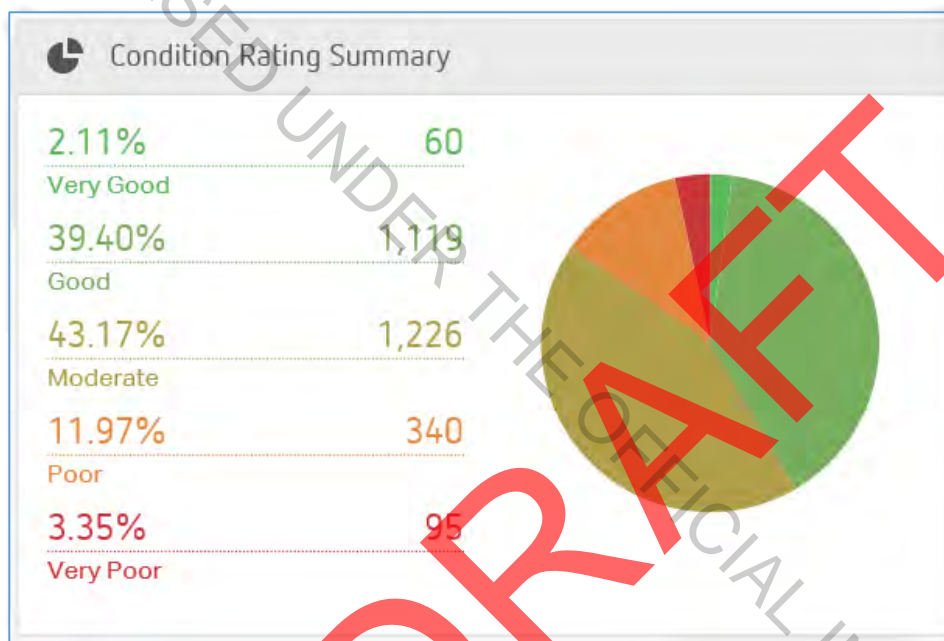
**Figure 2** Overall site Condition Summary

The overall average condition of all the assets surveyed is 2.8 out of 5.

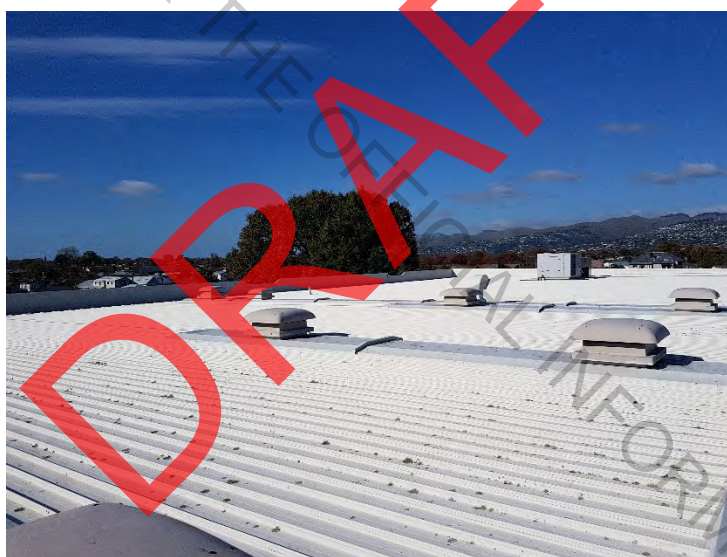
**Figure 5** Large flat roof area identified in the Laundry Services Building

During our site visit, we found there were multiple roof areas that could be substandard for snow loads, as shown in Figure 4. Of these buildings, we are particularly concerned about the roof in the laundry building (Figure 5) and the canopy structure in the pre-school, due to the large spans and relatively flat roofs. The canopy structure in the pre-school is likely to be unconsented and the large spans were observed to be significantly under designed. The buildings of concern include:

We recommended carrying out an assessment to check the capacity of these roofs as highlighted in Figure 4 due to the increase in snow loads, especially the laundry building and pre-school canopy structure.

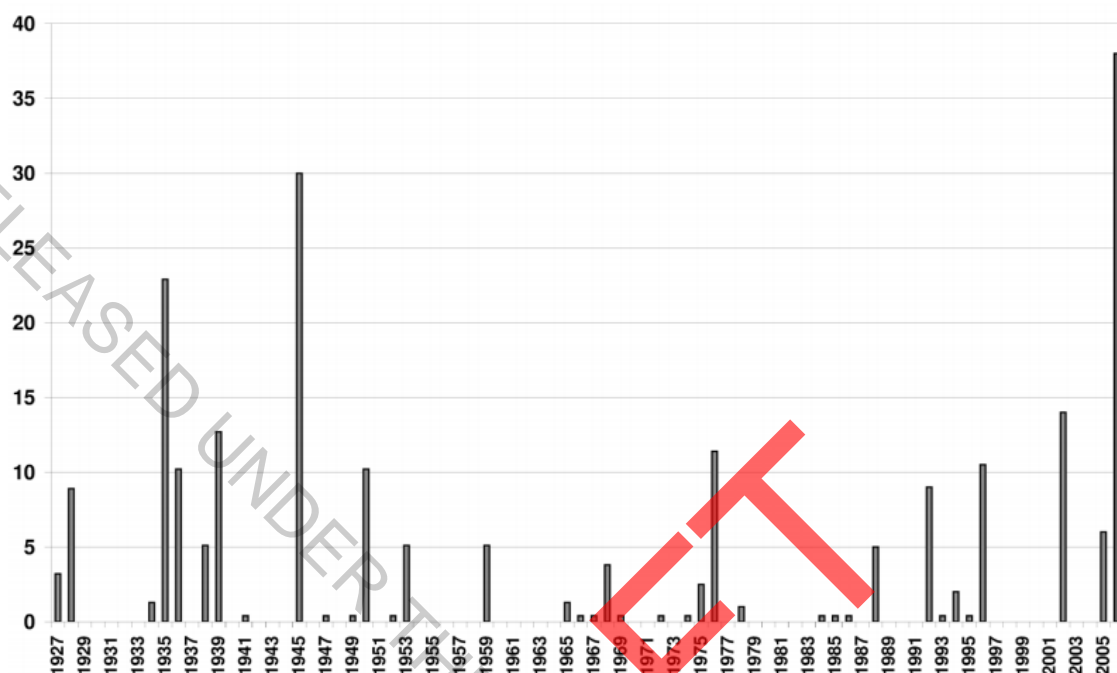
**Figure 6** Maximum observed annual snow depths for station H31971 in Ashburton for the period 1927-2006

A graph of snow depths in cm recorded in Ashburton is shown in Figure 6 below: -

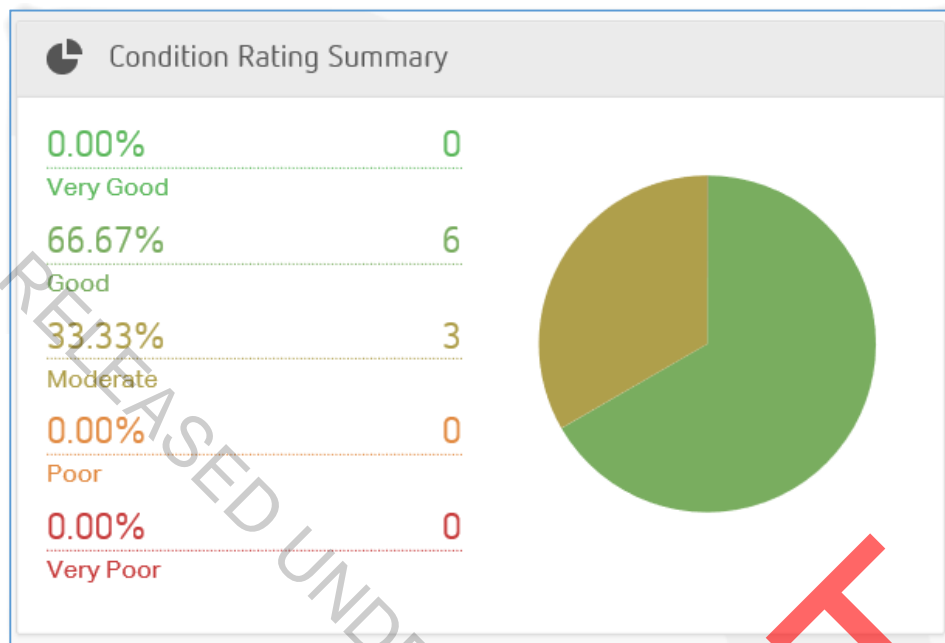
**Figure 20** Building 3 Condition of Mechanical Systems

Heating plant appears to be well-maintained with no apparent issues requiring immediate attention. The mechanical plant generally including the heat exchanger and calorifier are in the second half of their service life and will exhibit increasing maintenance costs over the next ten years. Pumps: heating water circulation, LTHW, calorifier circulation and domestic hot water circulation pumps appear to have been replaced more recently and should have more than ten years expected service life remaining.

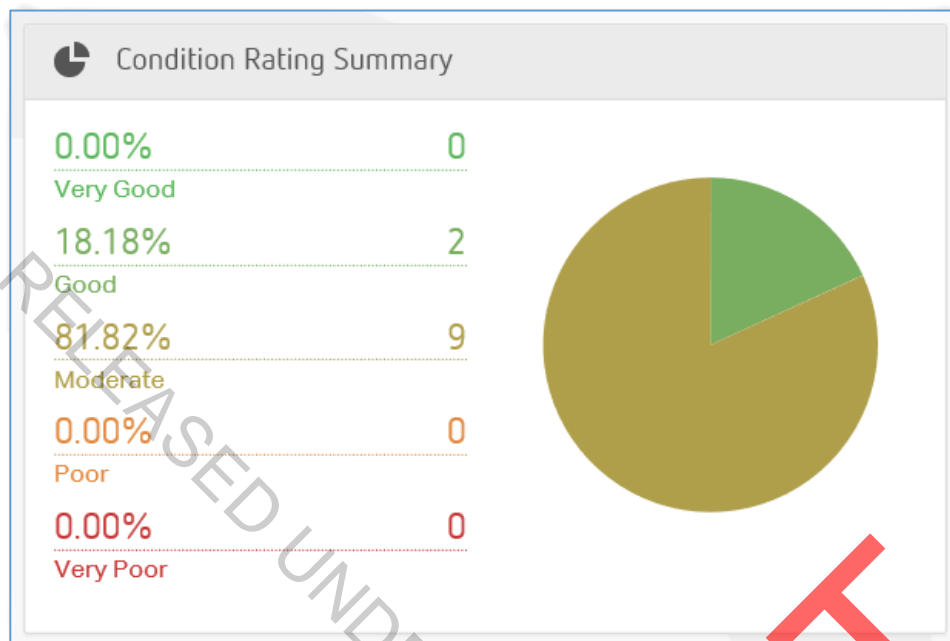
**Figure 26** Building 4 Condition of Mechanical Systems

The mechanical plant generally including the heat exchanger and calorifier are in the second half of their service life and will exhibit increasing maintenance costs over the next ten years. The mechanical control panel is original building equipment and should be replaced along with other electrical boards. The calorifier circulation pump and one mixing valve show signs of leakage and require maintenance attention.

Pumps: heating water circulation, LTHW, and domestic hot water circulation pumps appear to have been replaced more recently and should have more than ten years expected service life remaining.

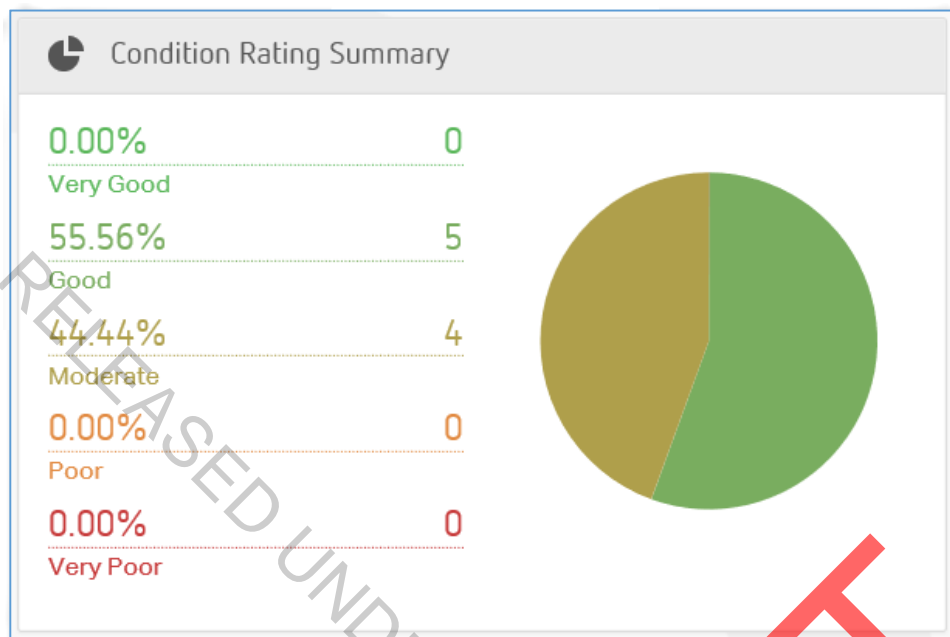
**Figure 31** Building 5 Condition of Mechanical Services

The mechanical plant generally including the heat exchanger and calorifier are in the second half of their service life and will exhibit increasing maintenance costs over the next ten years. The mechanical control panel is original building equipment and should be replaced along with other electrical boards.

Pumps: heating water circulation, LTHW, and domestic hot water circulation pumps appear to have been replaced more recently and should have more than ten years expected service life remaining.

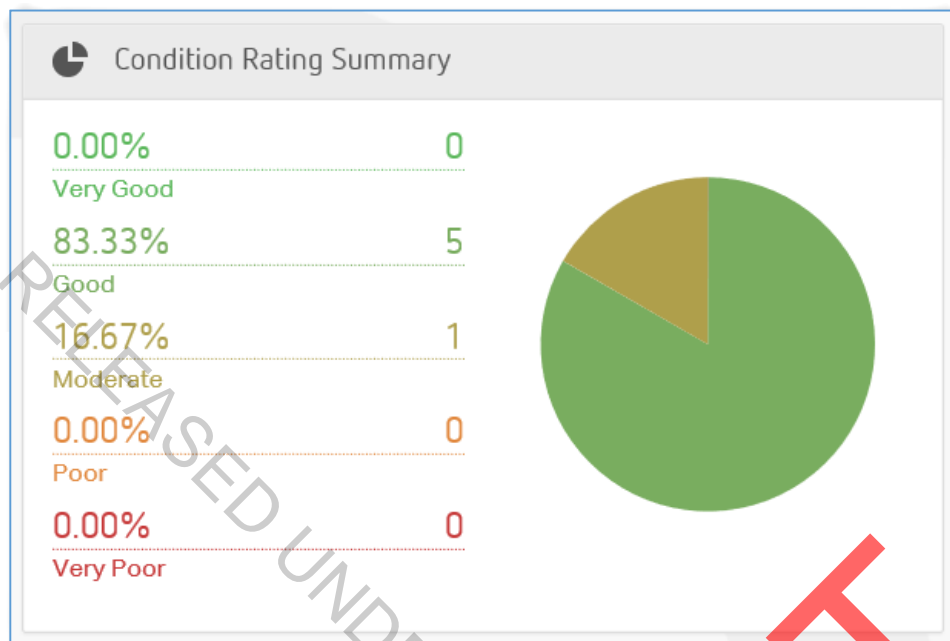
**Figure 36** Building 6 Condition of Mechanical Services

The mechanical plant generally including the heat exchanger, calorifier and the LTHW pump are in the second half of their service life and will exhibit increasing maintenance costs over the next ten years. The mechanical control panel is original building equipment and should be replaced along with other electrical boards.

The heating water circulation and domestic hot water circulation pumps appear to have been replaced recently and should have more than ten years expected service life remaining.

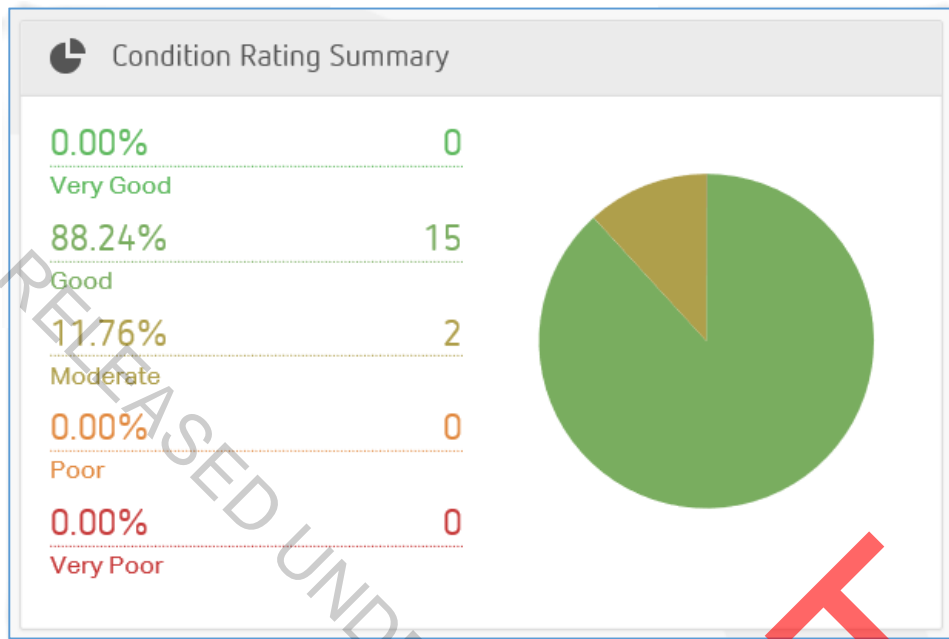
**Figure 41** Building 7 Condition of Mechanical Services

Heating is provided by two boilers. The Binder wood chip boiler is equipped with particulate emission controls to meet the resource consent particulate discharge requirements. The other Hoval boiler is LPG-fired. The energy centre also houses associated plant: pumps, expansion tanks, buffer tank.

The energy centre was refurbished with the installation of the wood chip boiler and has been in service approximately six years of an expected twenty year service life.

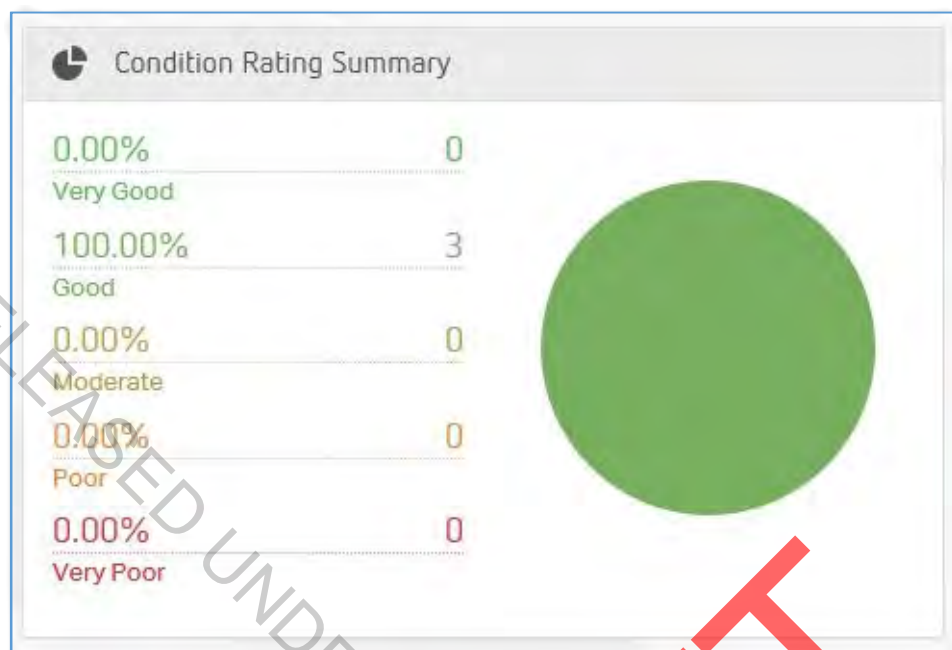
**Figure 42** Building 7 Condition of Electrical Services

The generator and the associated controls panel are in good condition.

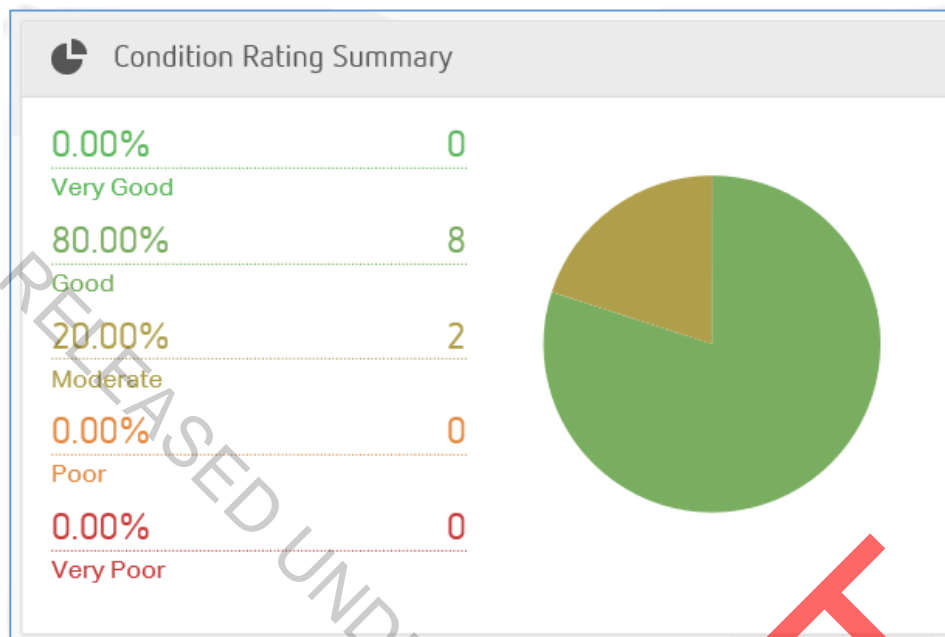
**Figure 46** Building 8 Condition of Mechanical Systems

The mechanical plant generally including the heat exchanger, and the calorifier are in the second half of their service life and will exhibit increasing maintenance costs over the next ten years. The mechanical control panel is original building equipment and should be replaced along with other electrical boards. One valve actuator has been removed and appears to require maintenance.

The pumps appear to have been replaced recently and should have more than ten years expected service life remaining.

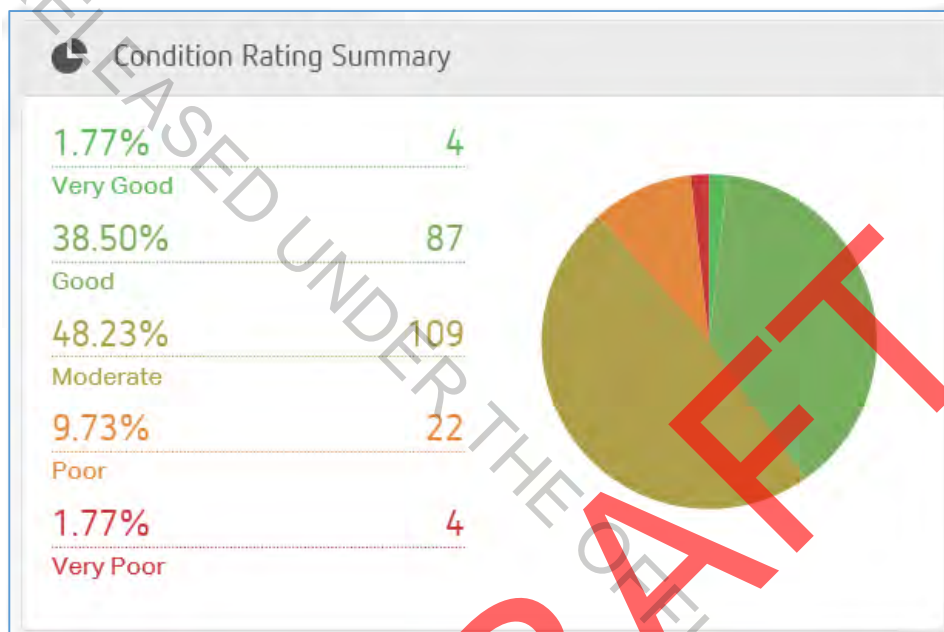
Figure 48 Building 9 Overall Condition

The overall condition of the building is rated at 2.9.

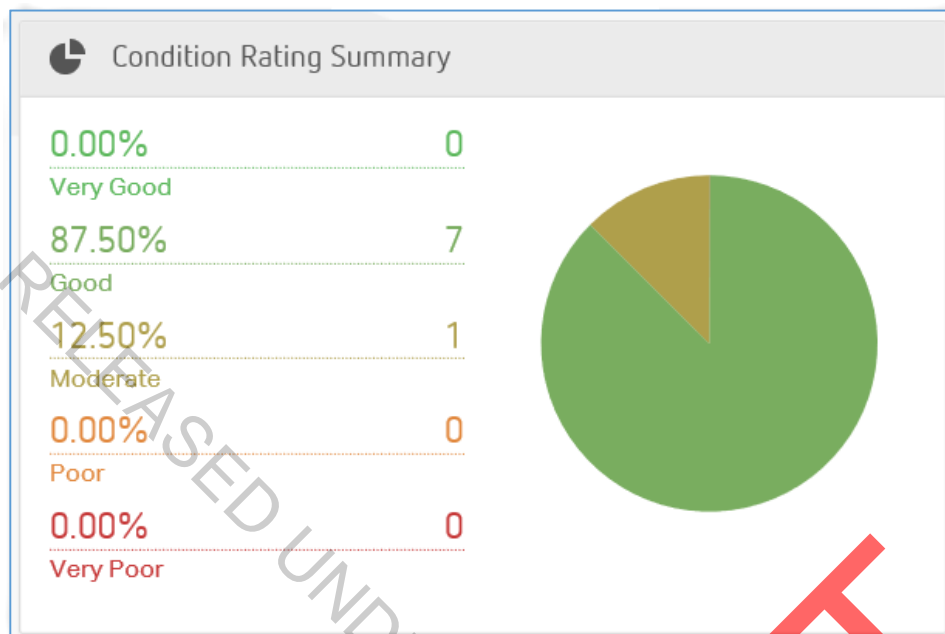
**Figure 51** Building 9 Condition of Mechanical Systems

The mechanical plant generally including the pumps and the heat exchanger are in the first half of their service life and should have more than ten years expected service life remaining.

The mechanical control panel is of an age that it should be replaced when other electrical work is scheduled for the building.

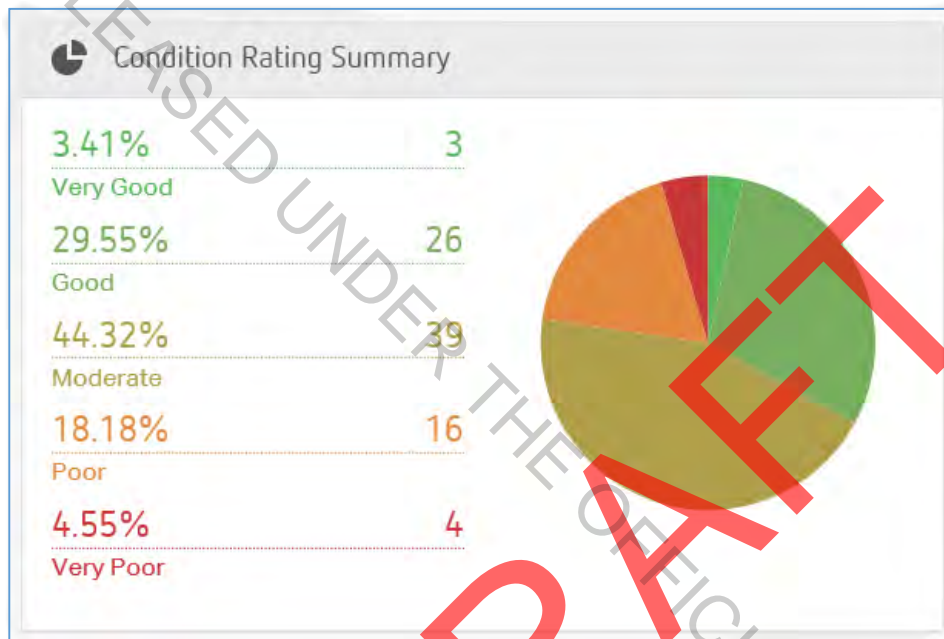
Figure 53 Building 10 Overall Condition

The overall condition of the building is rated at 2.7.

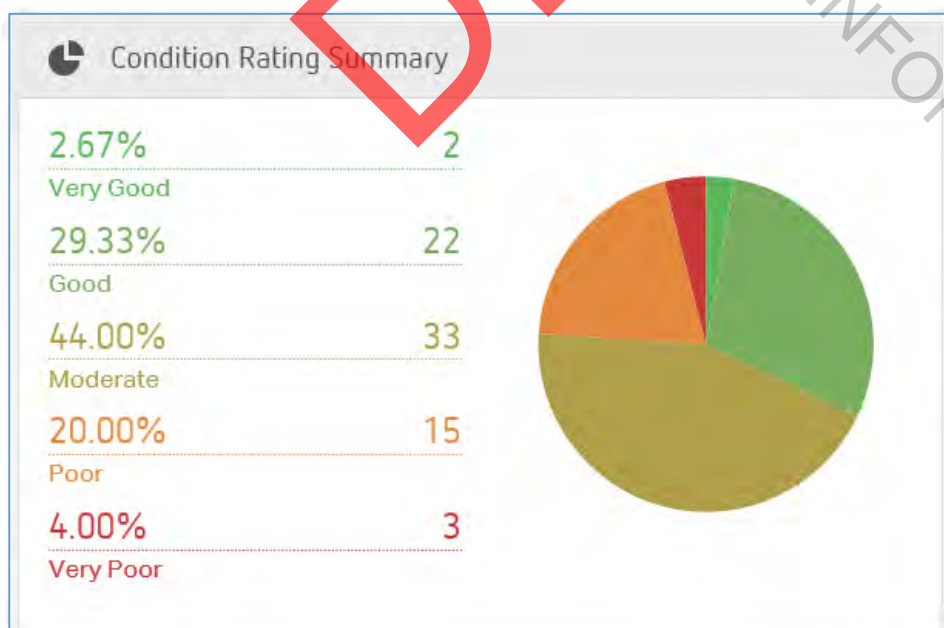
Figure 54 Building 10 Condition of Exterior Elevations

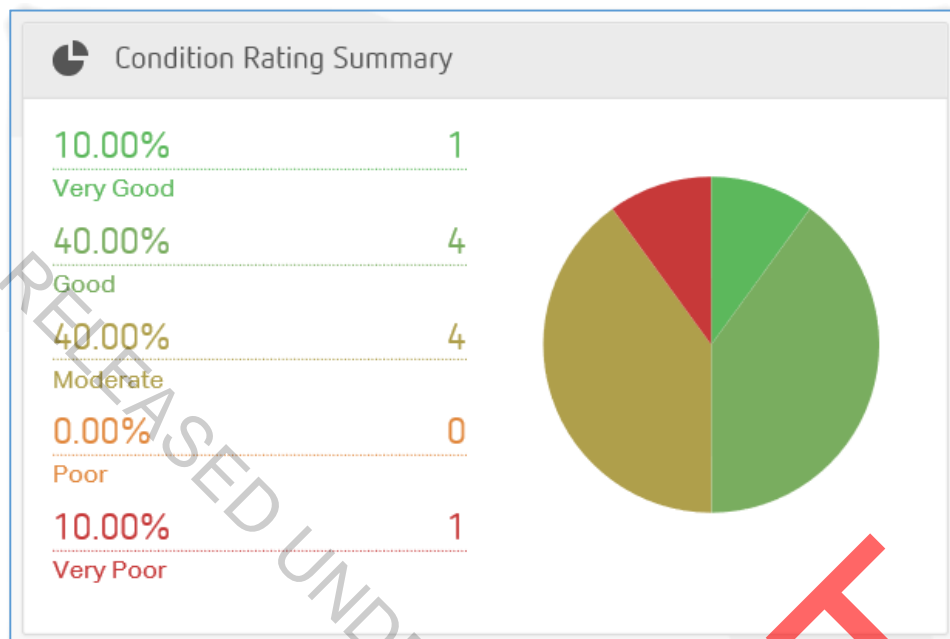
**Figure 55** Building 10 Condition of Roof

- Patio/Gardens blocking underfloor vents
- Some rot in timber windows
- Shade roof structure appears to be inadequately built
- Step cracks and failed pointing in brickwork, some displaced bricks
- Paint flaking off possible asbestos panels
- Deck boards failed

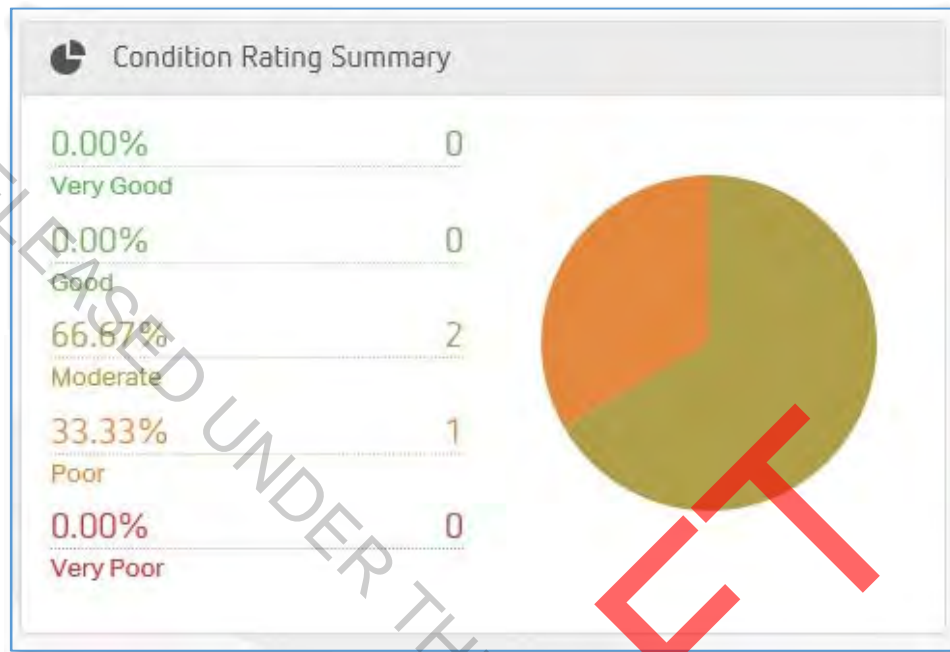
The main switchboard for Building 10 is situated in the Laundry. It consists of modern switchgear and equipment but is in moderate to poor condition. One half on the switchboard bi-fold doors is absent.

The distribution switchboard servicing the building consists of modern switchgear and equipment, which is in moderate condition.

**Figure 56** Building 10 Condition of Electrical Systems

The main switchboard and distribution switchboard be replaced in 10-15 years.

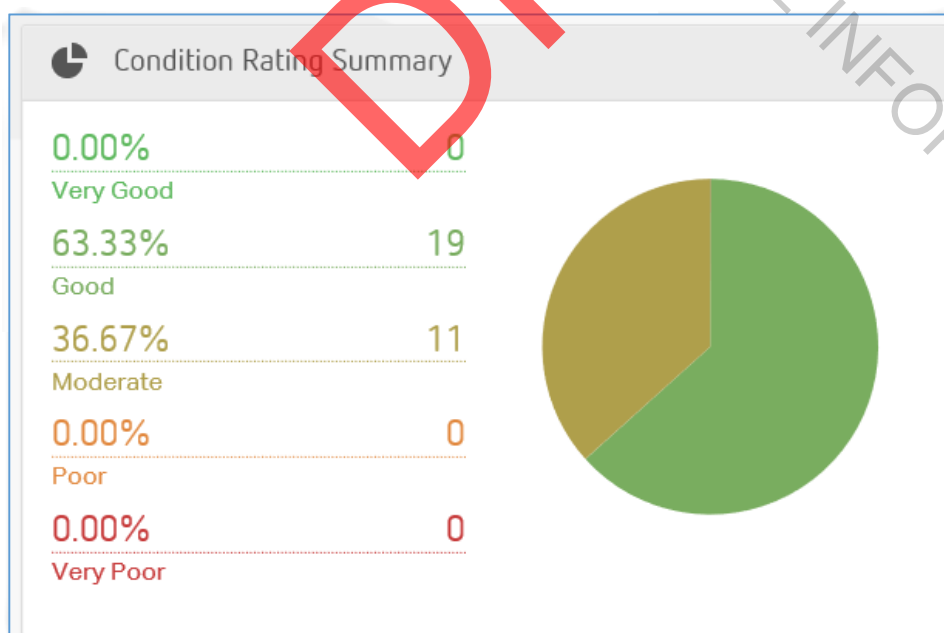
Figure 58 Building 13 Condition of Exterior Elevations

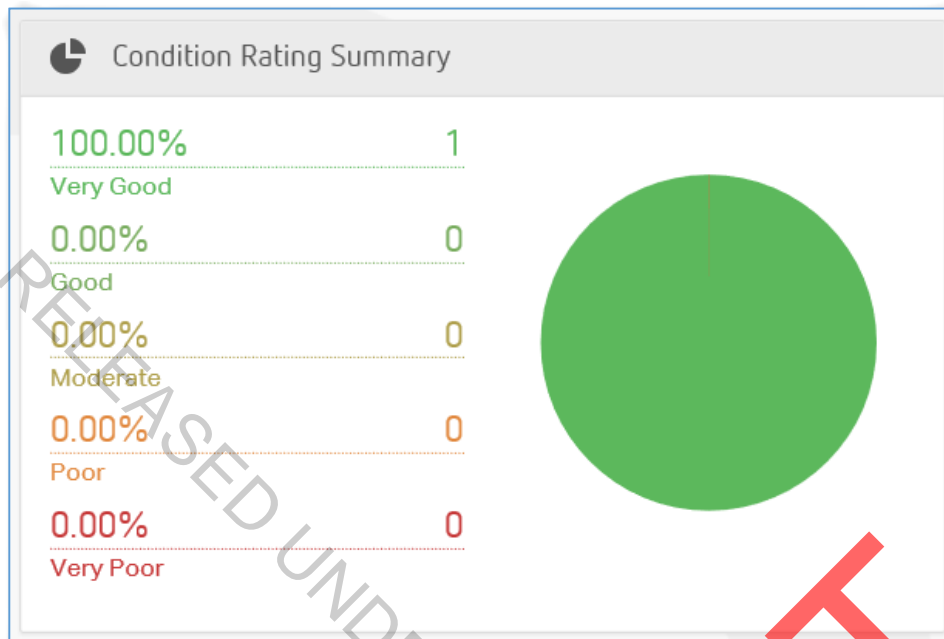
**Figure 59** Building 13 Condition of Roof

No specific deferred maintenance items were noted during the survey.

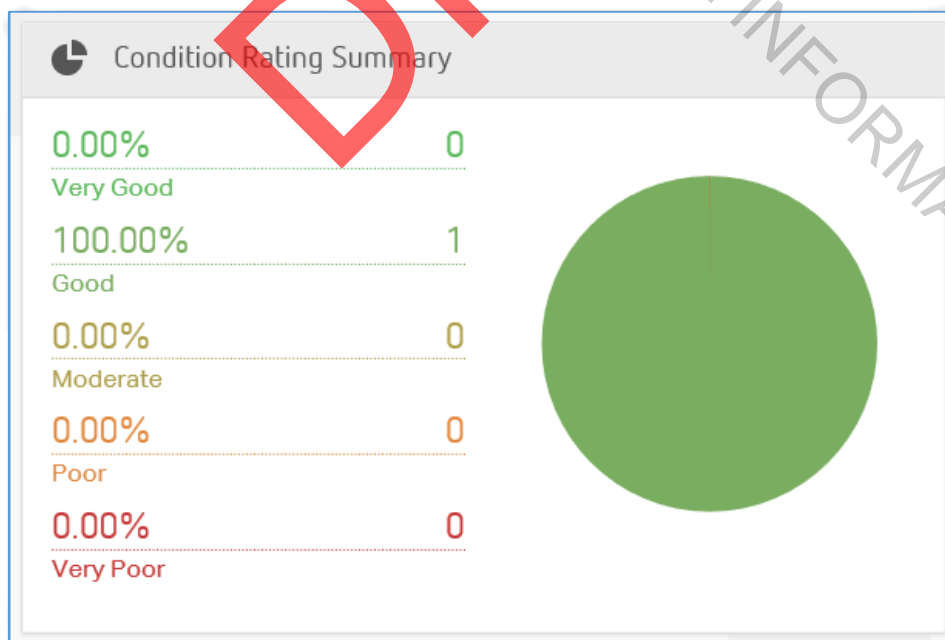
The heating plant for Building 13, Meeting Rooms 3 and 4 is provided by split system heat pumps with natural ventilation via opening windows.

**Figure 60** Building 13 Condition of Mechanical Systems

The split system heat pumps are in the second half of service life and should be monitored closely for deteriorating performance and replacement should be planned for within a five year time frame.

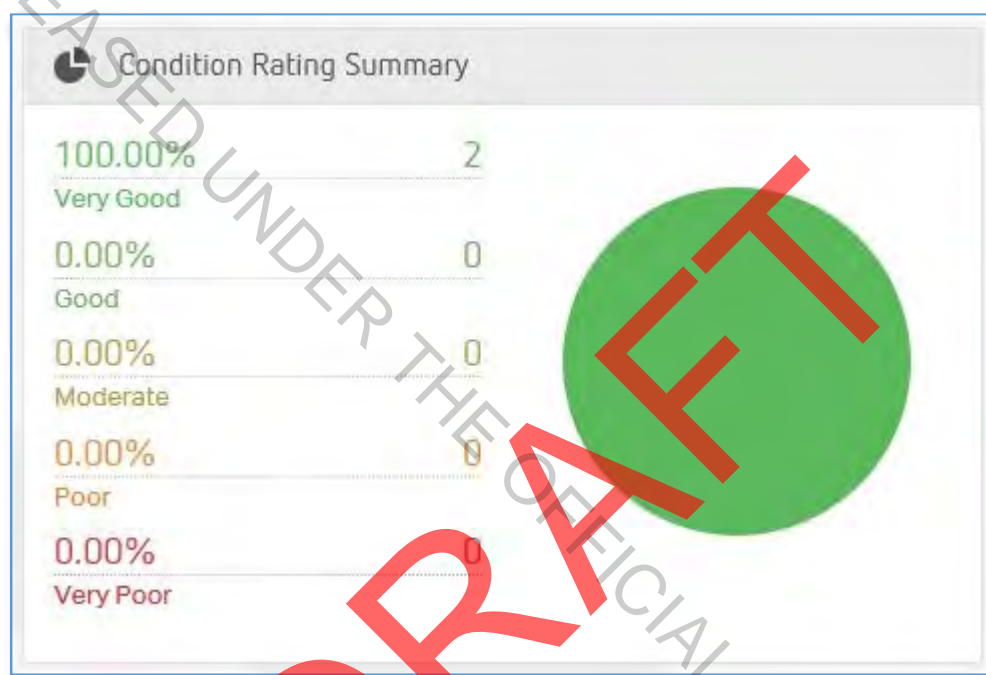
The distribution switchboards servicing Meeting Rooms 3 and 4 in building 13 are in good condition with modern switchgear and equipment.

**Figure 61** Building 13 Condition of Electrical Systems

The distribution switchboards be replaced in 15-20 years.

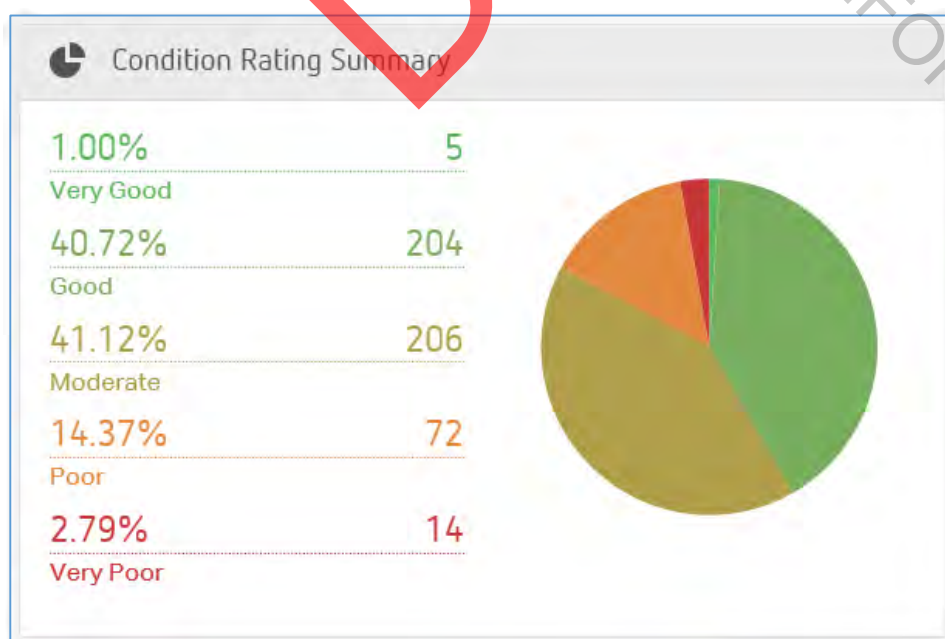
Figure 63 Building 10 Condition of Exterior Elevations

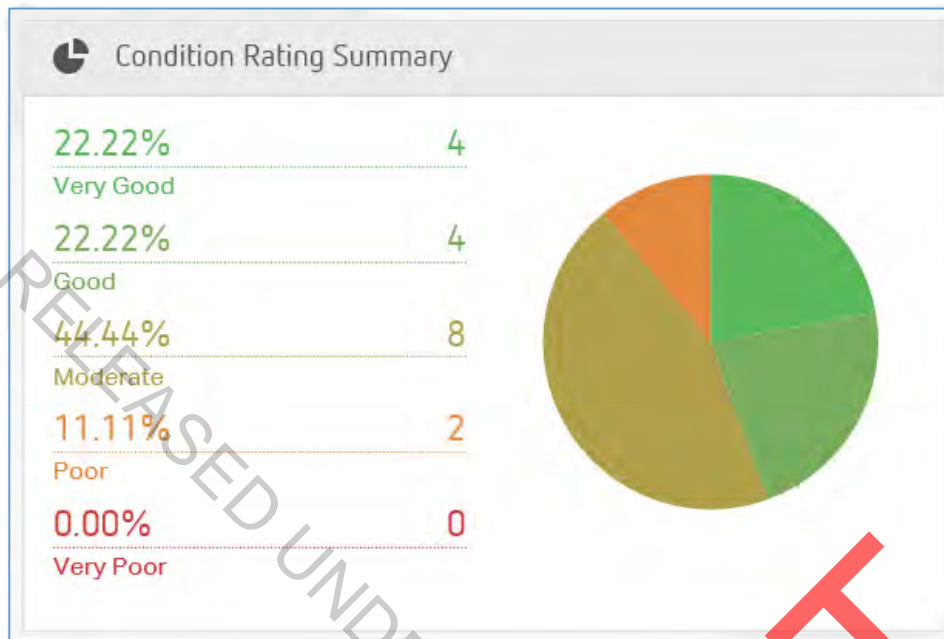
**Figure 64** Building 10 Condition of Roof

- Suspect roof sheeting rusting beneath ridge flashing
- Loose electrical cabling on roof
- Skylights deteriorated and leaking
- Gutters require cleaning
- Butanol patch repairs to roof evidence of roof leaks.
- Evidence of tree roots lifting pavers and subsidence
- Suspected asbestos cladding
- Dry rot noted in window cills
- Roof sheeting lifting
- Windows require repainting

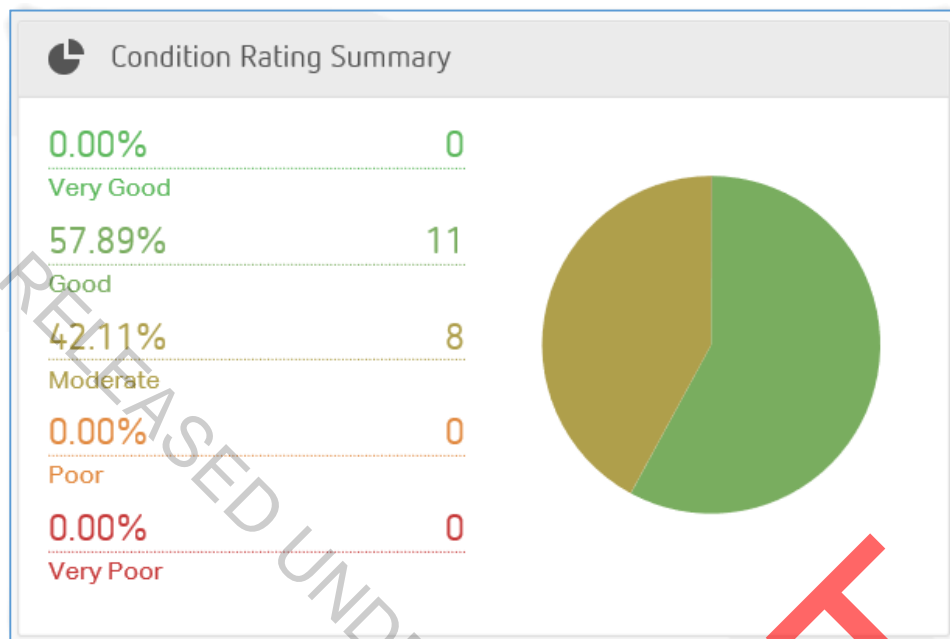
Site reticulated heating water is circulated through a plate heat exchanger to generate low temperature heating water for the building comfort heating and domestic hot water. Heating water is pumped to four heating zones throughout the building.

The mechanical heating plant is generally in good condition, much of it appearing to have been retrofitted recently and while the calorifiers are in the second half of their service life the remaining service life of the facility would be a minimum of ten years.

**Figure 65** Building 9 Condition of Mechanical Systems

The chiller, chilled water pumps and the air handling plant are at the end of their service life and should be monitored closely for deteriorating performance and replacement should be planned.

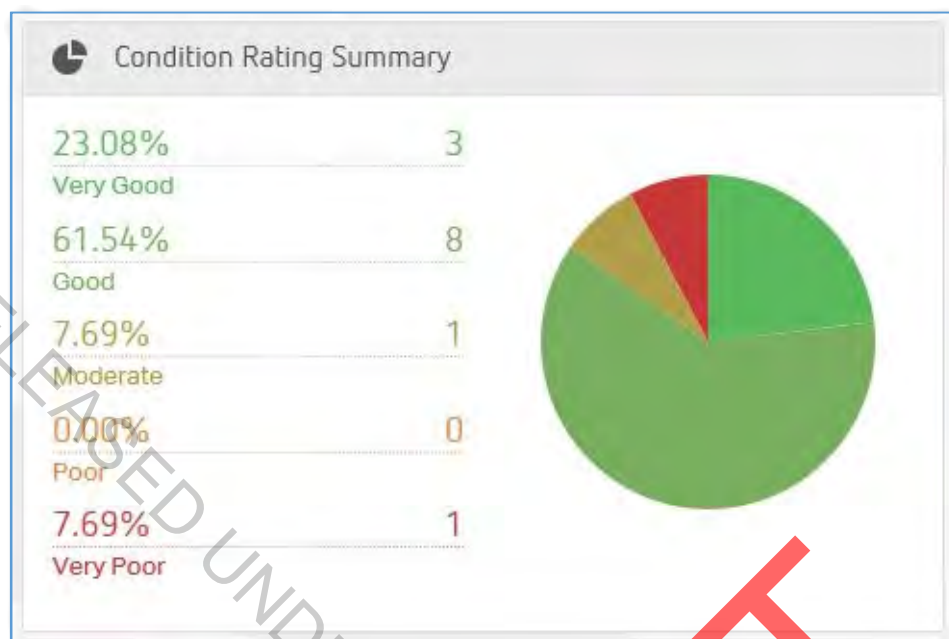
The main switchboard for Building 15 is situated in the Basement Plant Room. The board is in very good condition with modern switchgear and equipment.

The distribution switchboards and mechanical controls boards servicing Building 15 vary from very good to good condition with modern switchgear and equipment. The solitary exception is the mechanical controls board in Plant Room G010. The board is at the end of its' economic life and a replacement should be considered. A replacement also provides an opportunity to standardise the switchgear and equipment, which will be beneficial to the maintenance team when a replacement part or item is required. In addition, ageing switchgear and equipment are inefficient and potentially dangerous.

**Figure 66** Building 9 Condition of Electrical Systems

- The main switchboard and the distribution switchboards be replaced in 15-25 years.
- The mechanical controls board in Plant Room G010 be replaced within 5 years.

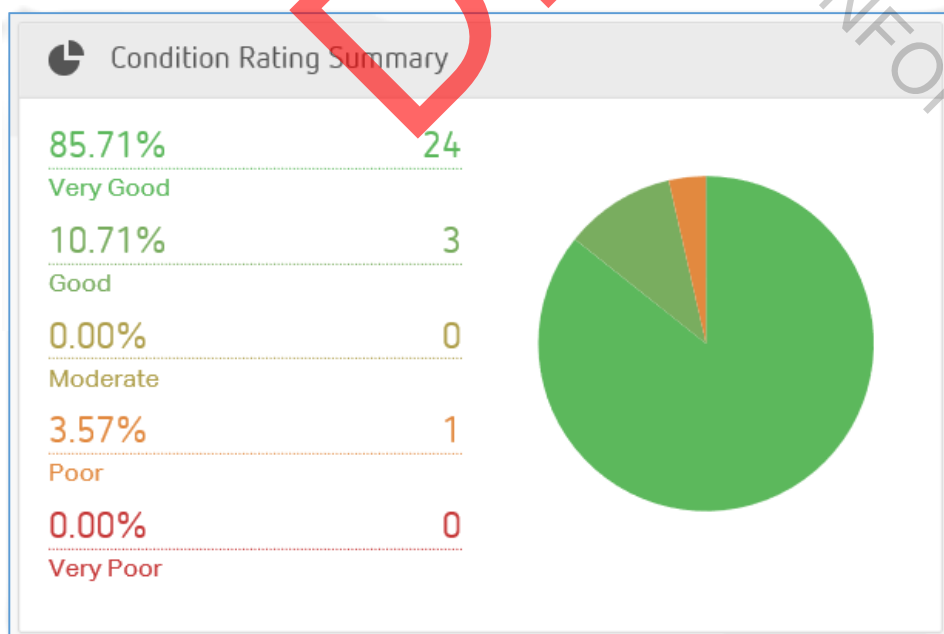
**Figure 68** Building 16 Condition of Exterior Elevations

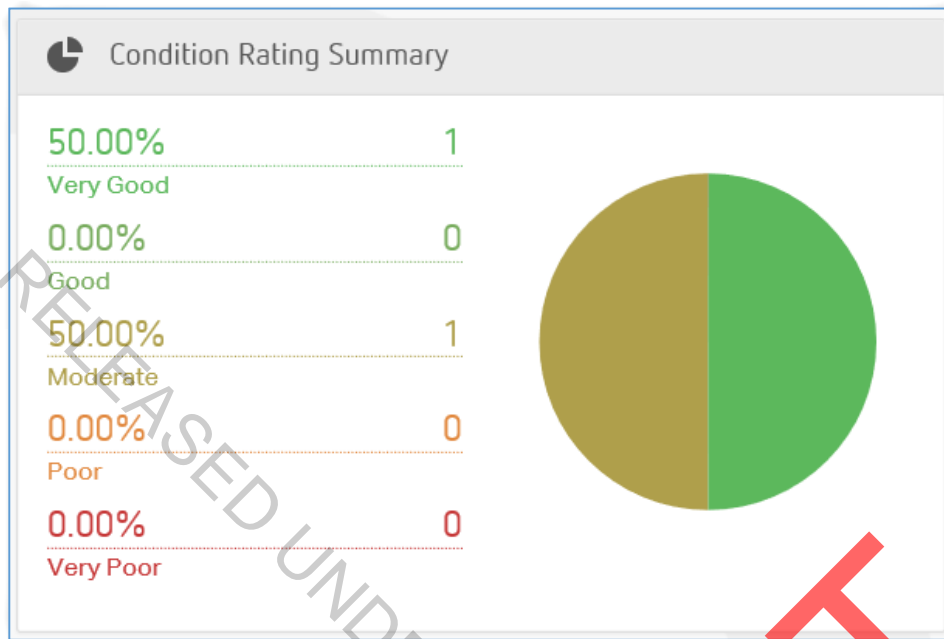
**Figure 69** Building 16 Condition of Roof

- Failure of sealants on cladding
- Damage to barge boards

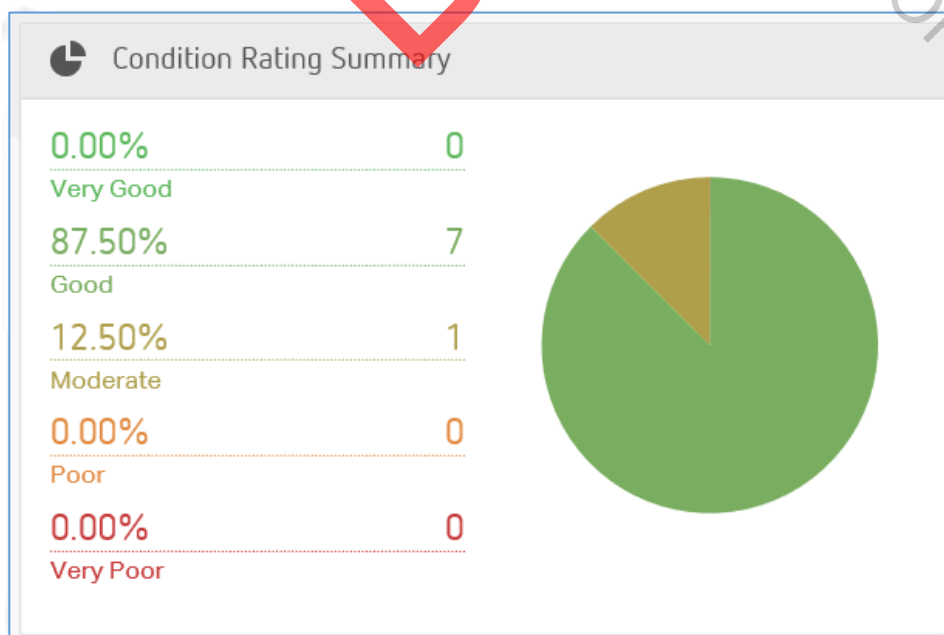
The heating plant for Building 16 is provided by split system heat pumps with natural ventilation via opening windows with some spaces extracted.

**Figure 70** Building 16 Condition of Mechanical Systems

The split system heat pumps are in the second half of service life and should be monitored closely for deteriorating performance and replacement should be planned for within a five year time frame.

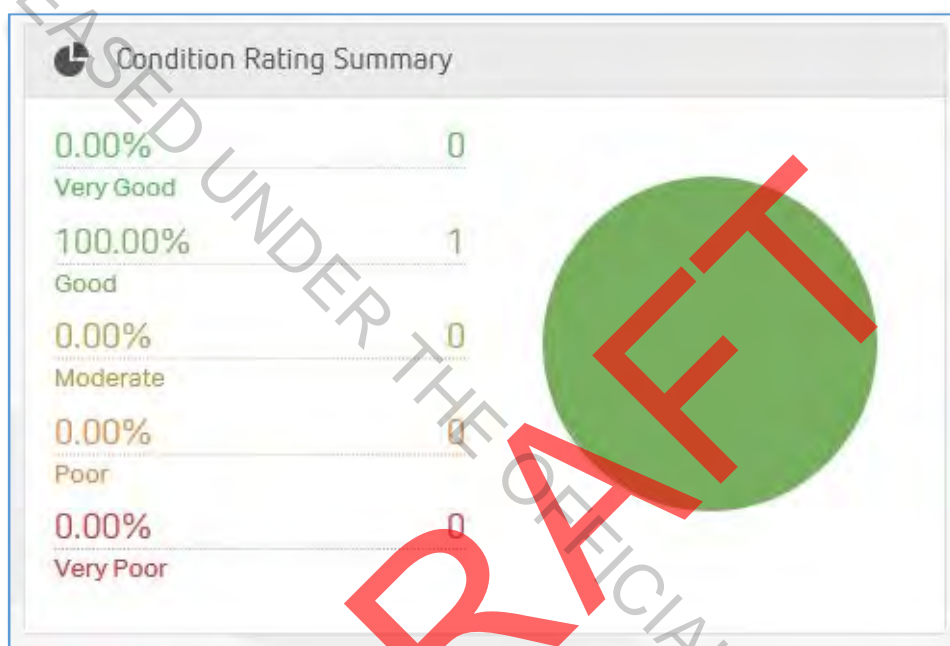
The main switchboard for Building 16 is situated in the Plant Room. It is in good condition with modern switchgear and equipment.

**Figure 71** Building 16 Condition of Electrical Systems

The main switchboard be replaced in 15-20 years.

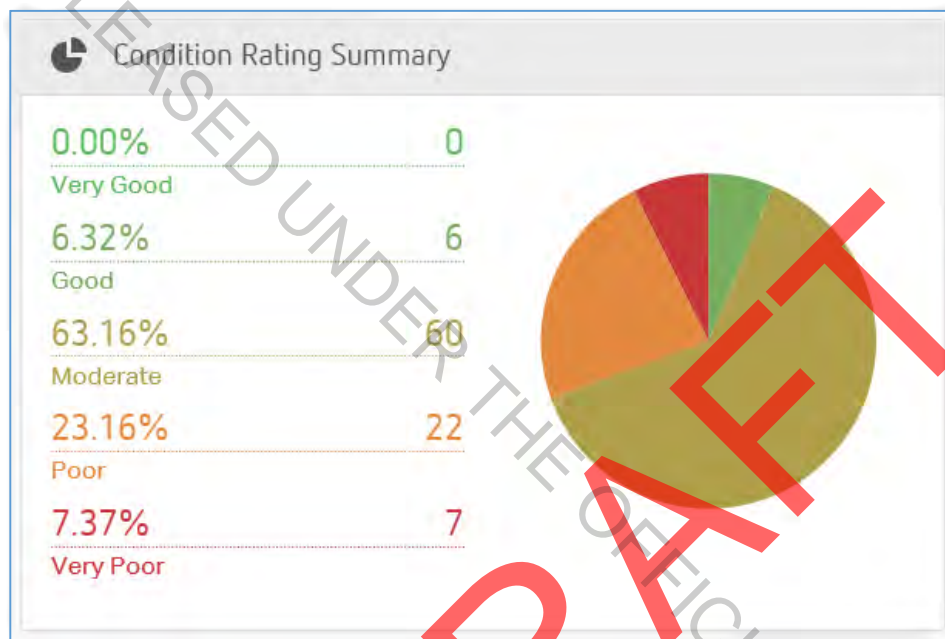
The overall condition of the building is rated at 3.2.

Figure 72 Building 21 Overall Building Condition

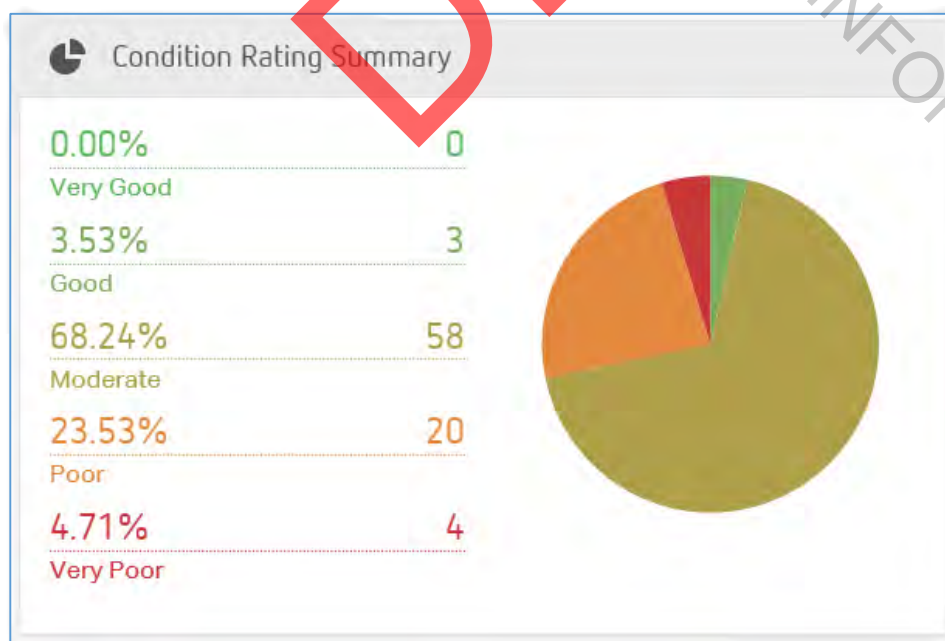
Figure 73 Building 21 Condition of Exterior Elevations

- Heavy build-up of tree debris next to building
- Cladding paint peeling
- Downpipes in poor condition
- Cracks noted in soffits
- Rot in timber flashings around windows

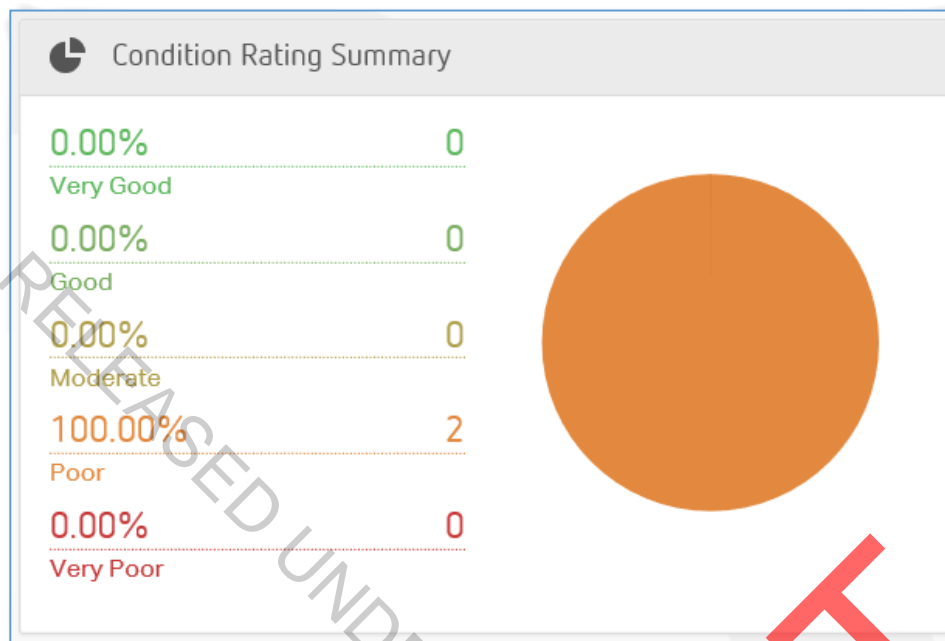
**Figure 74** Building 21 Condition of Roof

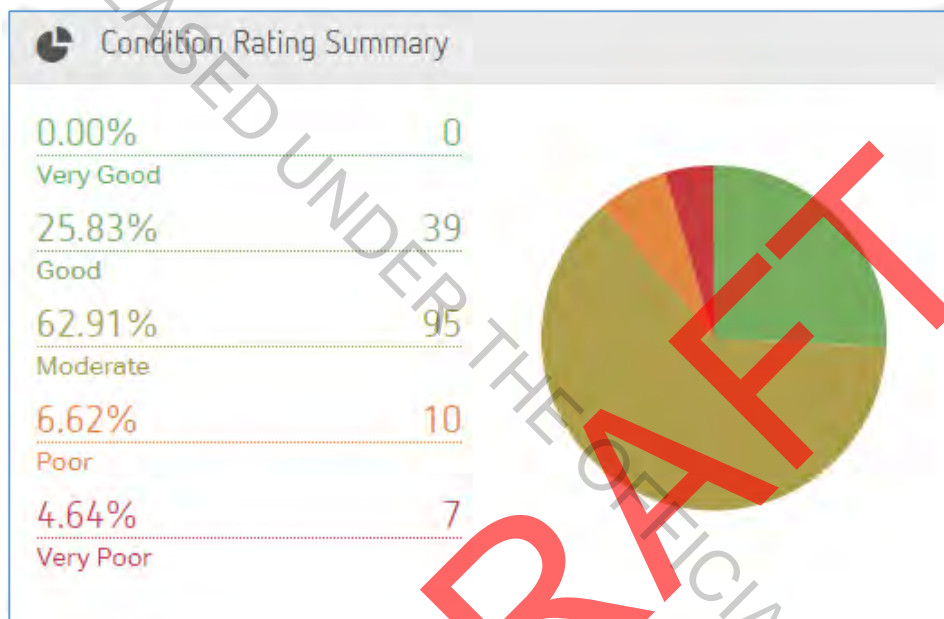
The building was constructed in 1985. The building is timber framed with a concrete block veneer, with stained horizontal timber weather boards above the aluminium joinery. The roof is clad with concrete tile, draining to steel spouting and downpipes. A Portacom style extension was added between 2000 and 2004 with a further extension added between 2005 and 2009. Generally, the original building is in better condition than the Portacom additions. The overall building condition is rated at 2.8.

**Figure 77** Building 22- overall condition

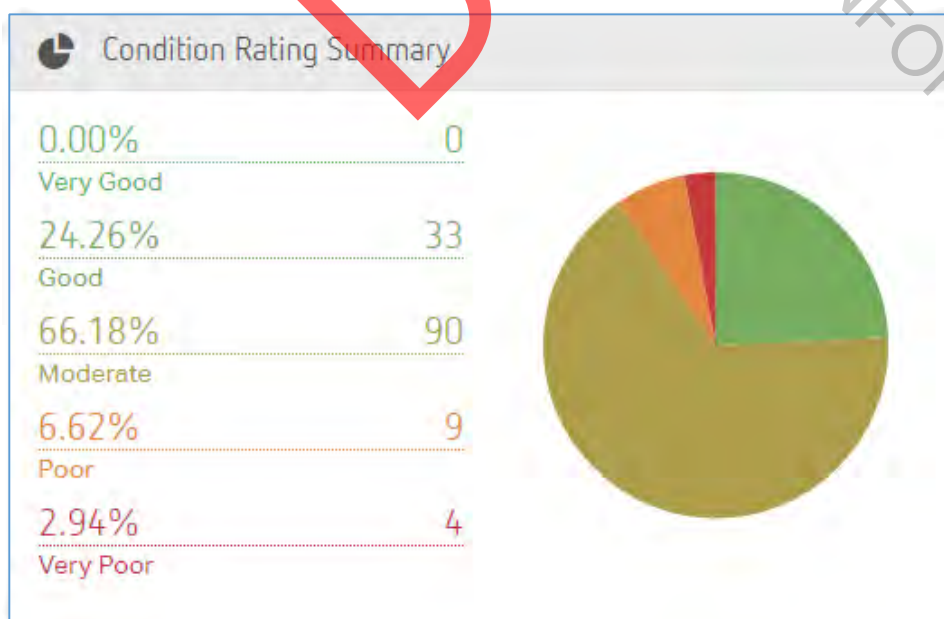
**Figure 78** Building 22- condition of Exterior Elevations

- Ceramic tiles are coming away from the substrate. Investigate cause and repair.
- Door is cracked at hinges. Replace door.
- Repair required to mortar to concrete block

- An overflow pipe that exits near the base of the wall is discharging a steady stream of water. Find cause and remediate.
- Doors to external storage area are heavily cracked and should be replaced.
