### RE Official information request CDHB 9881 and WCDHB 9161

## Condition Assessment of Hospital Buildings

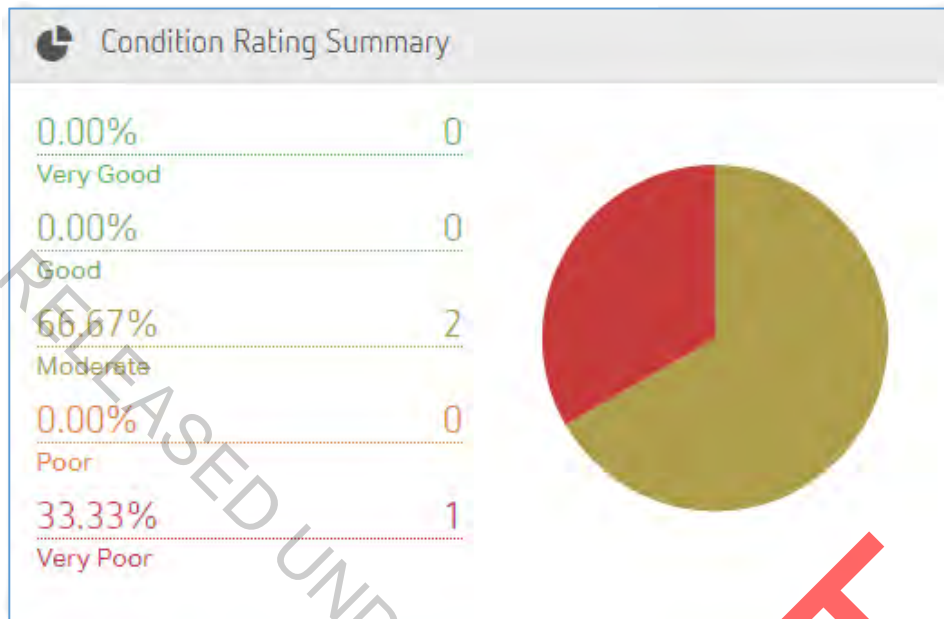
**Figure 79** Building 22- condition of roof

- Main Building: There are a number of visible defects;
  - Numerous cracked tiles
  - Evidence of roof leaks being temporarily repaired with sealant.
  - The gutters are rusted trough in places, there are also several joints that are leaking.

- Down pipes are rusted through in places, particularly in the internal courtyard. The down pipe on Elevation 19 is leaking at a high level, suggesting that it is completely blocked.

- Roof extension: Large areas of the roof have been painted with a mastic sealant, presumably to fix leaks. It may be prudent to coat the entire roof with a suitable painted membrane or lay Butanol or similar.

- Gutters and downpipes should be replaced, with the storm water laterals checked for blockages. The gutters should then be maintained with regular cleaning. Consideration should be given to replacing the entire roof- if this is not possible, then a competent roofer should permanently repair the old leaks, and replace any cracked tiles.

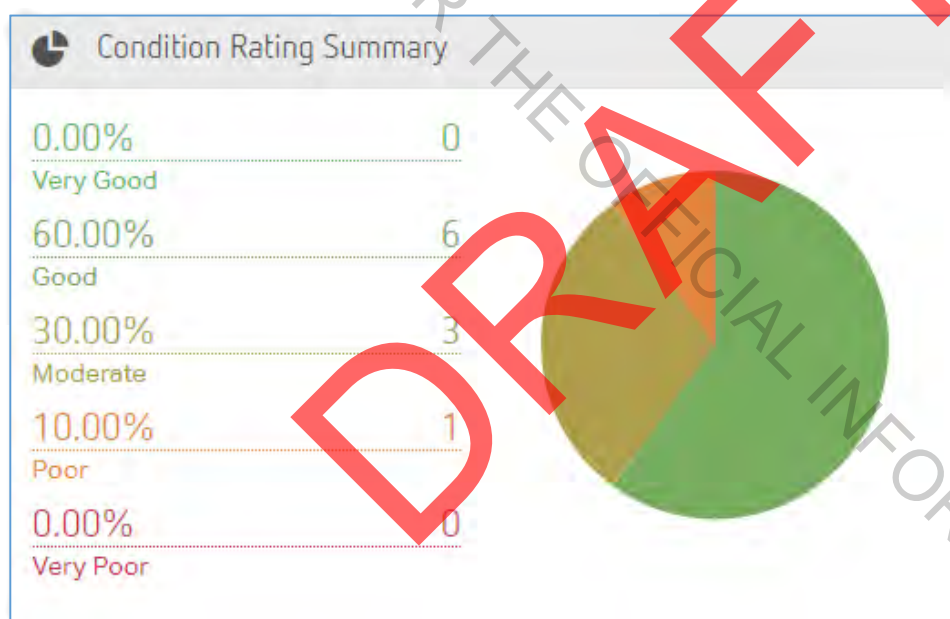
The heating plant for Building 22 is situated in the Calorifier Room. The system includes a modern condensing gas boiler supplying heating hot water, replacing site-reticulated heating water as the energy source. The boiler, expansion tank and circulation pumps for comfort heating, calorifier heating and for domestic hot water circulation have been replaced in recent years and are in the first half of their service lives. The domestic hot water calorifier and control valves are original plant and are nearing the end of their service lives. The heating control panel which includes pump controls and heating zone controls is of the same vintage.

**Figure 80** Building 22 condition of mechanical systems

The controls equipment should be replaced when the main switchboard and distribution switchboards are replaced within five years. The calorifier should be replaced within a similar time frame.

The boiler and circulation pumps should have an expected remaining service life of ten years.

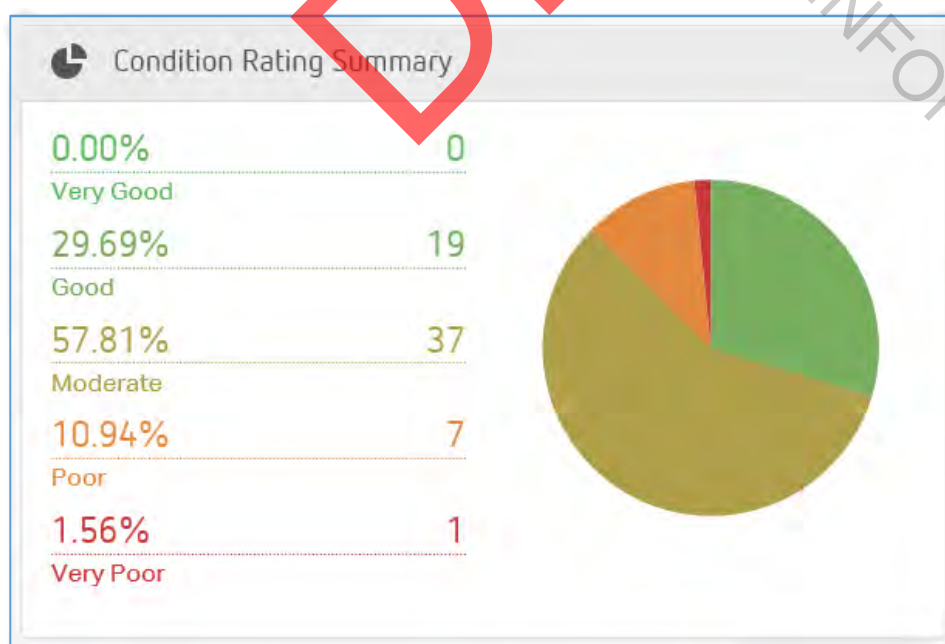
Figure 83 Building 23 Condition of Exterior Elevations

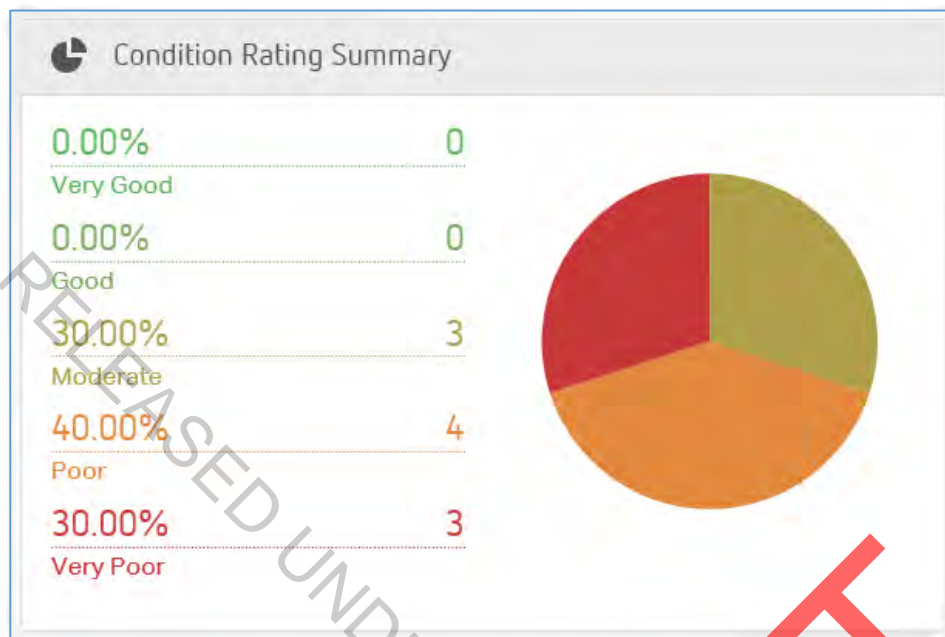
**Figure 84** Building 23 Condition of Roof

- Gutters and spouting in poor condition
- Section of roof flashing missing and damage to ridge flashing
- Lichen build up in shaded areas requires spraying
- Concrete blocks and steel used to hold down sections of roofing, permanent repair required
- Windows require repainting
- Roof vents removing paint from sections of roof

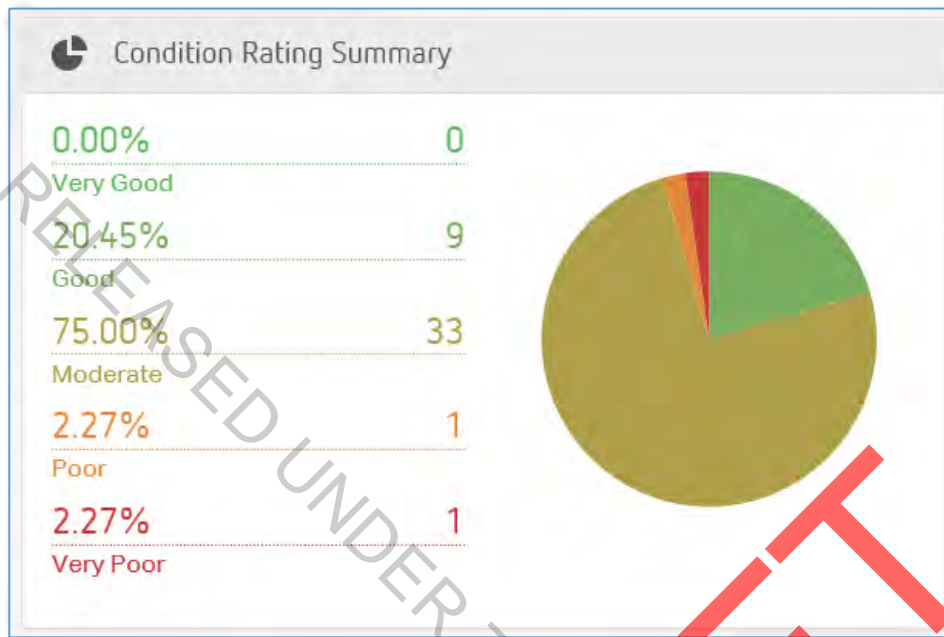
While some systems have been recently retro-fitted and have long remaining service lives, much of the plant is well into the latter end of its useful service life.

Ventilation plant including air handling and evaporative chillers located on level four of the laundry appears similarly to be nearing the end of its economic service life.

**Figure 85** Building 23 Condition of Mechanical Systems

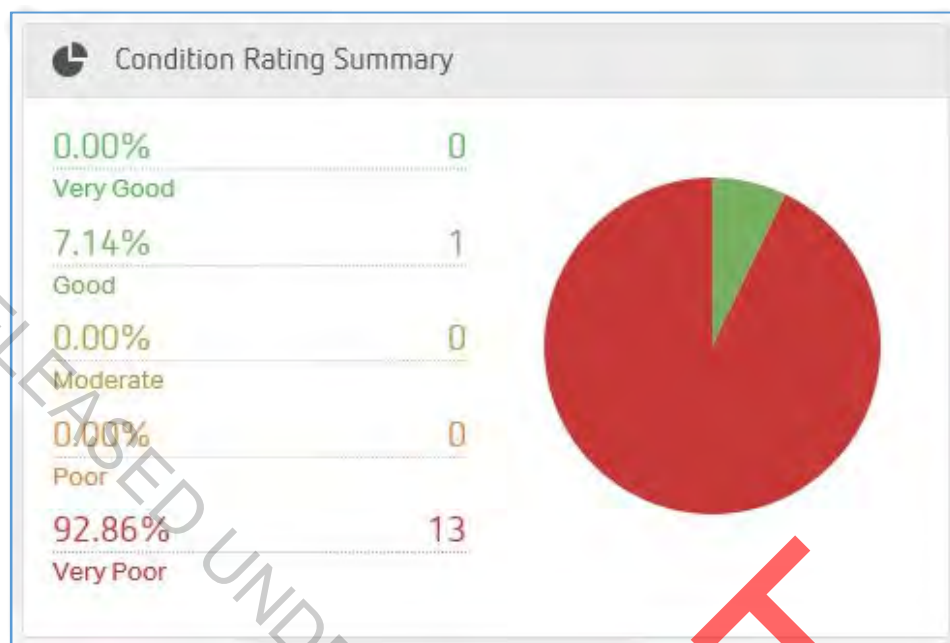
The distribution switchboards and mechanical controls boards servicing Building 23 are of the same age as the main switchboard and similarly, a replacement should be considered.

The exception is distribution switchboard DB-4, which is in good condition with modern switchgear and equipment.

**Figure 86** Building 23 Condition of Electrical Systems

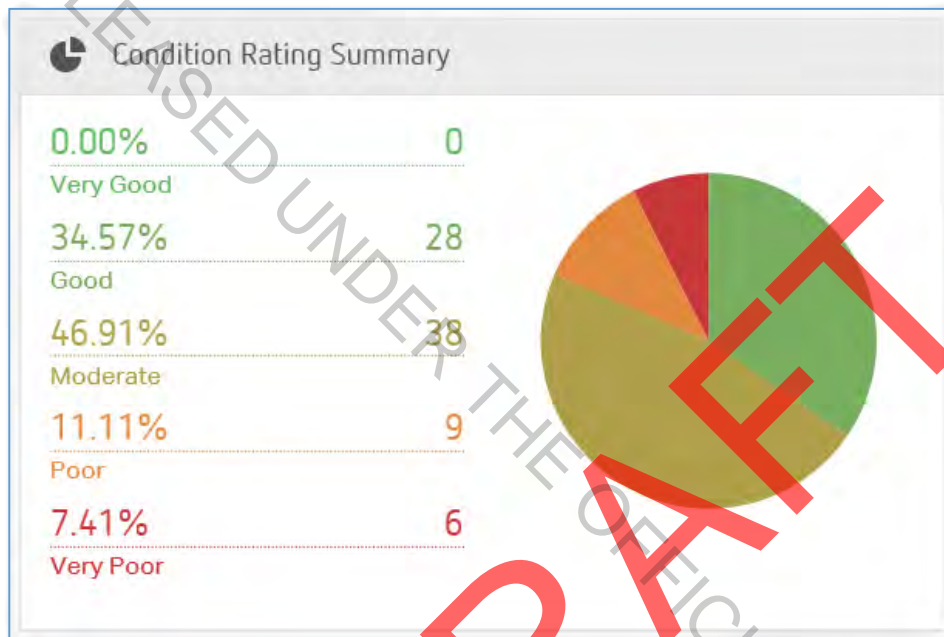
The overall condition of the building is rated at 2.5

Figure 87 Building 31 Overall Building Condition

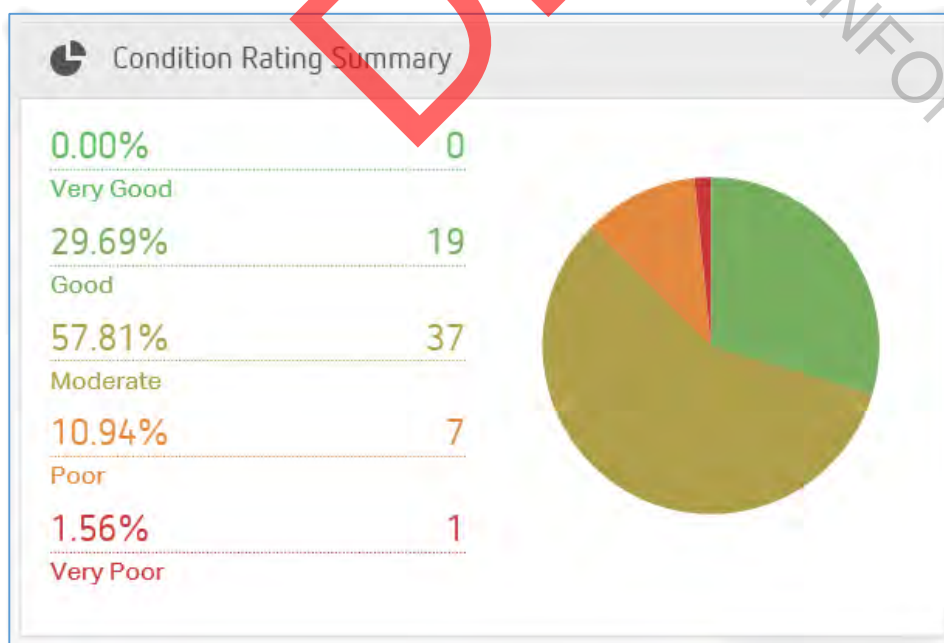
Figure 88 Building 31 Condition of Exterior Elevations

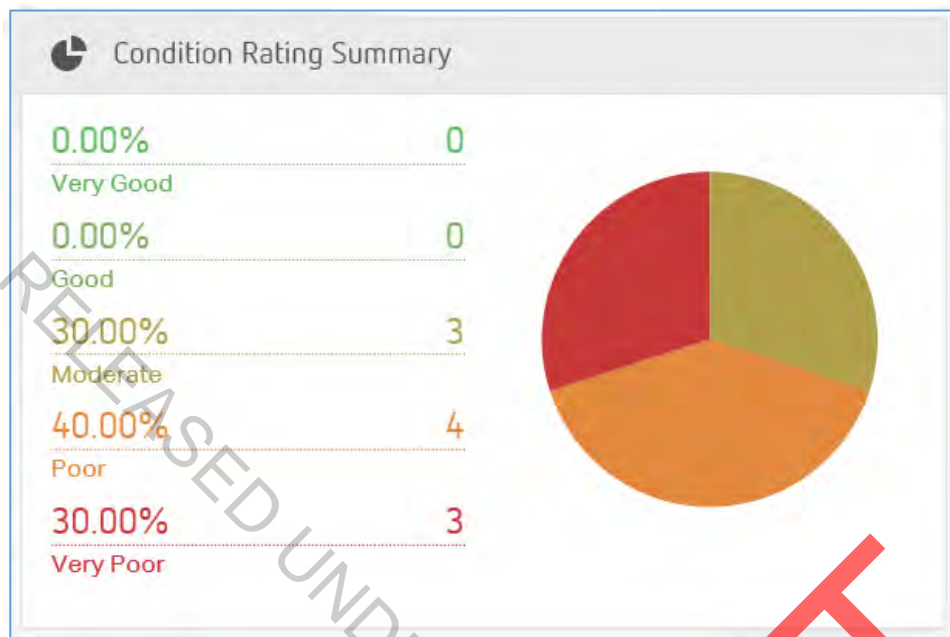
**Figure 89** Building 31 Condition of Roof

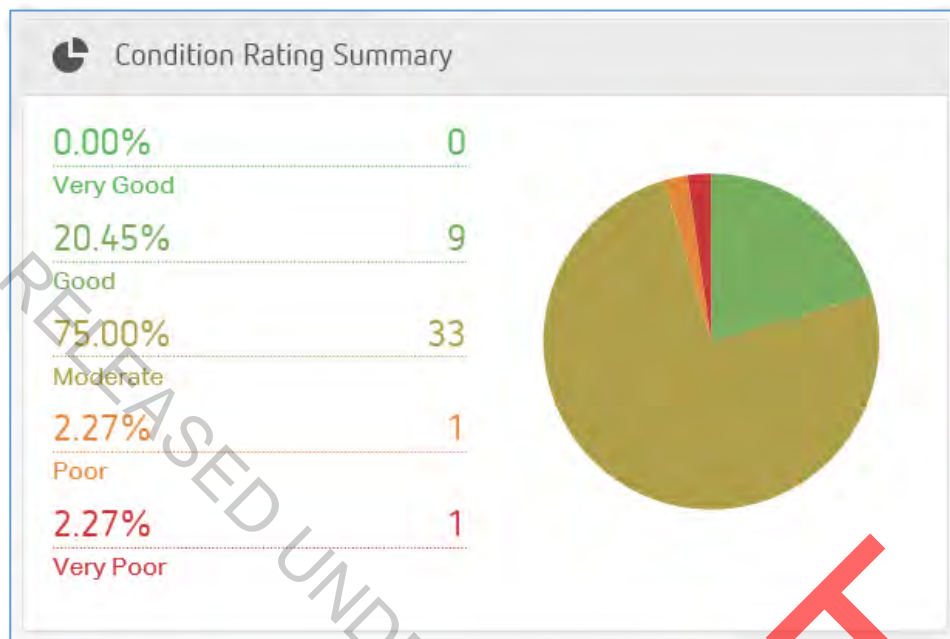
The heating plant for Building 31 is in the services basement spaces. Steam from the central heating plant is reticulated to the building and distributed to the kitchen. The plant is at or nearing the end of its useful service life.

**Figure 90** Building 31 Condition of Mechanical Systems

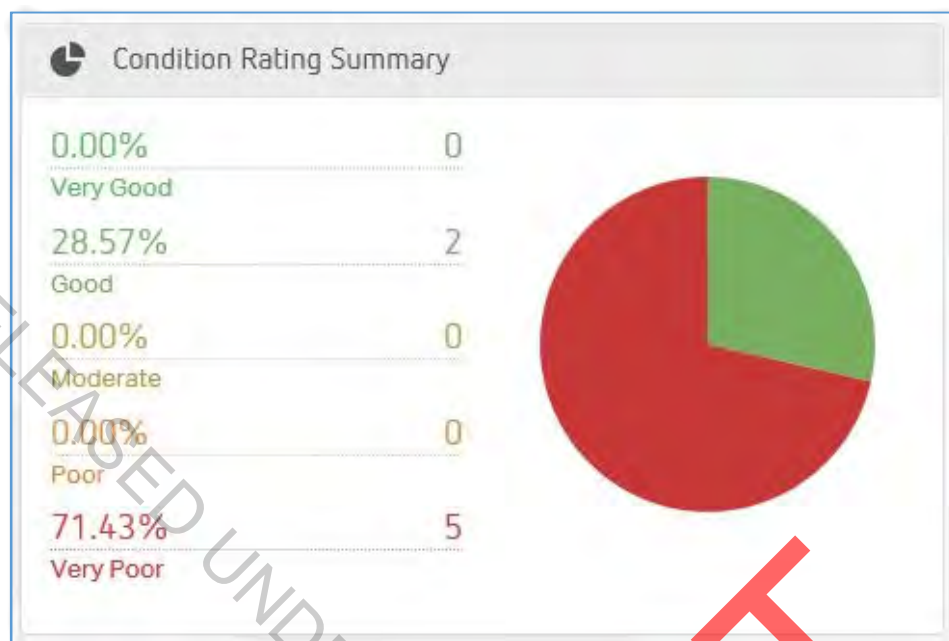
The distribution switchboards and mechanical controls boards servicing Building 31 are of the same age as the main switchboard and similarly, a replacement should be considered.

The exceptions are distribution switchboards DB-1E in the Plant Room and DB.5 in G023, which are in good condition with modern switchgear and equipment.

**Figure 91** Building 31 Condition of Electrical Systems
