RE Official Information Act request CDHB 9830

Door and Window Condition Assessment

Hillmorton Hospital
Te Whare Manaaki
Te Whare Roko

SEPTEMBER 2016
CDH0001.004

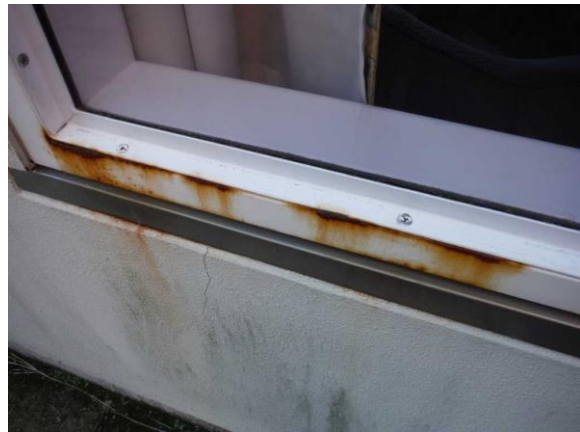
Photograph 315 Window 30

W30	Steel framed single glazed	Anti-tamper screws have been	Poor. Localised areas of severe rusting	Window to be removed and replaced	315-318

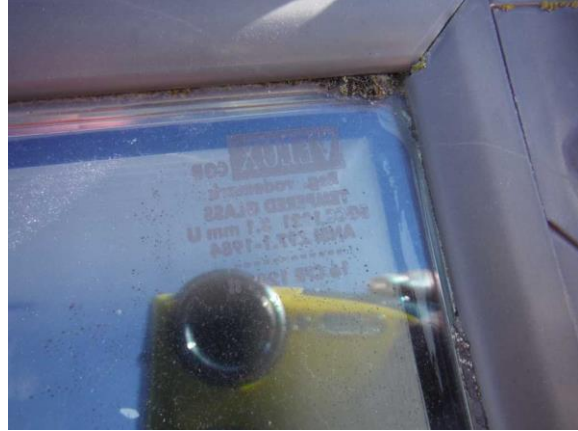
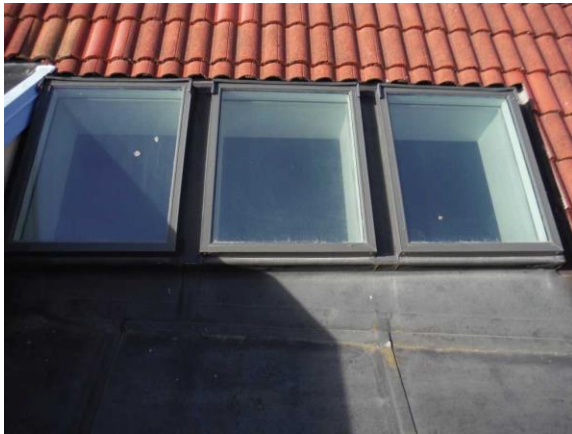
Photograph 479 RL2

RL2	Aluminium Velux rooflight with powdercoated finish	Lapped joints to butyl membrane flashings not sealed.	Reasonable/Satisfactory.	As a temporary repair, we recommend applying a bitumen	479-480

ITEM	CONSTRUCTION	DEFECT	CONDITION	RECOMMENDATION	PHOTO REFERENCE
	and butyl membrane upstand flashings.			jointing tape to the lapped joints in order to prevent future water ingress. Ideally, the butyl around the rooflight upstands should be removed and new pre-fabricated aluminium flashings installed.	
RL3	3x aluminium Velux rooflight with powdercoated finish and butyl membrane upstand flashings.	Localised areas of loose butyl flashings. Isolated lapped joints to butyl membrane flashings not sealed.	Reasonable/Satisfactory. Deteriorated sealant to butyl lapped joints. Minor crazing to rooflight glazing bead to localised area.	As a temporary repair, we recommend applying a bitumen jointing tape to the lapped joints not already sealed and touch up deteriorated sealant. Ideally, the butyl around the rooflight upstands should be removed and new pre-fabricated aluminium flashings installed.	481-484

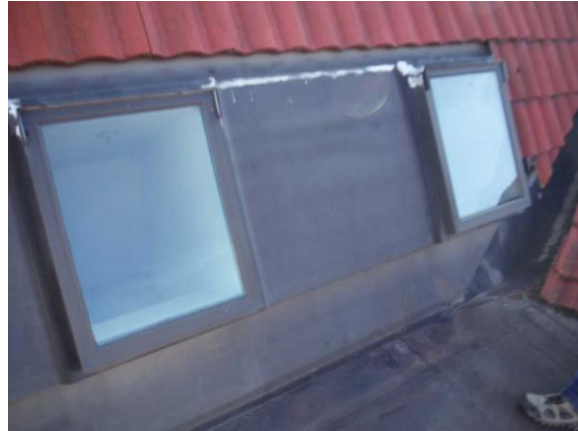
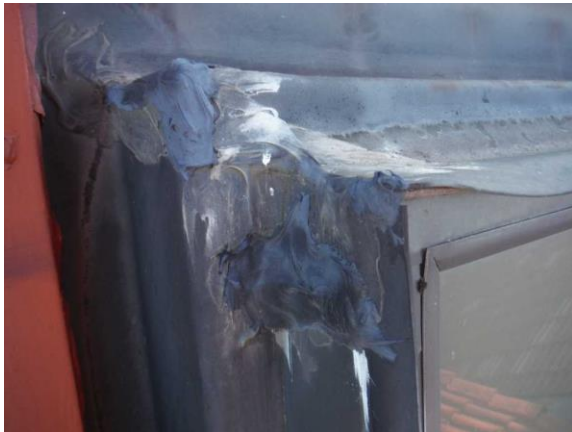
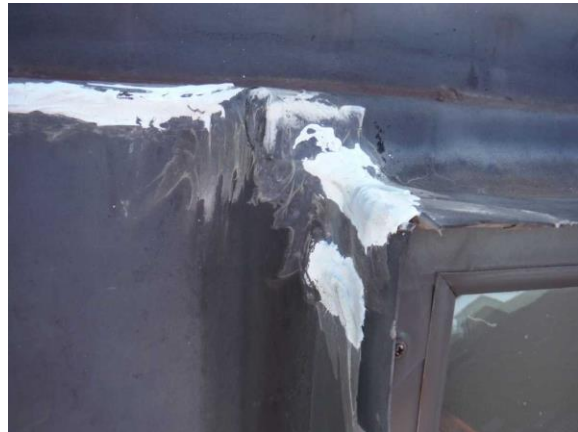
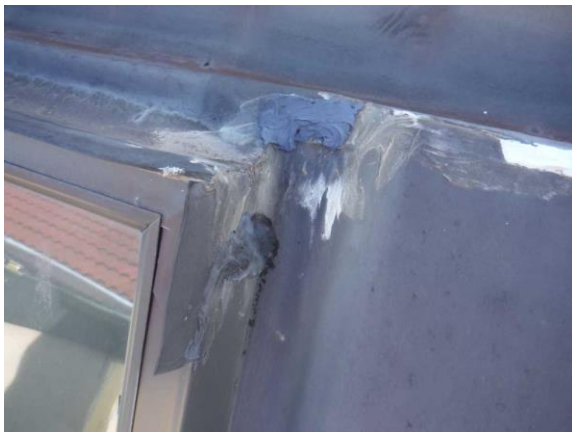
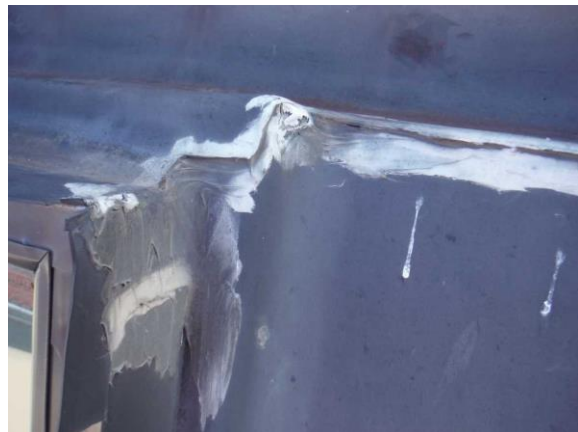
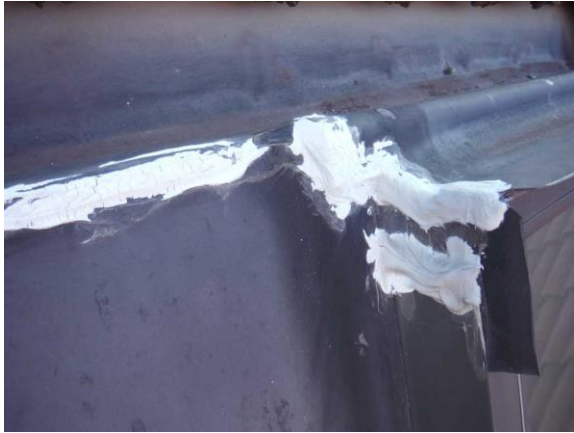
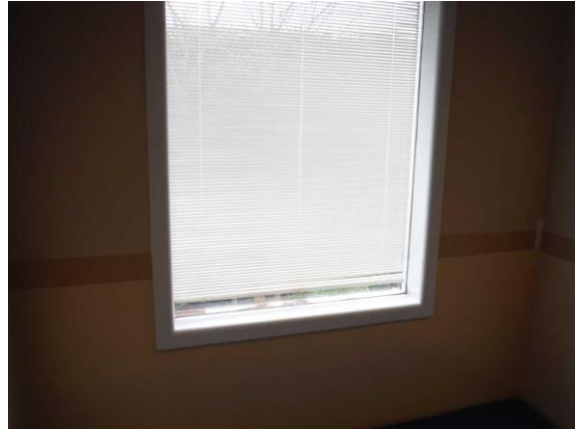
Photograph 485 RL4

RL4	3x aluminium Velux rooflight with powdercoated finish and butyl membrane upstand flashings.	Localised areas of loose butyl flashings. Isolated lapped joints to butyl membrane flashings not sealed.	Reasonable/Satisfactory. Deteriorated sealant to butyl lapped joints.	As a temporary repair, we recommend applying a bitumen jointing tape to the lapped joints not already sealed and touch up deteriorated sealant. Ideally, the butyl around the rooflight upstands should be removed and new pre-fabricated aluminium flashings installed.	485-491
W60	Steel framed double glazed window with integrated venetian blinds and powdercoated finish.	Anti-tamper screws have been fixed through frame to install powdercoated steel framed window beading. Note that bottom rail has received a protective paint coating.	Poor. Severe rusting to bottom spacer and fixings of window cavity. Localised areas of severe rusting and pitting to bottom rail of window casement. Crazing noted to the powdercoated finish. Note that bottom rail has received a protective paint coating.	Window to be removed and replaced with new steel framed security window inclusive of double-glazed anti-bandit glazing, hardware and associated flashings.	492-494
