RE Official Information Act request CDHB 9834

Canterbury DHB does have two buildings at its Hillmorton campus that have retrofitted steel frame security doors and windows that are in poor condition. Those doors and windows have anti-tamper screws installed through the steel frame that have compromised the durability of the powdercoat finish. As a result, there is some water ingress and corrosion of the steel frame reported. We attach as **Appendix 1** a condition assessment report dated September 2016 obtained in respect of those buildings.

2.3 Door and Window Condition Schedule

Appendix B Site Plans - Window & Door Repair Strategy

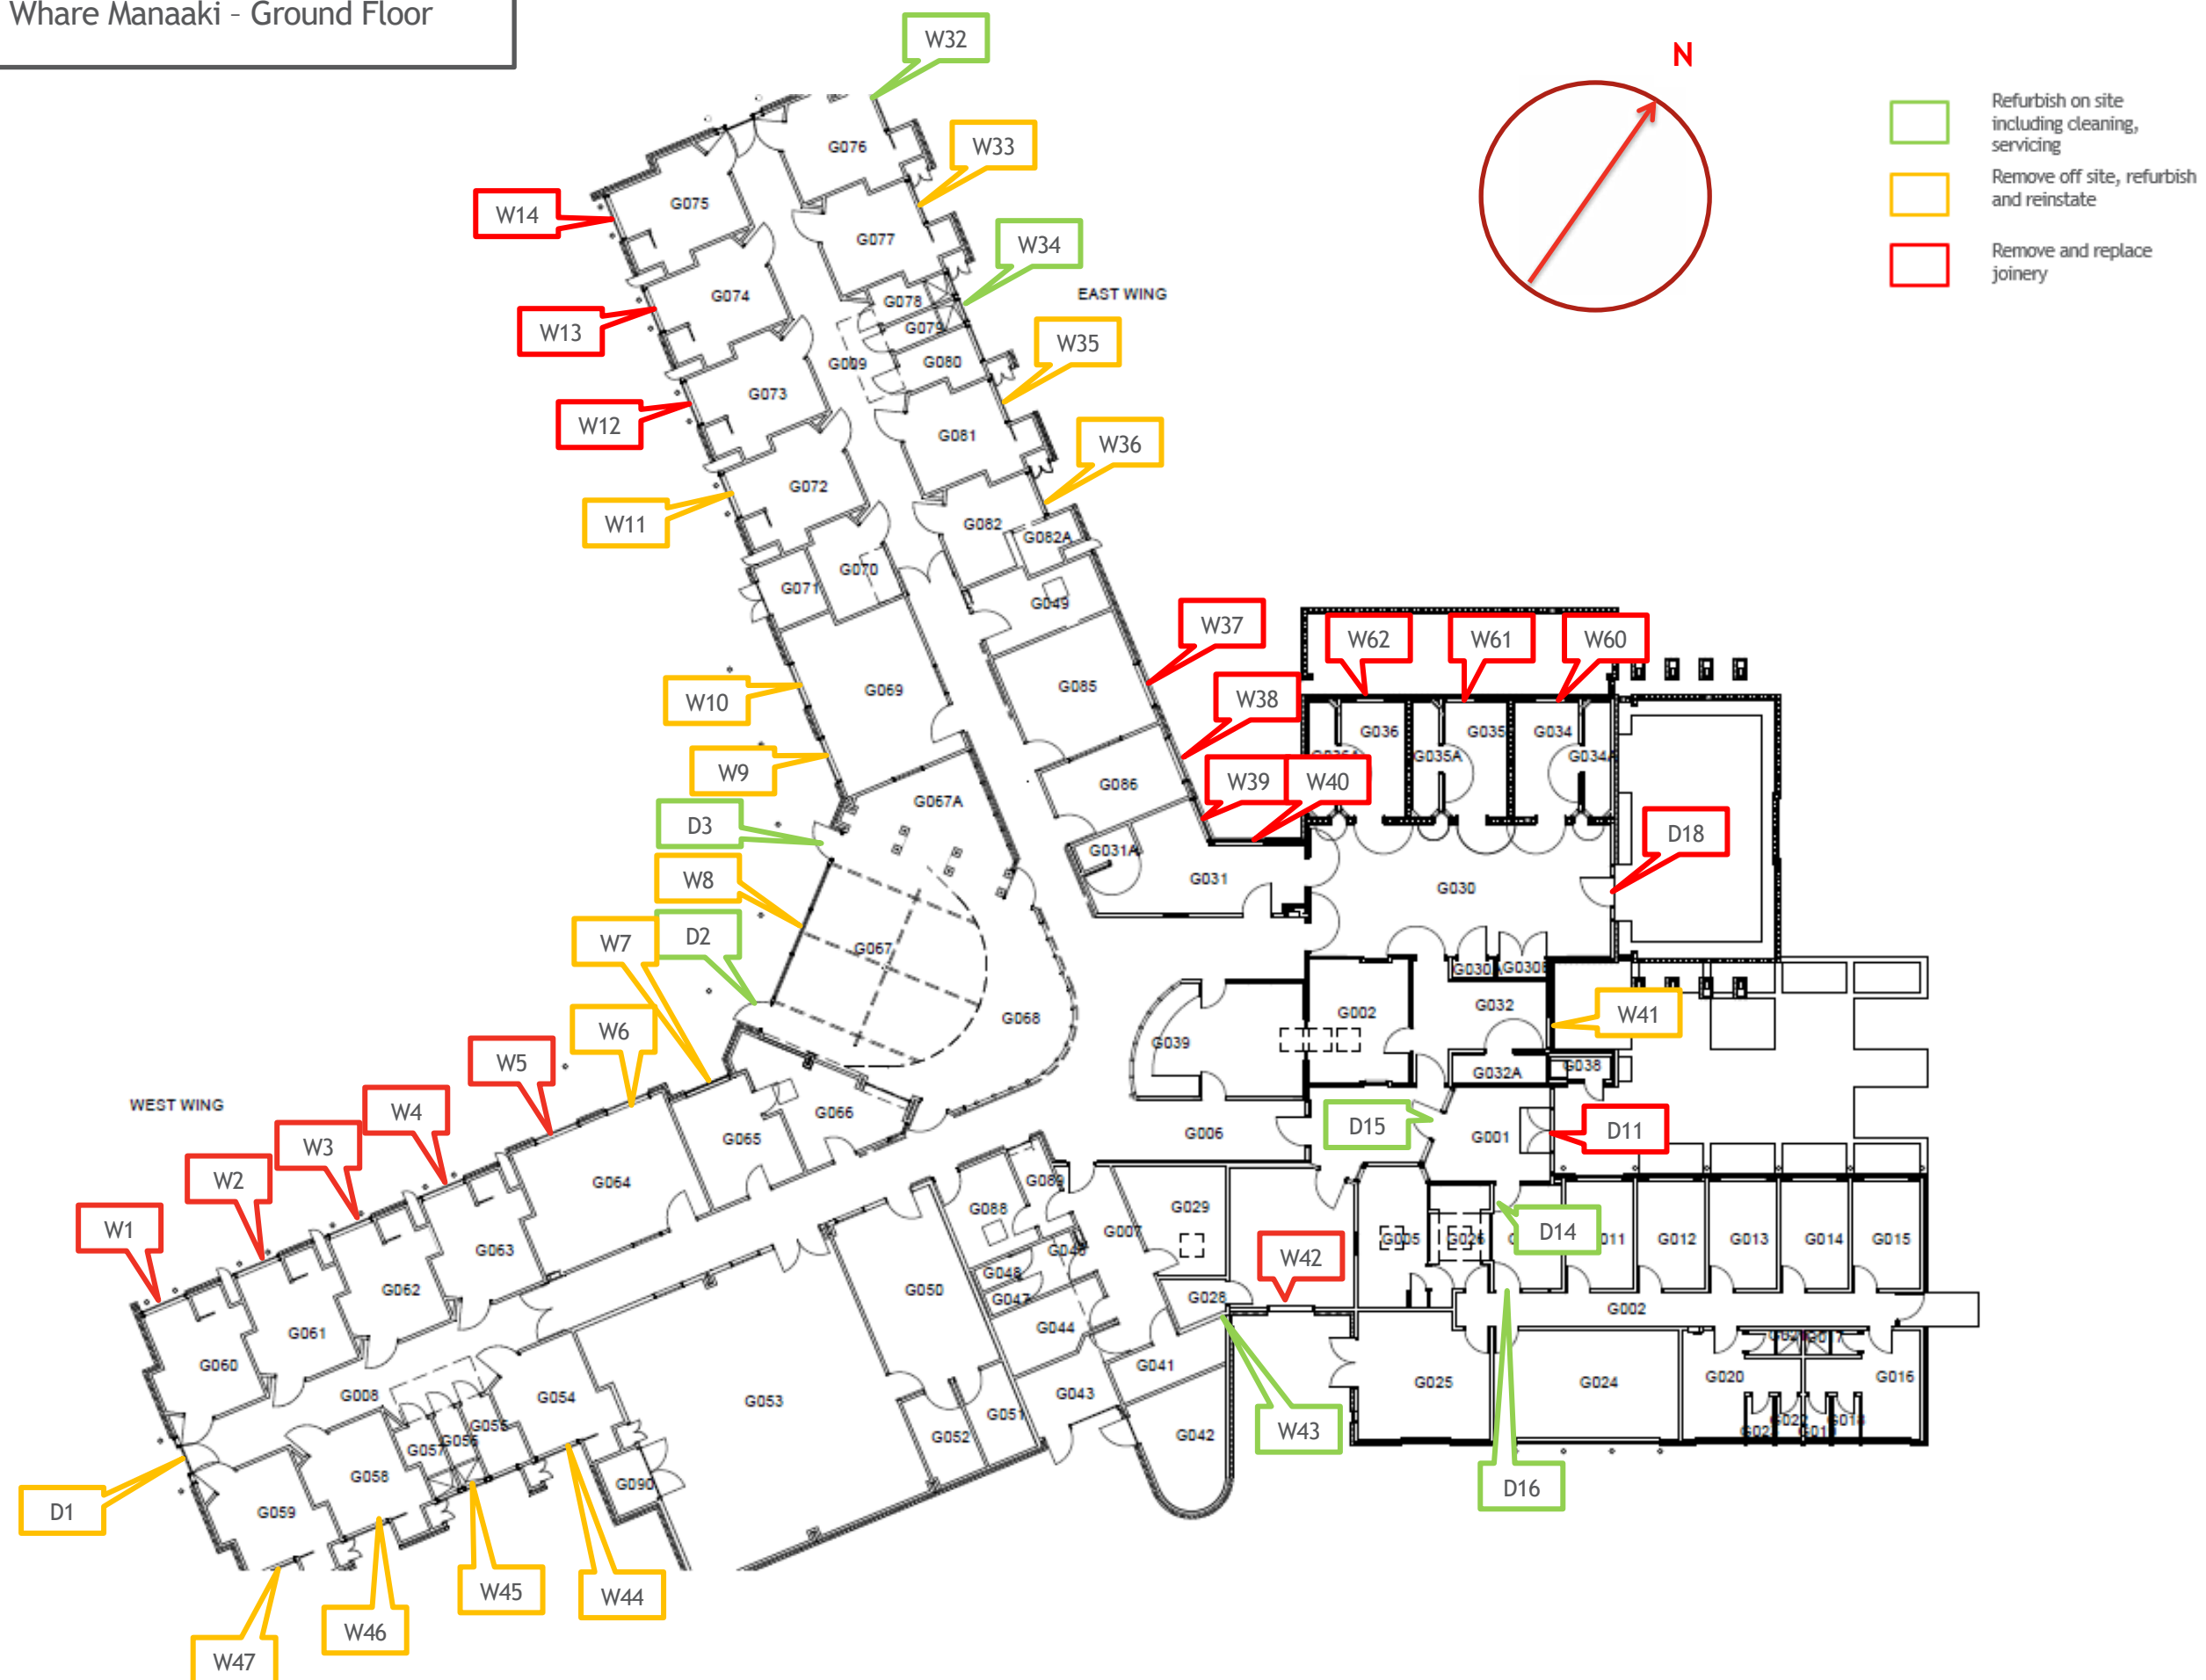
Te Whare Manaaki

Te Whare Hohou Roko

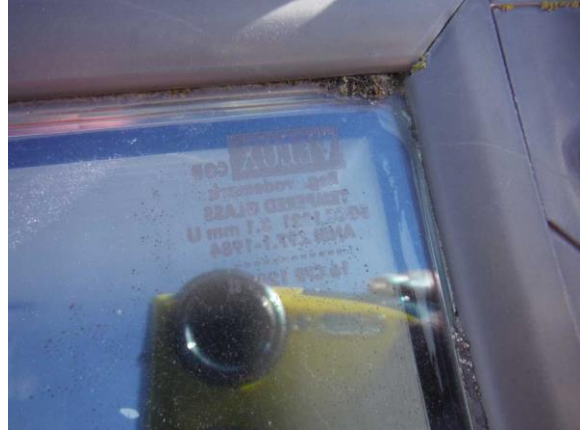
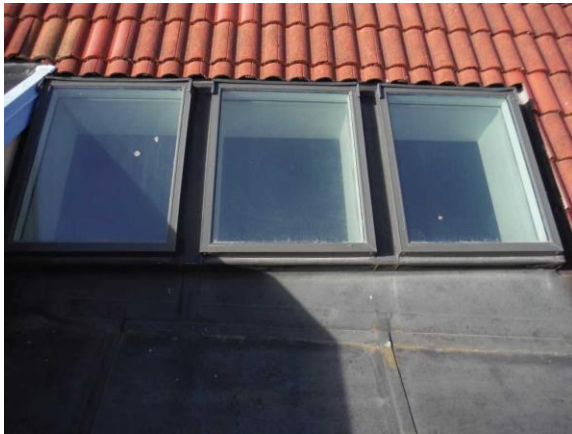
Photograph 479 RL2

RL2	Aluminium Velux rooflight with powdercoated finish	Lapped joints to butyl membrane flashings not sealed.	Reasonable/Satisfactory.	As a temporary repair, we recommend applying a bitumen	479-480

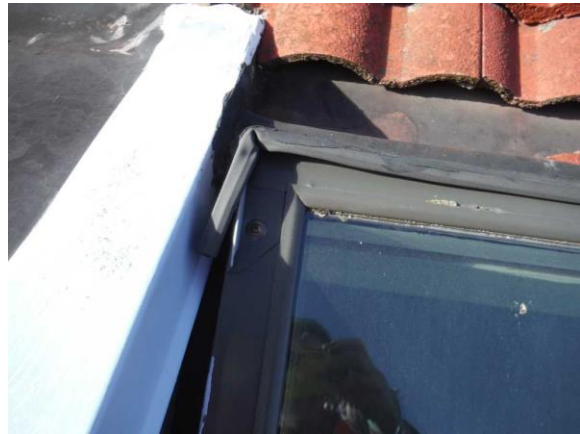
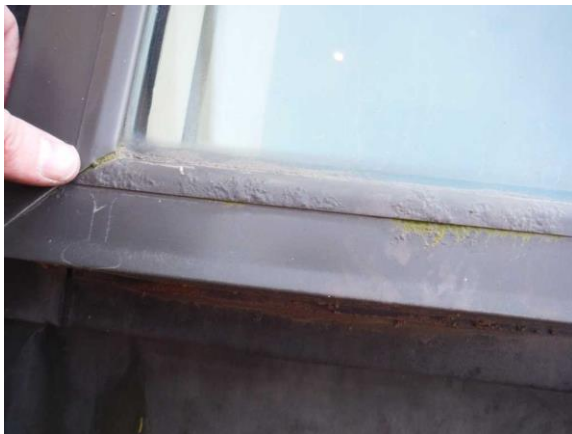
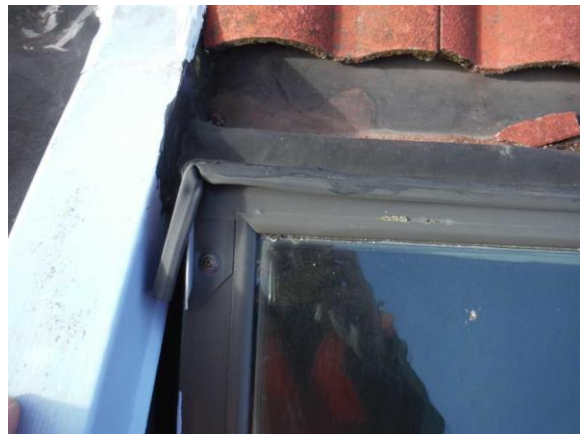
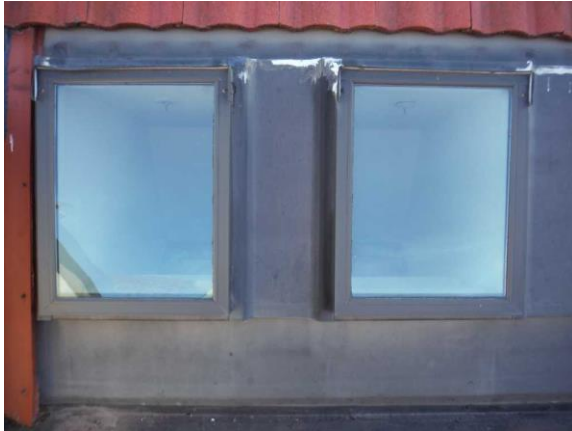
Photograph 481 RL3

ITEM	CONSTRUCTION	DEFECT	CONDITION	RECOMMENDATION	PHOTO REFERENCE
	and butyl membrane upstand flashings.			jointing tape to the lapped joints in order to prevent future water ingress. Ideally, the butyl around the rooflight upstands should be removed and new pre-fabricated aluminium flashings installed.	
RL3	3x aluminium Velux rooflight with powdercoated finish and butyl membrane upstand flashings.	Localised areas of loose butyl flashings. Isolated lapped joints to butyl membrane flashings not sealed.	Reasonable/Satisfactory. Deteriorated sealant to butyl lapped joints. Minor crazing to rooflight glazing bead to localised area.	As a temporary repair, we recommend applying a bitumen jointing tape to the lapped joints not already sealed and touch up deteriorated sealant. Ideally, the butyl around the rooflight upstands should be removed and new pre-fabricated aluminium flashings installed.	481-484

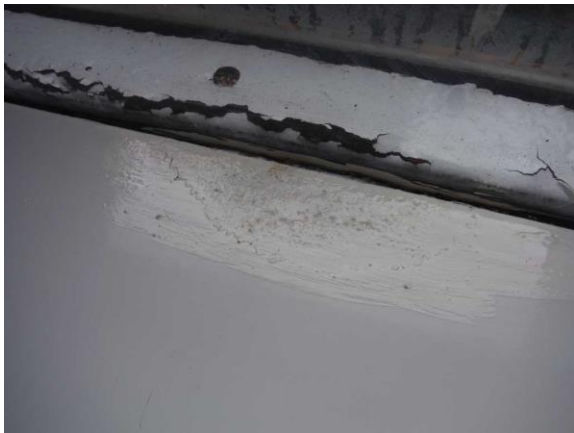
Photograph 495 W61

W61	Steel framed double glazed	Anti-tamper screws have been	Poor. Severe rusting to bottom spacer	Window to be removed and replaced	495
